Coal Terminal Maintenance Analysis

RECLAIMER

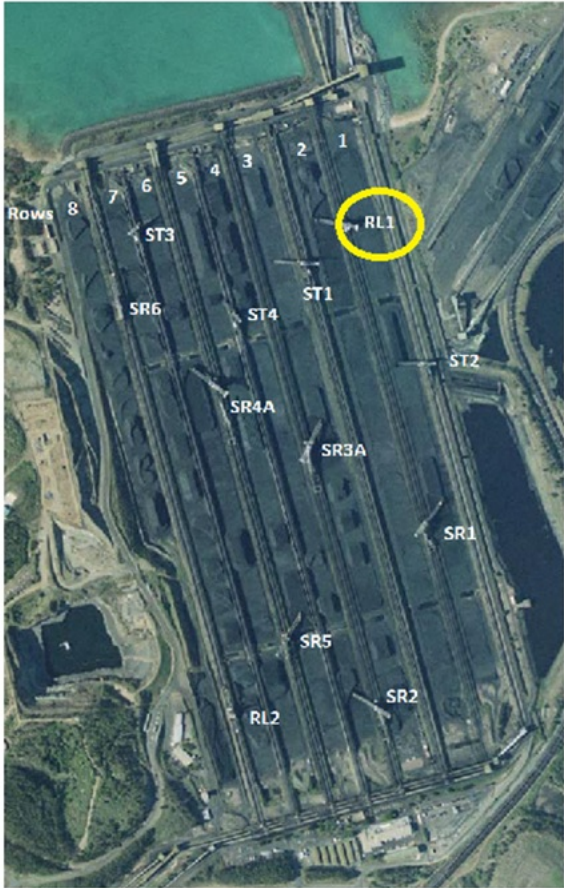
The image above illustrates the 8-hour moving average of idle capacity for Reclaime-1 (RL1), expressed as a percentage of nominal capacity.

Throughout the month RL1 exceeded the allowable threshold multiple times.

2nd September - rolling average peaked at 14%

14th September - rolling average peaked at 12%

21st September - rolling average peaked at 15%

30th September - rolling average peaked at 13%

In addition, the data shows upward trend in the unused capacity for this machine. If the trend continues, every hour of operation will be increasing idle capacity by approximately 0.06% in the long run. It is evident that this machine requires maintenance in the upcoming month.

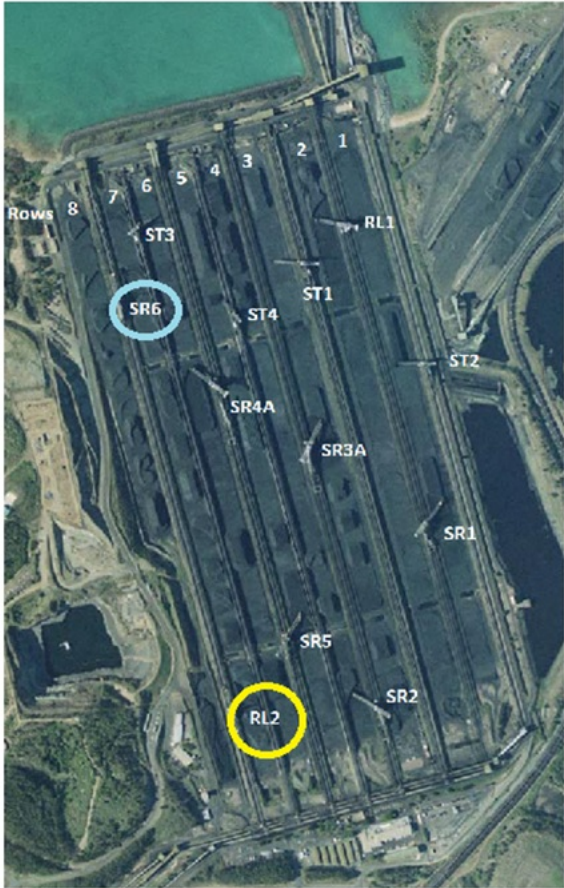
The image above illustrates the 8-hour moving average of idle capacity for Reclaimer-2 (RL2), expressed as a percentage of nominal capacity.

The chart shows that at no given point in time did the 8-hour average exceed the threshold of 10%. This suggests that the machine is running smoothly and does not require maintenance.

The chart at the 10th September 2015, suggests that the machine was working at full capacity for a prolonged period of time. Further investigation of the data showed that possibly this may have been achieved at the expense of sacrificed utilization of Machine SR6 which will be discussed in the report of this machine.

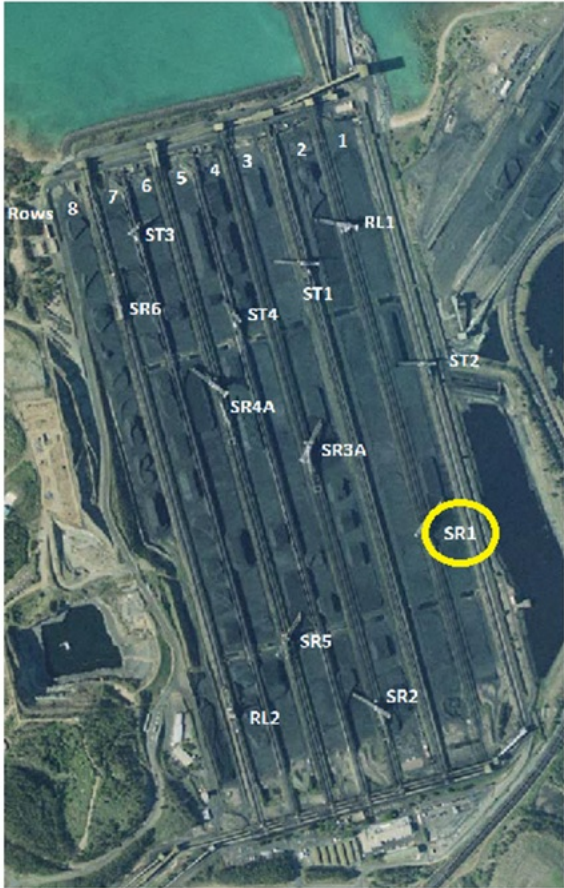
The image above illustrates the 8-hour moving average of idle capacity for StackerReclaimer-1 (SR1), expressed as a percentage of nominal capacity.

The chart shows that at no given point in time did the 8-hour average exceed the threshold of 10%. This suggests that the machine is running smoothly and does not require maintenance.

The gap in the chart is attributed to lack of data for the period of 10 September 00:00 to 16 September 23:00 (inclusive). It is assumed that the machine was performing stacking tasks during the indicated period.

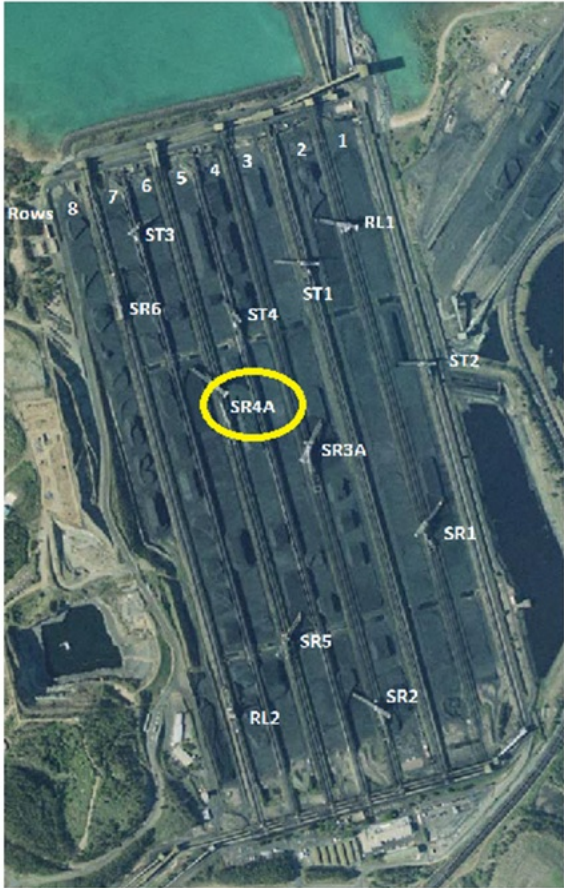
The image above illustrates the 8-hour moving average of idle capacity for StackerReclaimer-4A (SR4A), expressed as a percentage of nominal capacity.

The chart shows that at no given point in time did the 8-hour average exceed the threshold of 10%. However, there is an evident upward trend in the dynamic range of this metric. If this trend continues, the 8-hour moving average of idle capacity is predicted to increase at a rate of approximately 0.13% per hour in the long run. It is highly recommended to review the performance of this machine in the coming weeks as preventative maintenance may be required.

The gap in the chart is attributed to lack of data for the period of 13 September 00:00 to 16 September 23:00 (inclusive). It is assumed that the machine was performing stacking tasks during the indicated period.

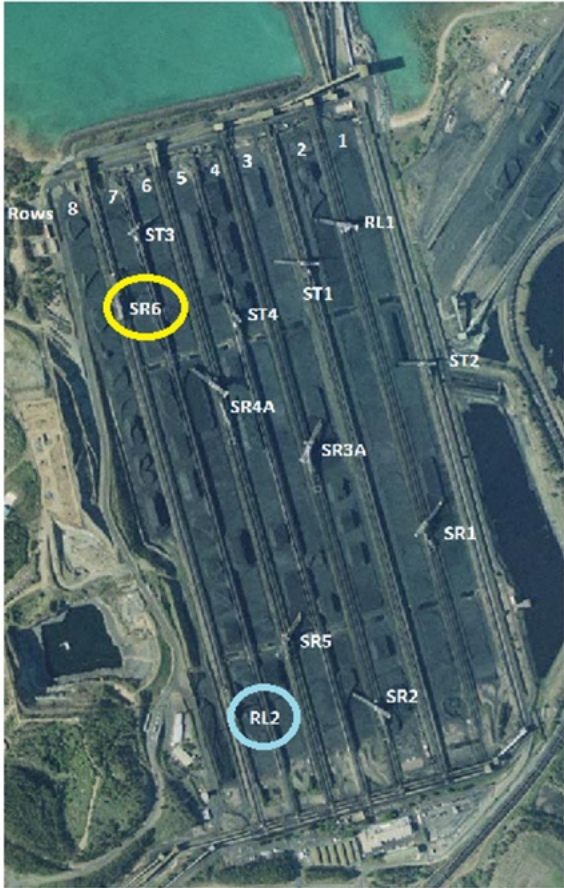
The image above illustrates the 8-hour moving average of StackerReclaimer-6 (SR6), expressed as a percentage of nominal capacity.

The chart shows a surge in the 8-hour moving average of the idle capacity around the 10th of September 2015. Although per standard criterion this suggests that SR6 requires maintenance, this surge doesn't look normal. Further investigation uncovered that for the period between 9 September 19:00 to 10 September 19:00 this machine was operating at the constant reduced capacity of 3,000 tonnes flat. This happens to be the same period when the machine RL2 was operating at its maximum capacity. Given that both these machines are situated on the same line in the stockyard, it may be the case that there was a conflict of tasks between the two machines and priority was given to RL2. If this is the case, then it appears that SR6 does not require maintenance since it has not exceeded the 10% threshold at any other point of the month.
