Overview				Site
Inspect N	34775	Page:	1/1	<div>ROTHERHAM DO/OFF</div> <div>MAIN STREET</div> <div>ROTHERHAM</div> <div>S60 1AA</div>
Job No	12332			
Customer	AECOM			
Contact		Date	26/01/2024	
Tel

ISI Equipment No	Make / Model	Serial No	Client ID
RM090124386	Turnstile Access		A41TURNSTILE01

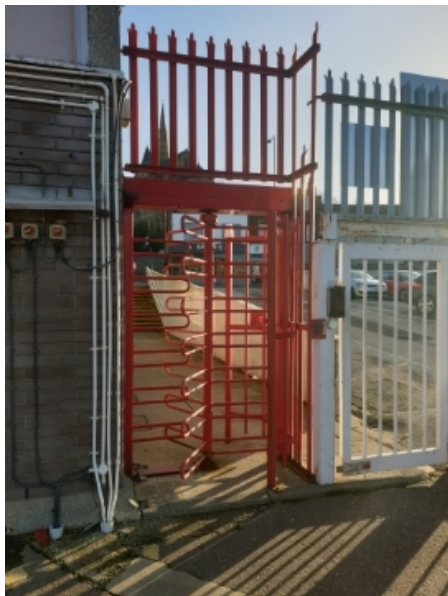
Capture photograph of Asset, including asset number	See Photo 1
---	-------------

Intolerable - Defects requiring immediate action	None
Substantial - Defects requiring attention within a time period	None
Moderate - Other defects requiring attention	signs of heavy corrosion at the base of the turnstile this is to be attended to and rectified to prevent further deterioration
Tolerable - Observations	None
