Re: Incorrect Thermal broken Aluminum Joinery: 2 Rapare St. Job No.27363 - JSR Construction.

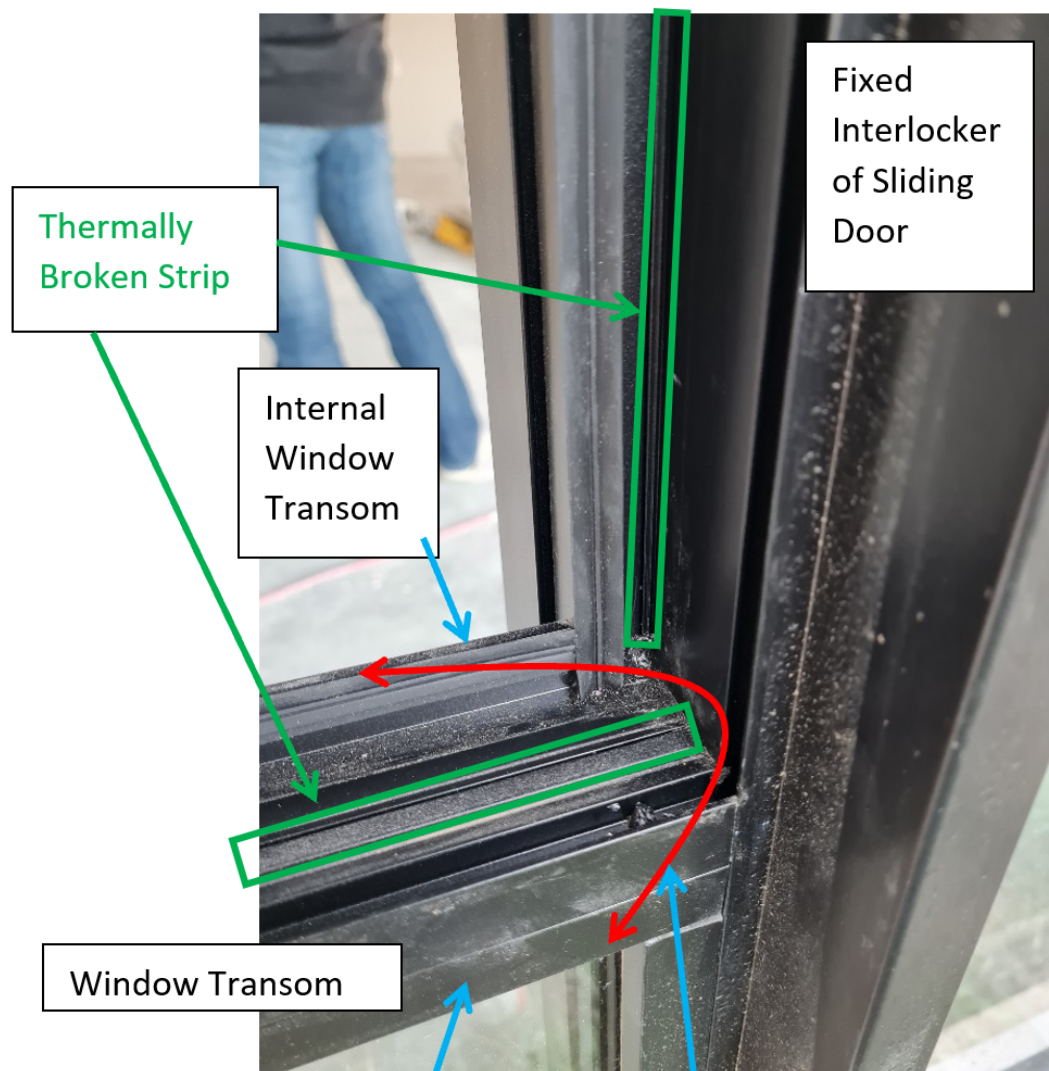
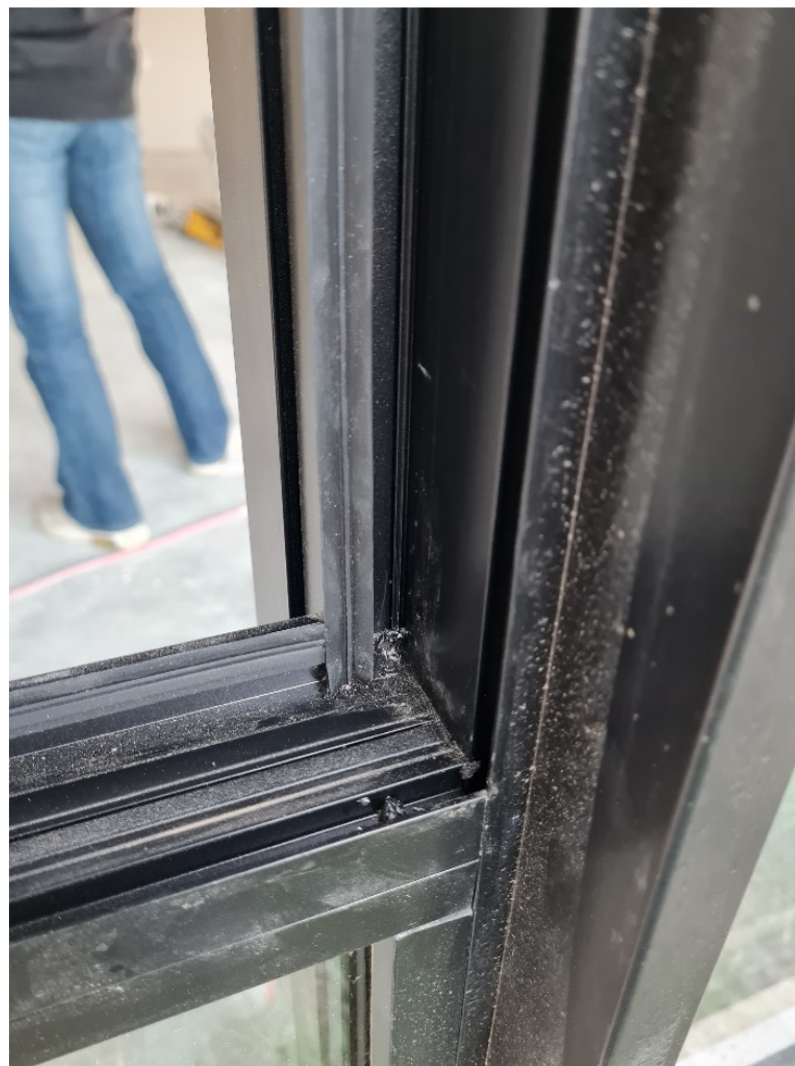
Photo 1: Path of thermal conduction at the joint of window transom and sliding-door fixed interlocker and the same photo without marking is given side by side for easy reference

1. You shall replace all non-thermally broken components of the sliding doors and windows which including but not limited to the stiles and fixed interlocker. There is a path of thermal conduction where it is not thermally broken at the joint of the window transom and sliding-door fixed interlocker as indicated by the red line on the marked photo as shown on Photo 1 below. The same photo without marking is given side by side for easy reference. You are required to change the fixed interlocker to have the proper thermally broken strip align with the strip on the window transom. I also took a thermal image (see Photo 2) with the sunshine reaching half the height of the sliding door. It showed that the non-thermally broken components (the joint in between the interlocker and the window transom, and the stiles) creating a thermal conduction between the internal and external parts of the thermally-broken members (e.g. bottom of the sliding door frames and the window transom).

In short, you are required to at least but not limited to replace the fixed interlocker and stiles with full warranty of the entire products. The details are given below.

Just to let you know that Hagley aluminium has re-ordered all the stiles in thermally broken and we will replace these on site for you once they arrive.

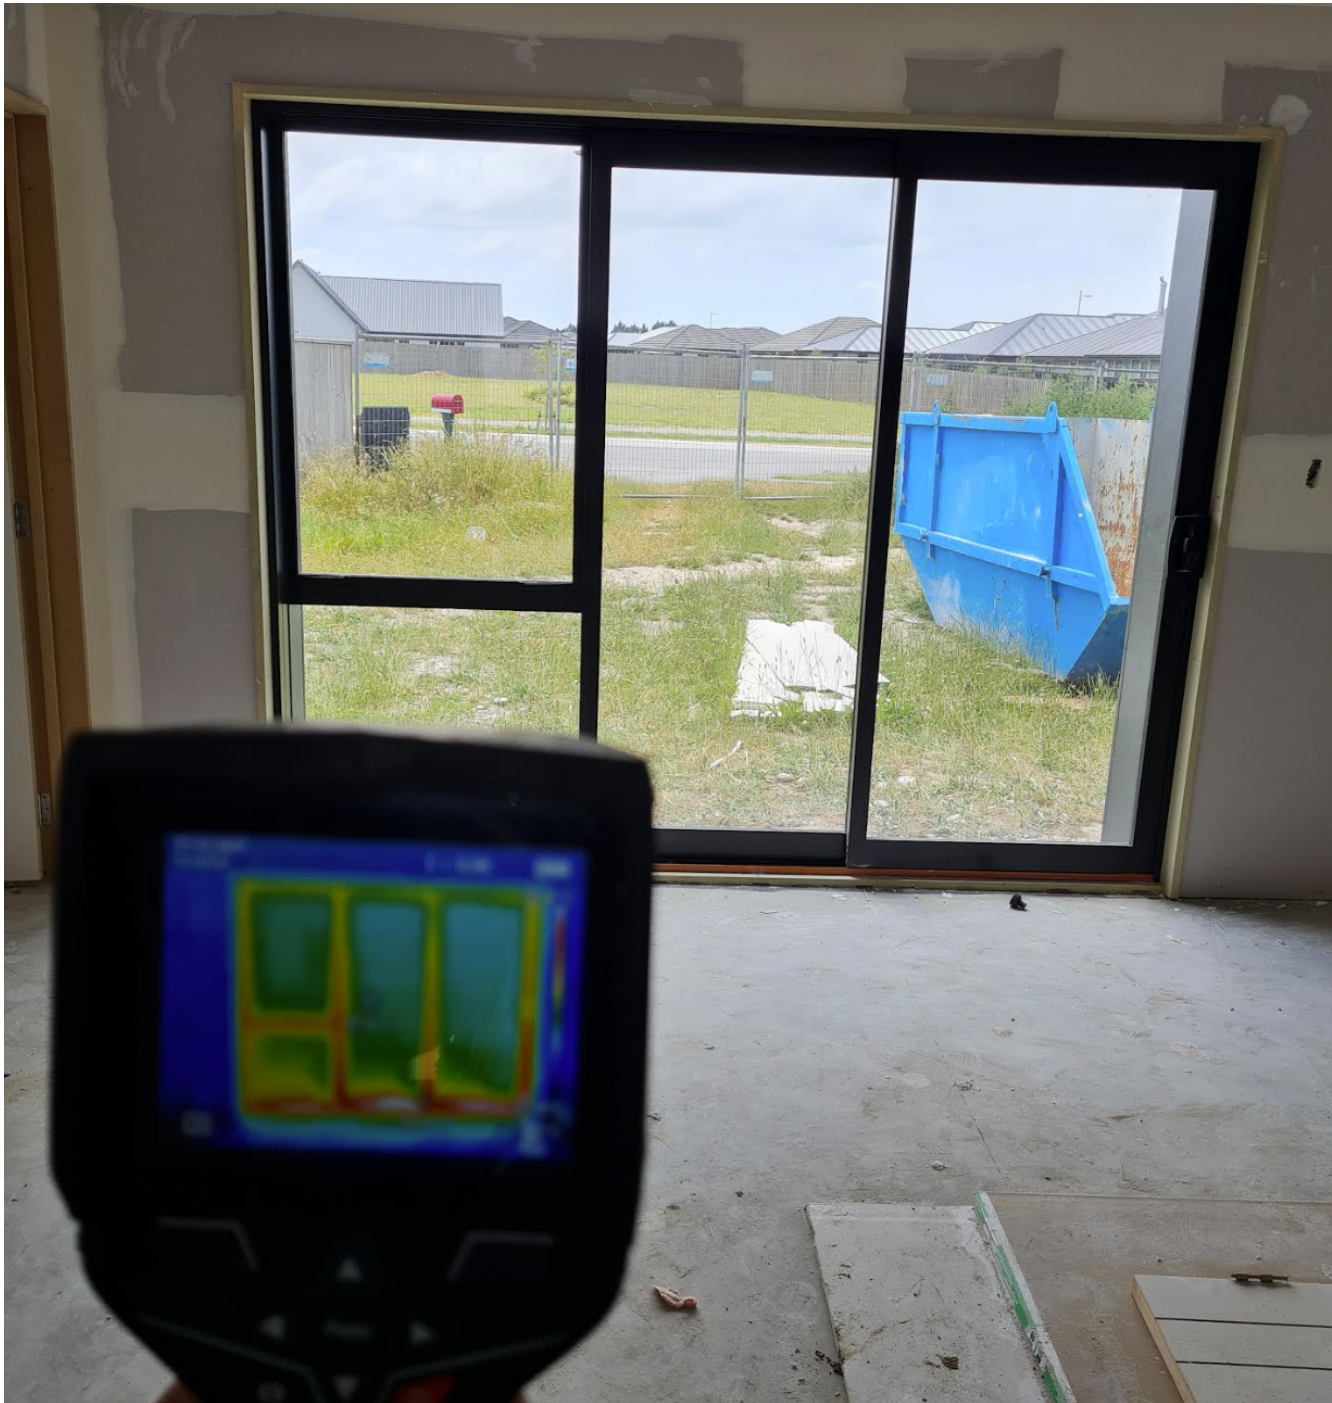
Photo 2: Thermal image of the sliding door and window with the sunshine reaching half the height of the sliding door. It showed that the non-thermally broken components (the joint in between the interlocker and the window transom, and the stile) creating a thermal conduction between the internal and external parts of the thermally-broken members (e.g. bottom of the sliding door frames and the window transom).
