**Re: Incorrect Thermal broken Aluminum Joinery: 2 Rapare St. Job No.27363 - JSR Construction.**

Gmail - Re: Incorrect Thermal broken Aluminum Joinery: 2 Rapare St. Job No.27363 - JSR Construction.

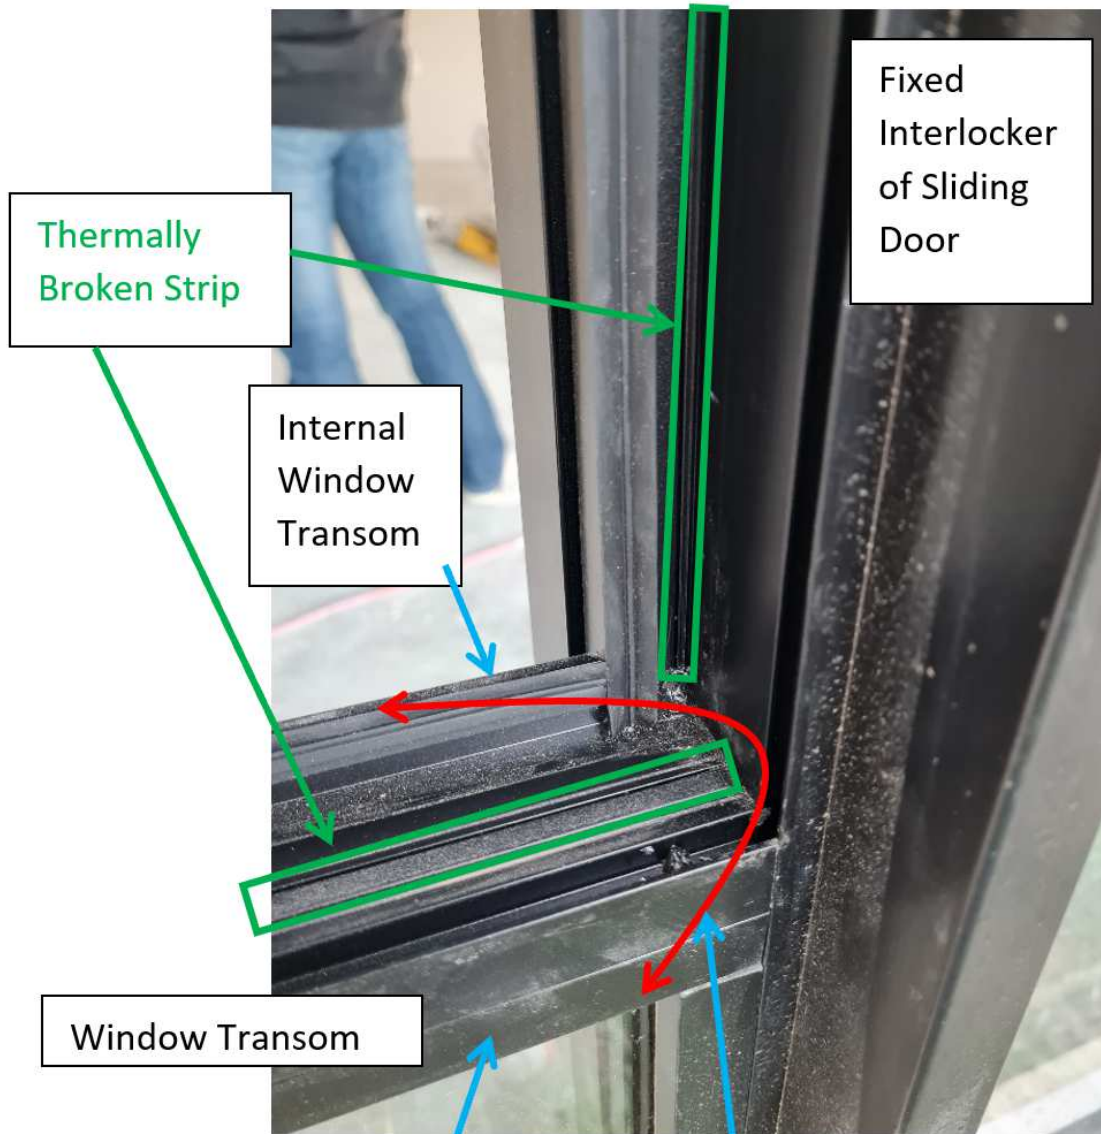
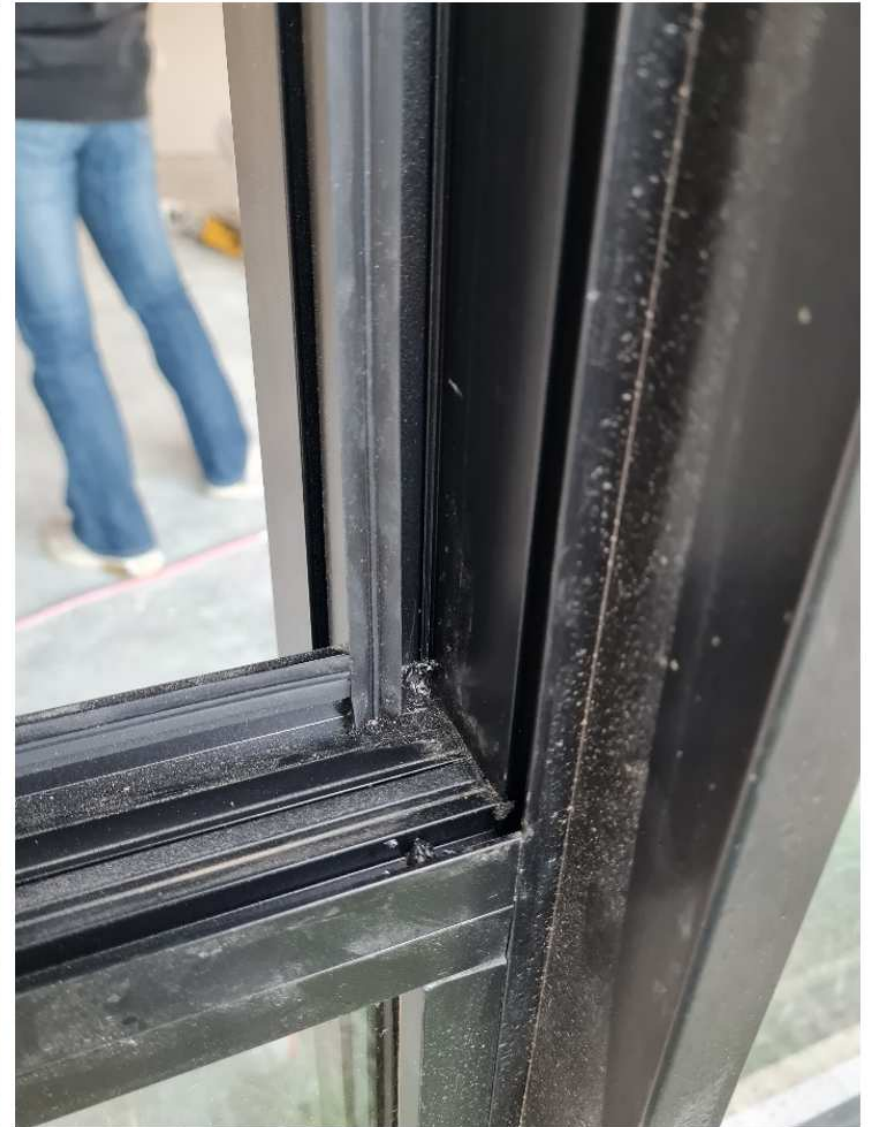
Photo 1: Path of thermal conduction at the joint of window transom and sliding-door fixed interlocker and the same photo without marking is given side by side for easy reference

Path of thermal conduction (red line) between internal and external parts of the window

External Window Transom

1. You shall replace all non-thermally broken components of the sliding doors and windows which including but not limited to the stiles and fixed interlocker. There is a path of thermal conduction where it is not thermally broken at the joint of the window transom and sliding-door fixed interlocker as indicated by the red line on the marked photo as shown on Photo 1 below. The same photo without marking is given side by side for easy reference. You are required to change the fixed interlocker to have the proper thermally broken strip align with the strip on the window transom. I also took a thermal image (see Photo 2) with the sunshine reaching half the height of the sliding door. It showed that the non-thermally broken components (the joint in between the interlocker and the window transom, and the stiles) creating a thermal conduction between the internal and external parts of the thermally-broken members (e.g. bottom of the sliding door frames and the window transom).

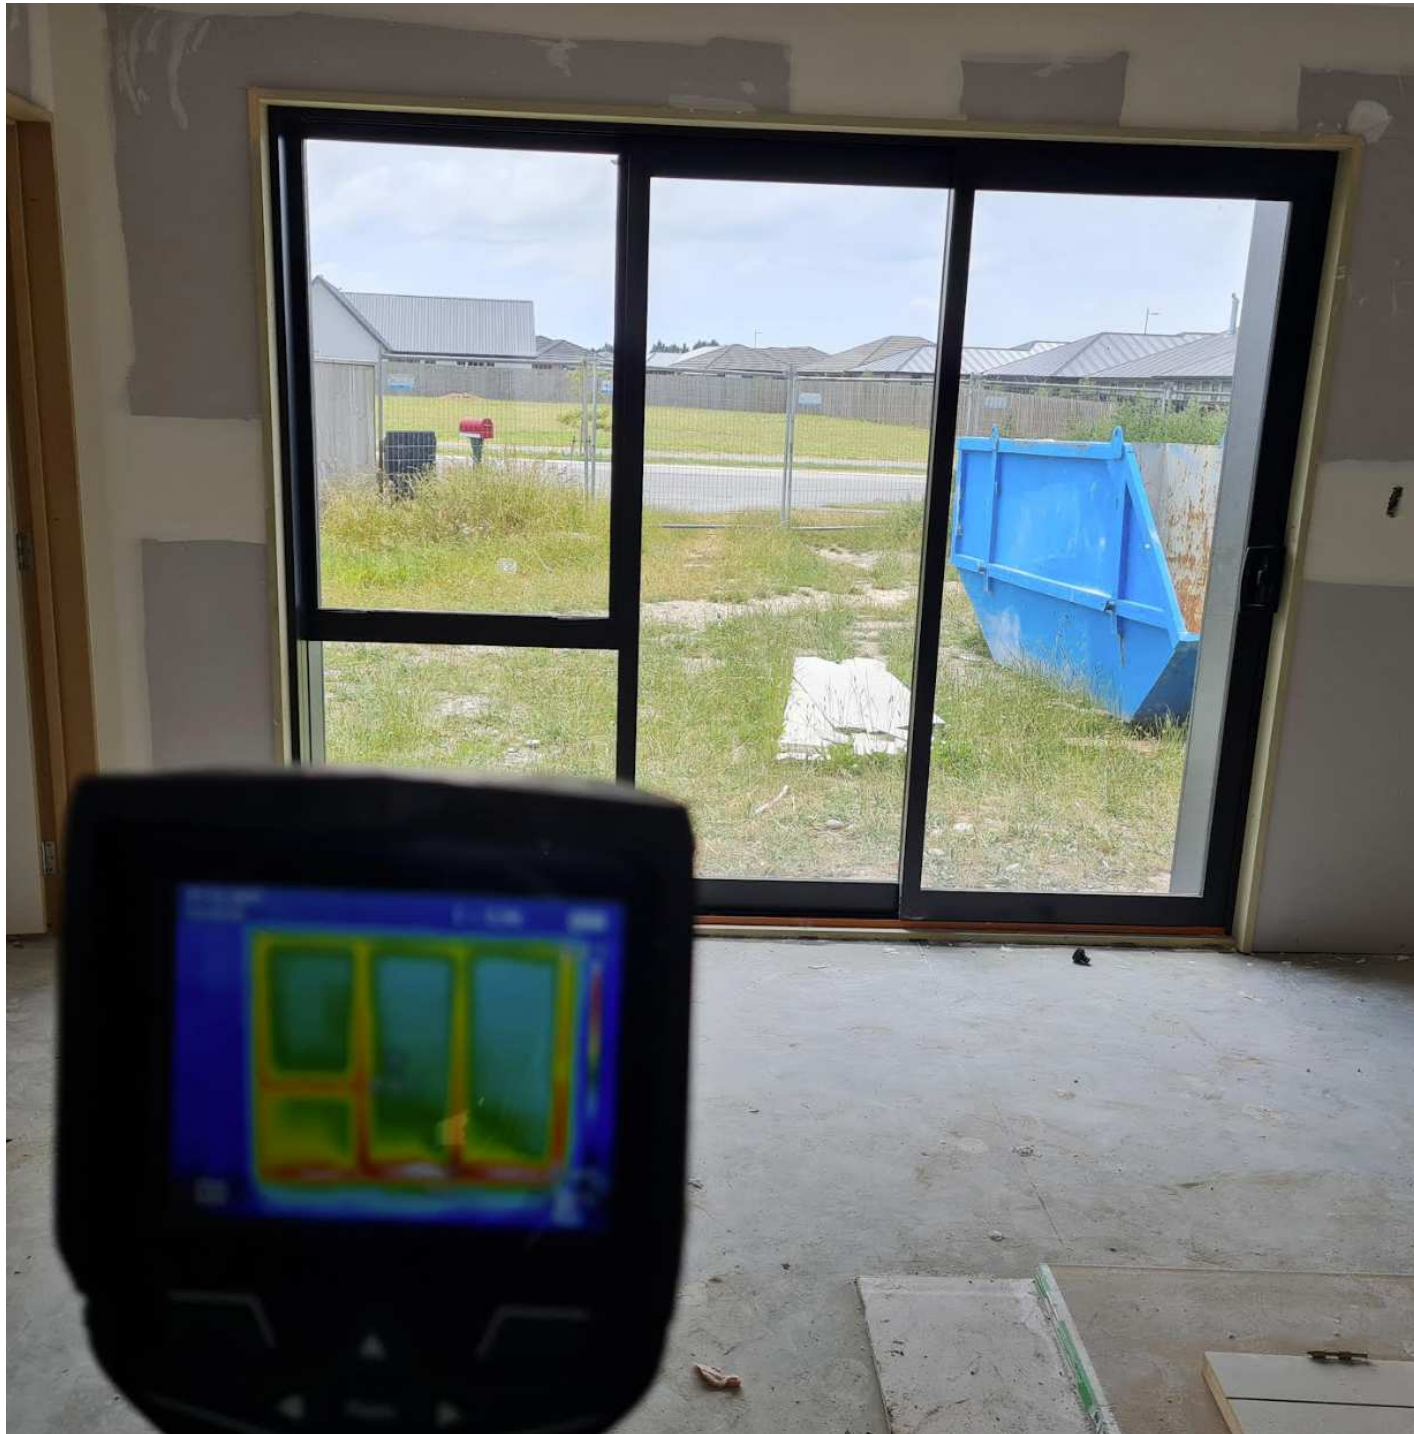
**Photo 2:** Thermal image of the sliding door and window with the sunshine reaching half the height of the sliding door. It showed that the non-thermally broken components (the joint in between the interlocker and the window transom, and the stile) creating a thermal conduction between the internal and external parts of the thermally-broken members (e.g. bottom of the sliding door frames and the window transom).

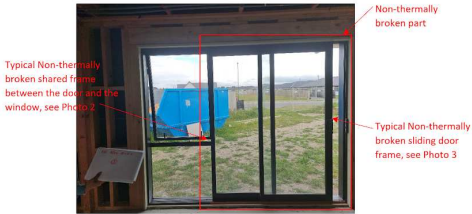
Photo 1 – Indicating the non-thermally broken parts of the Sliding Door “Lounge D6” (Door number referred to the attached quote no. 27363) (Trim Size: 2130 x 2700; Area: 5.751 m sq.)

- a) Photo 1 – Indicating the non-thermally broken parts of the Sliding Door “Lounge D6” (Door number referred to the attached quote no. 27363) (Trim Size: 2130 x 2700; Area: 5.751 m sq.)

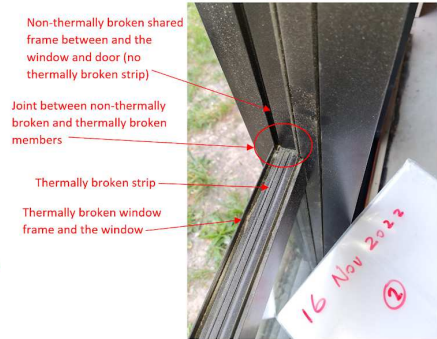
Photo 2 – Typical joint between the vertical frame of the sliding door and the horizontal frame of the window shows that the shared frame between the door and the window do not have the thermally broken strip.

- b) Photo 2 – Typical joint between the vertical frame of the sliding door and the horizontal frame of the window shows that the shared frame between the door and the window do not have the thermally broken strip.

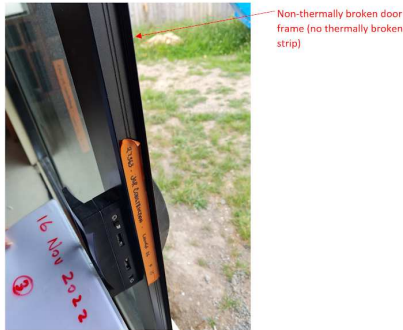
Photo 3 – Typical slide door frame shows that the slide door does not have thermally broken

- c) Photo 3 – Typical slide door frame shows that the slide door does not have thermally broken strip
  - d) Photo 4 – Indicating the non-thermally broken parts of the Sliding Door “Living D6” (Door number referred to the attached quote no. 27363) (Trim Size: 2130 x 2700; Area: 5.751 m sq.)

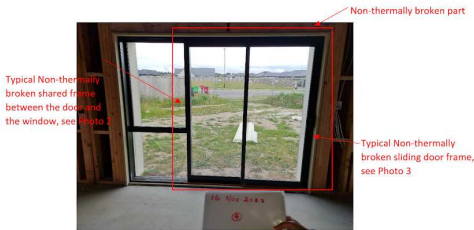
Photo 4 – Indicating the non-thermally broken parts of the Sliding Door “Living D6” (Door number referred to the attached quote no. 27363) (Trim Size: 2130 x 2700; Area: 5.751 m sq.)

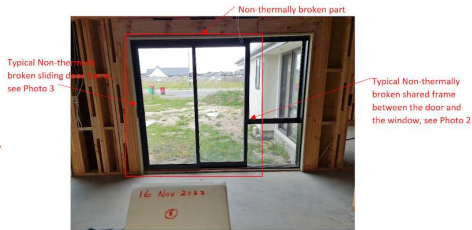
Photo 5 – Indicating the non-thermally broken parts of the Sliding Door “Dining D6” (Door number referred to the attached quote no. 27363) (Trim Size: 2130 x 2700; Area: 5.751 m sq.)

- e) Photo 5 – Indicating the non-thermally broken parts of the Sliding Door “Dining D6” (Door number referred to the attached quote no. 27363) (Trim Size: 2130 x 2700; Area: 5.751 m sq.)

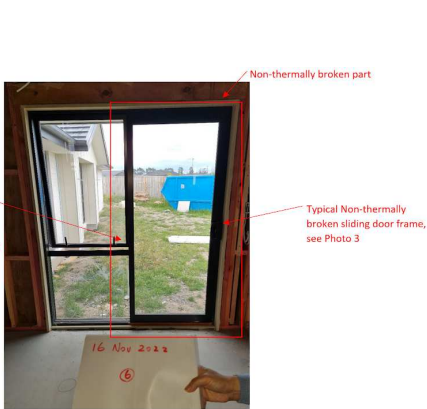
Photo 6 – Indicating the non-thermally broken parts of the Sliding Door “Bedroom 3 D5” (Door number referred to the attached quote no. 27363) (Trim Size: 2130 x 1800; Area: 3.834 m sq.)

- f) Photo 6 – Indicating the non-thermally broken parts of the Sliding Door “Bedroom 3 D5” (Door number referred to the attached quote no. 27363) (Trim Size: 2130 x 1800; Area: 3.834 m sq.)

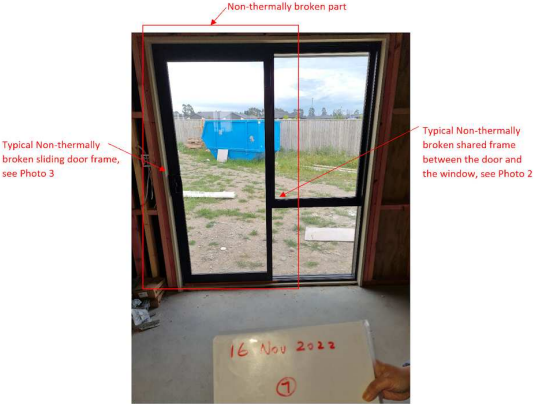
Photo 7 – Indicating the non-thermally broken parts of the Sliding Door “Bedroom 2 D4” (Door number referred to the attached quote no. 27363) (Trim Size: 2130 x 1800; Area: 3.834 m sq.)

- g) Photo 7 – Indicating the non-thermally broken parts of the Sliding Door “Bedroom 2 D4” (Door number referred to the attached quote no. 27363) (Trim Size: 2130 x 1800; Area: 3.834 m sq.)

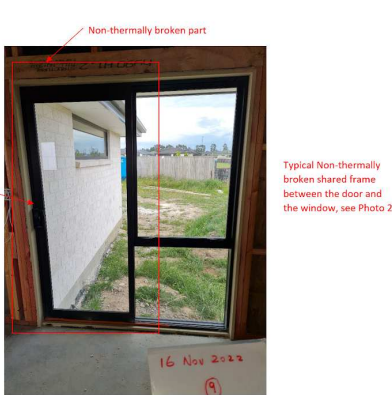
Photo 9 – Indicating the non-thermally broken parts of the Sliding Door “Master Bedroom D3” (Door number referred to the attached quote no. 27363) (Trim Size: 2130 x 1800; Area: 3.834 m sq.)

- h) Photo 9 – Indicating the non-thermally broken parts of the Sliding Door “Master Bedroom D3” (Door number referred to the attached quote no. 27363) (Trim Size: 2130 x 1800; Area: 3.834 m sq.)

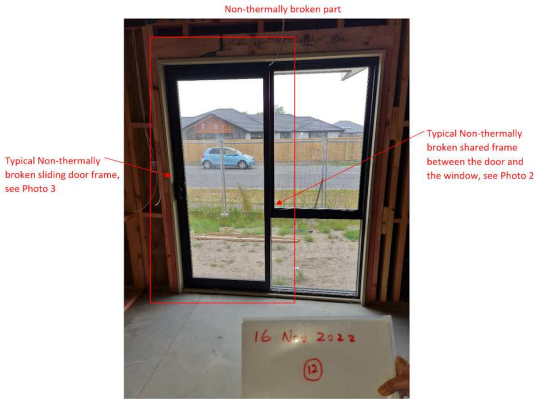
Photo 12 – Indicating the non-thermally broken parts of the Sliding Door “Bedroom 4 D4” (Door number referred to the attached quote no. 27363) (Trim Size: 2130 x 1800; Area: 3.834 m sq.)

- i) Photo 12 – Indicating the non-thermally broken parts of the Sliding Door “Bedroom 4 D4” (Door number referred to the attached quote no. 27363) (Trim Size: 2130 x 1800; Area: 3.834 m sq.)

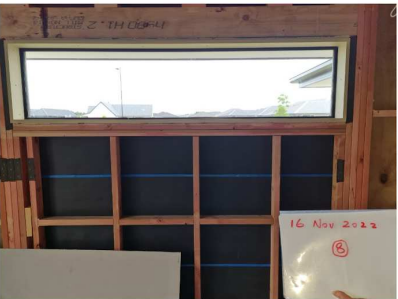
Photo 8 – Indicating uncertain thermally broken window “Bedroom 2 W5” (Door number referred to the attached quote no. 27363) (Trim Size: 600 x 2400; Area: 1.37 m sq.)

- a) Photo 8 – Indicating uncertain thermally broken window “Bedroom 2 W5” (Door number referred to the attached quote no. 27363) (Trim Size: 600 x 2400; Area: 1.37 m sq)

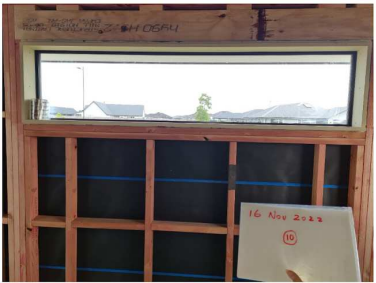
Photo 10 – Indicating uncertain thermally broken window “Master Bedroom W4” (Door number referred to the attached quote no. 27363) (Trim Size: 600 x 2400; Area: 1.37 m sq.)

- b) Photo 10 – Indicating uncertain thermally broken window “Master Bedroom W4” (Door number referred to the attached quote no. 27363) (Trim Size: 600 x 2400; Area: 1.37 m sq)

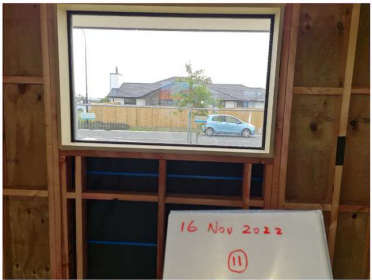
Photo 11 – Indicating uncertain thermally broken window “Master Bedroom W3” (Door number referred to the attached quote no. 27363) (Trim Size: 1000 x 1500; Area: 1.5 m sq.)

- c) Photo 11 – Indicating uncertain thermally broken window “Master Bedroom W3” (Door number referred to the attached quote no. 27363) (Trim Size: 1000 x 1500; Area: 1.5 m sq)
