Incorrect Thermal broken Aluminum Joinery: 2 Rapare St. Job No.27363 - JSR Construction.

The following evidence showed that your supplier does not have capability to provide the up-to-standard thermal broken aluminium windows and doors though the supplier has accepted the offer to supply you all the thermal broken aluminium windows and doors for our house at 2 Rapere Street, Rolleston 7615.

There are following two issues on the thermally broken aluminium windows and doors:

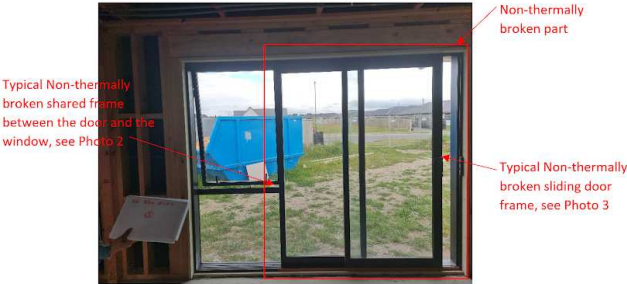
Photo 1 – Indicating the non-thermally broken parts of the Sliding Door “Lounge D6” (Door number referred to the attached quote no. 27363) (Trim Size: 2130 x 2700; Area: 5.751 m sq.)

You shall provide us with all the satisfied up-to-standard thermally broken aluminium joinery. You are requested to replace and re-install all the incorrect entire windows and doors. Partly replacement of aluminium materials on the site is not acceptable. You are also liable for all our losses of cost including but not limited to the related matters of any material reinstatements, any material variations, any time delay and any opportunity costs incurred by the correction of the aluminium windows and doors. The incorrect and uncertain products are stated below with the corresponding photos and the photo location plan (Figure 1 below). The product quote no. 27363 from your subcontractor is attached for your reference.

- a) Photo 1 – Indicating the non-thermally broken parts of the Sliding Door “Lounge D6” (Door number referred to the attached quote no. 27363) (Trim Size: 2130 x 2700; Area: 5.751 m sq.)

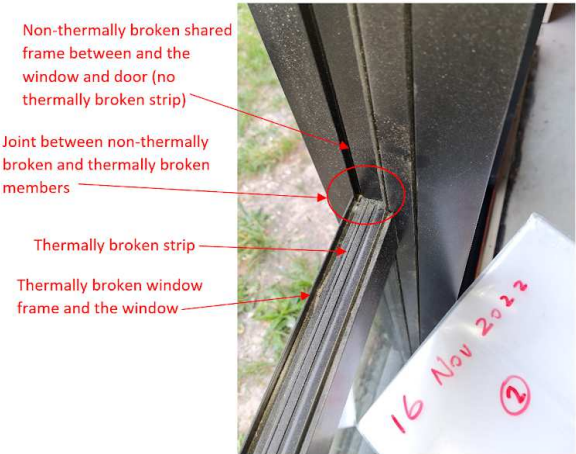
Photo 2 – Typical joint between the vertical frame of the sliding door and the horizontal frame of the window shows that the shared frame between the door and the window do not have the thermally broken strip.

- b) Photo 2 – Typical joint between the vertical frame of the sliding door and the horizontal frame of the window shows that the shared frame between the door and the window do not have the thermally broken strip.

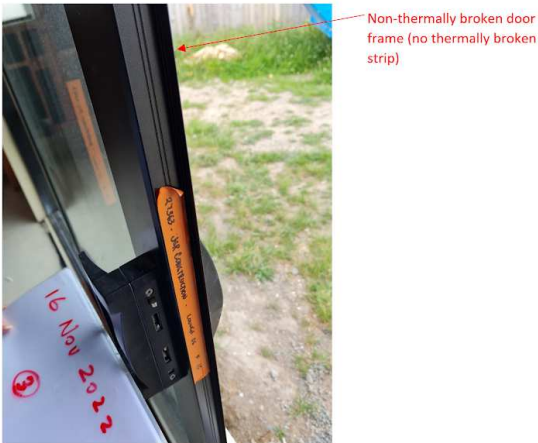
Photo 3 – Typical slide door frame shows that the slide door does not have thermally broken

- c) Photo 3 – Typical slide door frame shows that the slide door does not have thermally broken strip
 - d) Photo 4 – Indicating the non-thermally broken parts of the Sliding Door “Living D6” (Door number referred to the attached quote no. 27363) (Trim Size: 2130 x 2700; Area: 5.751 m sq.)

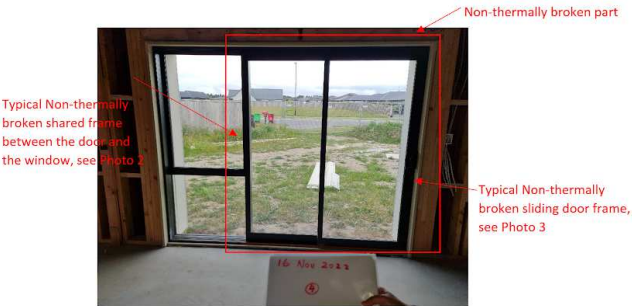
Photo 4 – Indicating the non-thermally broken parts of the Sliding Door “Living D6” (Door number referred to the attached quote no. 27363) (Trim Size: 2130 x 2700; Area: 5.751 m sq.)

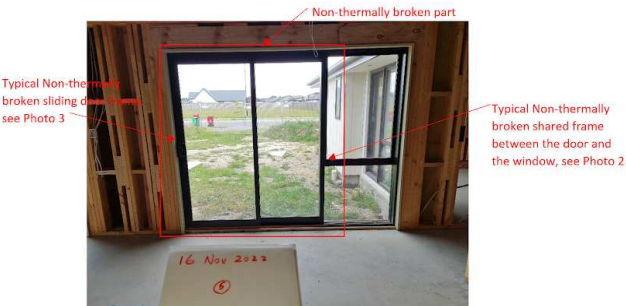
Photo 5 – Indicating the non-thermally broken parts of the Sliding Door “Dining D6” (Door number referred to the attached quote no. 27363) (Trim Size: 2130 x 2700; Area: 5.751 m sq.)

- e) Photo 5 – Indicating the non-thermally broken parts of the Sliding Door “Dining D6” (Door number referred to the attached quote no. 27363) (Trim Size: 2130 x 2700; Area: 5.751 m sq.)

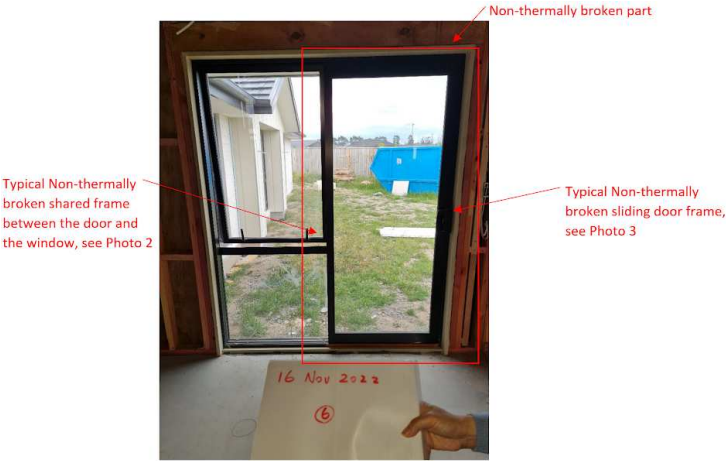
Photo 6 – Indicating the non-thermally broken parts of the Sliding Door “Bedroom 3 D5” (Door

- f) Photo 6 – Indicating the non-thermally broken parts of the Sliding Door “Bedroom 3 D5” (Door number referred to the attached quote no. 27363) (Trim Size: 2130 x 1800; Area: 3.834 m sq.)

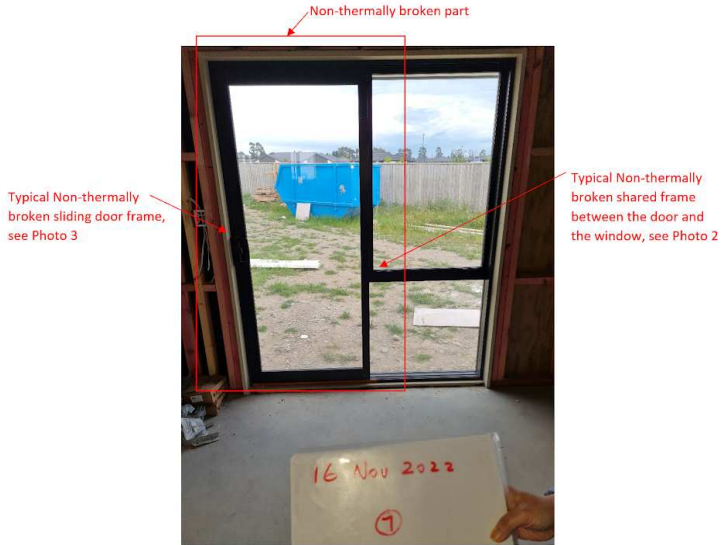
Photo 7 – Indicating the non-thermally broken parts of the Sliding Door “Bedroom 2 D4” (Door number referred to the attached quote no. 27363) (Trim Size: 2130 x 1800; Area: 3.834 m sq.)

- g) Photo 7 – Indicating the non-thermally broken parts of the Sliding Door “Bedroom 2 D4” (Door number referred to the attached quote no. 27363) (Trim Size: 2130 x 1800; Area: 3.834 m sq.)

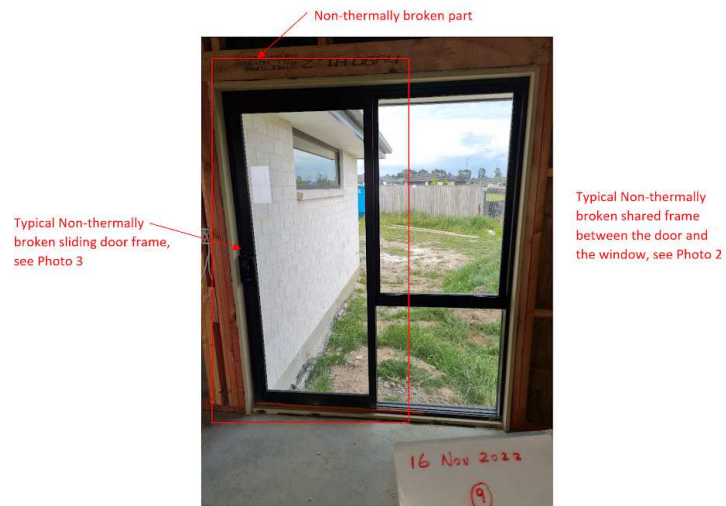
Photo 9 – Indicating the non-thermally broken parts of the Sliding Door “Master Bedroom D3” (Door number referred to the attached quote no. 27363) (Trim Size: 2130 x 1800; Area: 3.834 m sq.)

- h) Photo 9 – Indicating the non-thermally broken parts of the Sliding Door “Master Bedroom D3” (Door number referred to the attached quote no. 27363) (Trim Size: 2130 x 1800; Area: 3.834 m sq.)

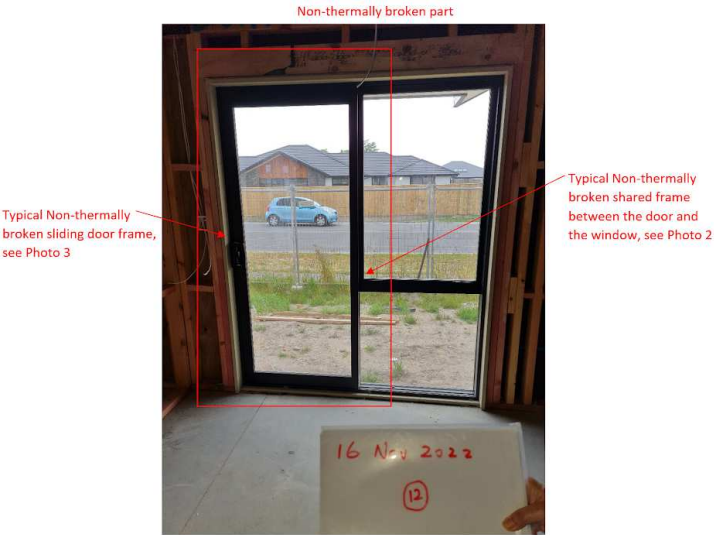
Photo 12 – Indicating the non-thermally broken parts of the Sliding Door “Bedroom 4 D4” (Door number referred to the attached quote no. 27363) (Trim Size: 2130 x 1800; Area: 3.834 m sq.)

- i) Photo 12 – Indicating the non-thermally broken parts of the Sliding Door “Bedroom 4 D4” (Door number referred to the attached quote no. 27363) (Trim Size: 2130 x 1800; Area: 3.834 m sq.)

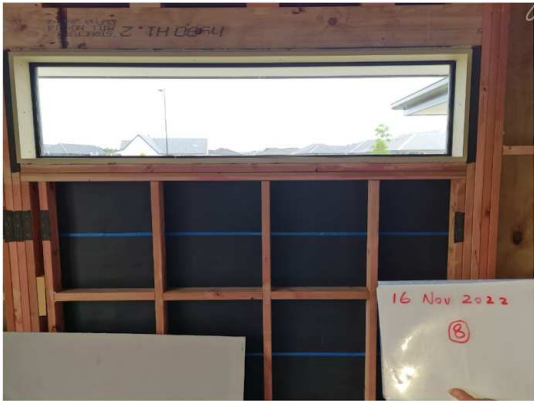
Photo 8 – Indicating uncertain thermally broken window “Bedroom 2 W5” (Door number referred to the attached quote no. 27363) (Trim Size: 600 x 2400; Area: 1.37 m sq.)

- 2) The frames of the windows that we are not sure if they are thermally broken or not since the depths of those window frames seems to be smaller than others 32% of the thermally broken joinery by comparing the distances between the frames and the internal and external walls. The total area of these uncertain aluminium joinery is 4.2 m sq. (8.7 % of the total area). These products are shown in the following photos:

- a) Photo 8 – Indicating uncertain thermally broken window “Bedroom 2 W5” (Door number referred to the attached quote no. 27363) (Trim Size: 600 x 2400; Area: 1.37 m sq)

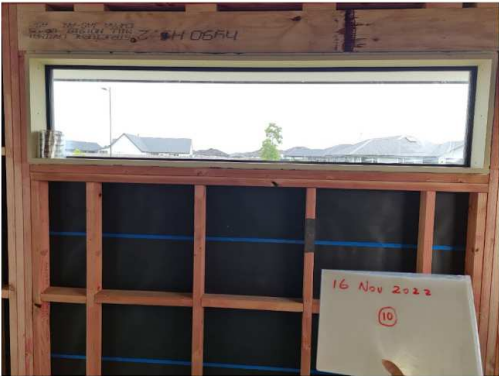
Photo 10 – Indicating uncertain thermally broken window “Master Bedroom W4” (Door number referred to the attached quote no. 27363) (Trim Size: 600 x 2400; Area: 1.37 m sq.)

- b) Photo 10 – Indicating uncertain thermally broken window “Master Bedroom W4” (Door number referred to the attached quote no. 27363) (Trim Size: 600 x 2400; Area: 1.37 m sq)

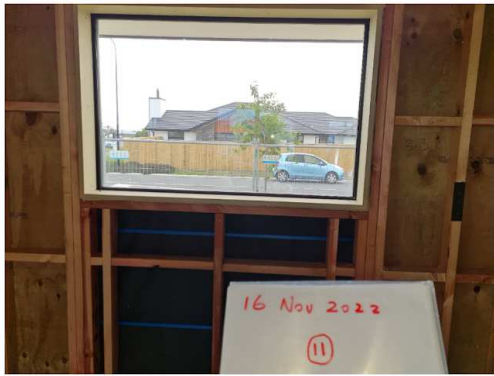
Photo 11 – Indicating uncertain thermally broken window “Master Bedroom W3” (Door number referred to the attached quote no. 27363) (Trim Size: 1000 x 1500; Area: 1.5 m sq.)

- c) Photo 11 – Indicating uncertain thermally broken window “Master Bedroom W3” (Door number referred to the attached quote no. 27363) (Trim Size: 1000 x 1500; Area: 1.5 m sq)
