Additional information: Re: (RE: (RE: Re: (RE: Re: (RE: Building Dispute MB # 050417))))

1) I have got three different quotations below for the same sliding doors or similar doors meeting our expected purpose. These show that there could be a lot of other suppliers who can provide us with the doors meeting our expected purpose, if the builder or the current supplier has told us they are incapable of providing us with products before the order. However, now we are getting the doors, which do not suit for our purpose, from the current supplier.

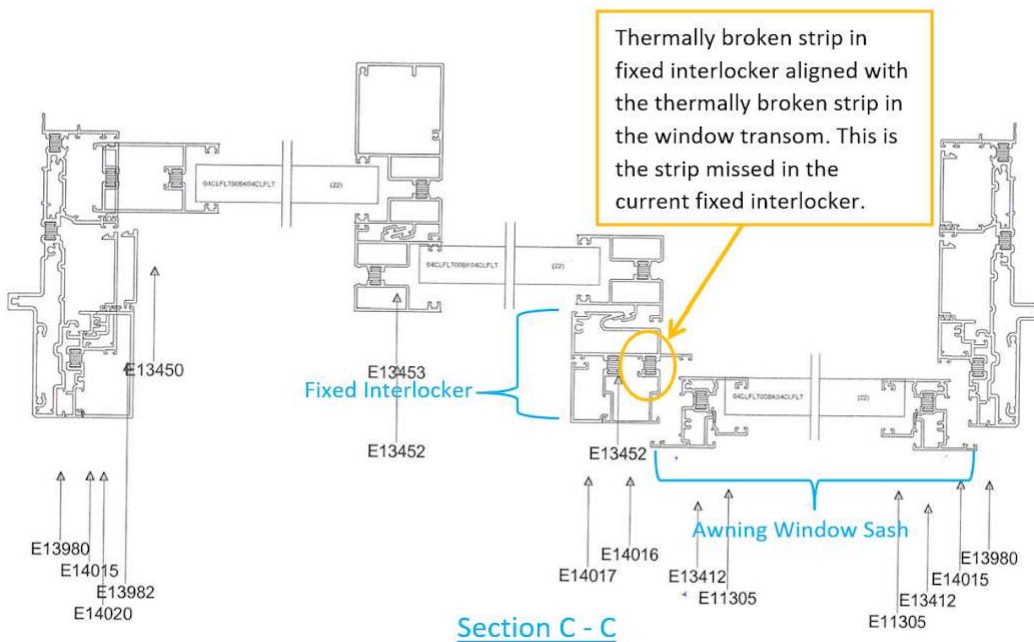
Figure 1: Cross Section C - C of Sliding Door from Another

- ii) Colour: Group 1, which includes coal dust.
 - iii) All thermally broken aluminum joinery including the stiles and the fixed interlocker;
 - iv) Cross sections of the sliding door showing that there is a thermal insulation strip in the fixed interlocker (see Figure 1 below) aligned with the thermal insulation strip in the window transom (see Figure 2 below). The elevation in Figure 3 indicated the locations of the cross sections given in Figure 1 and 2. These figures are extracted from the quotation documents with additional explanation notes. That strip in the fixed interlocker as shown in Figure 1 is missed in the current sliding doors (compared with Figure 4 below) supplied by the builder.

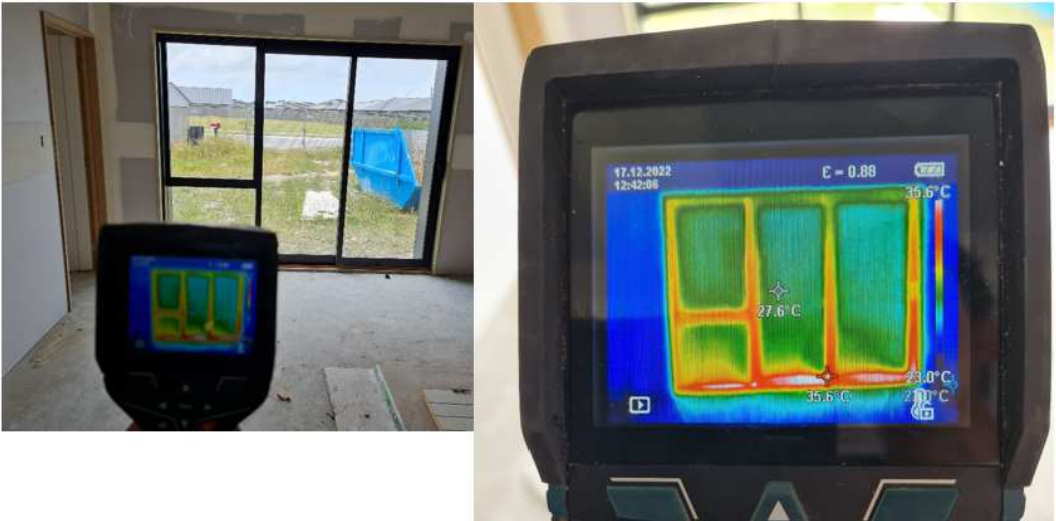
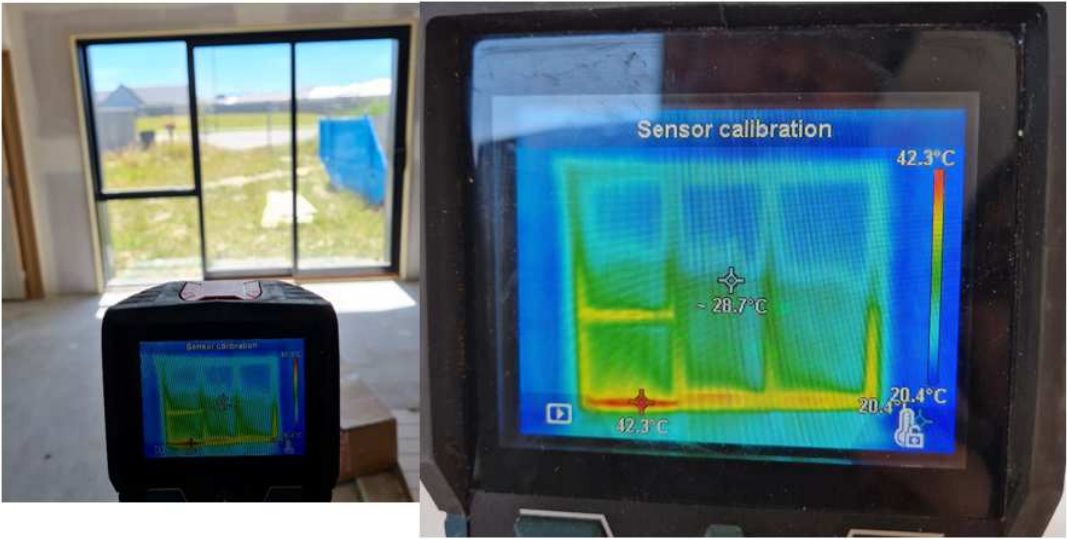
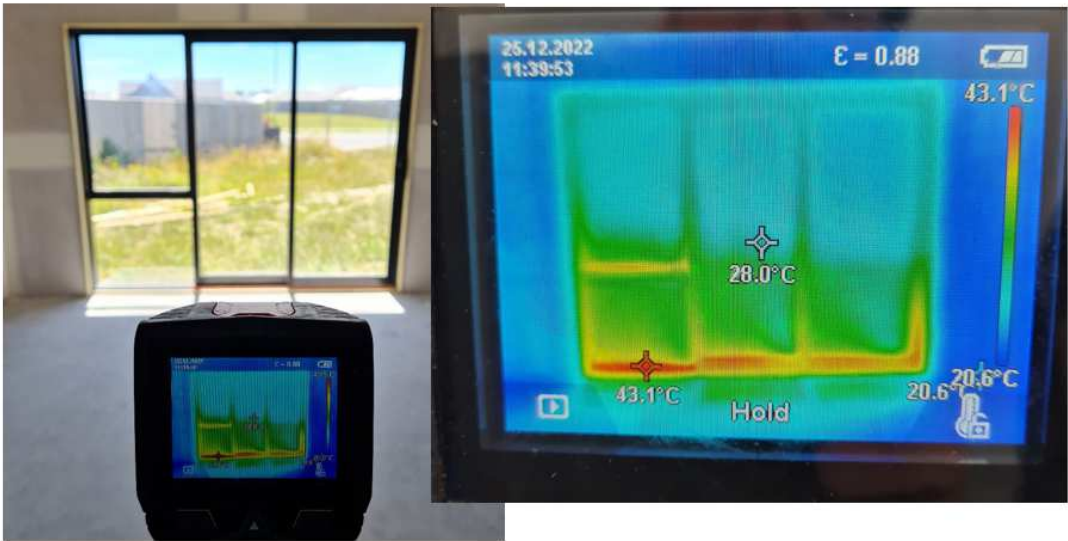
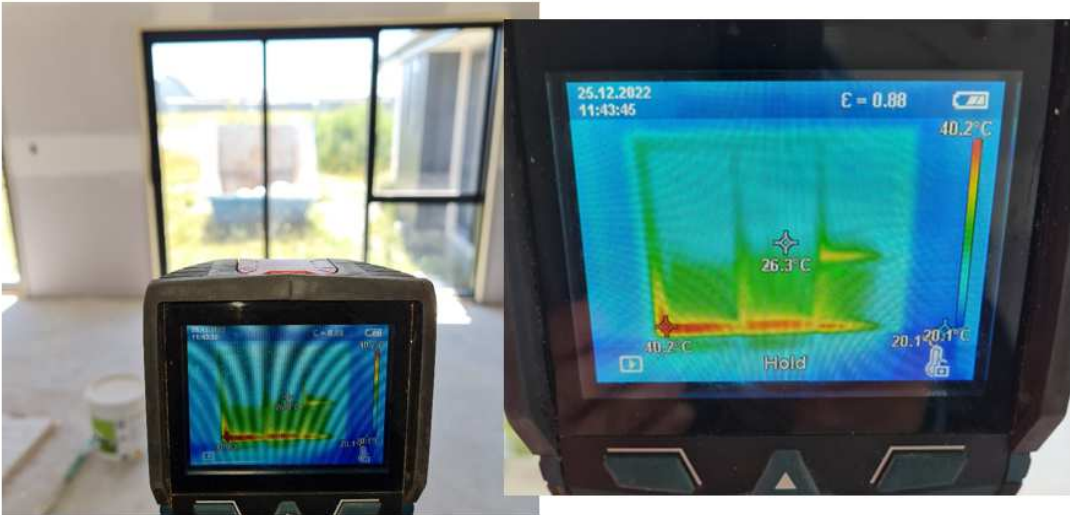
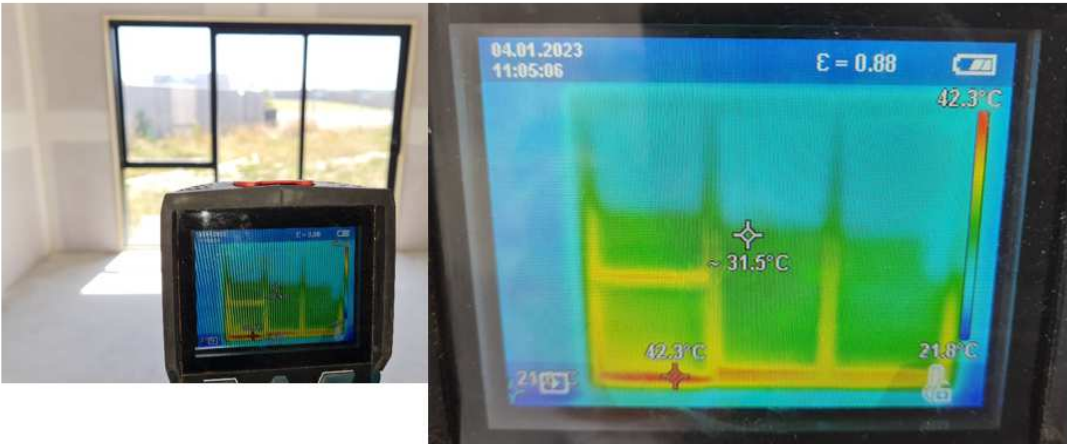
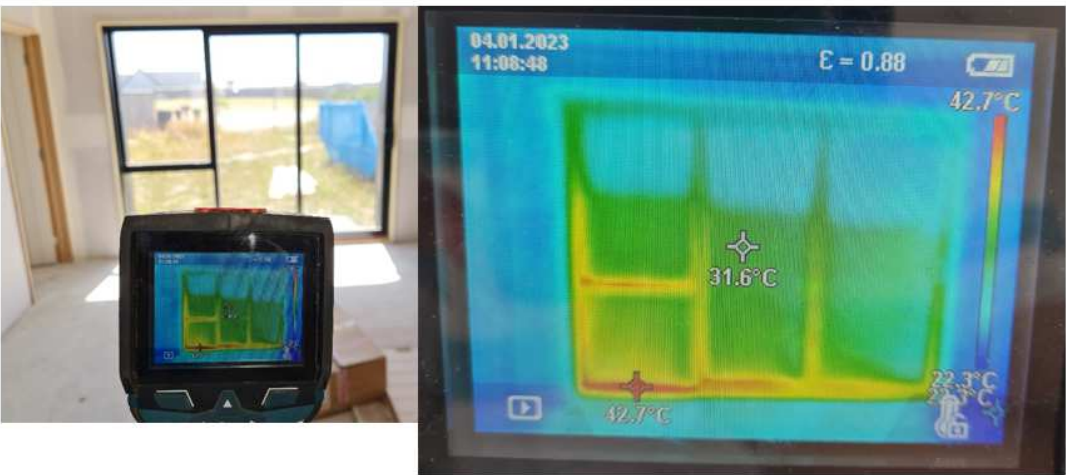
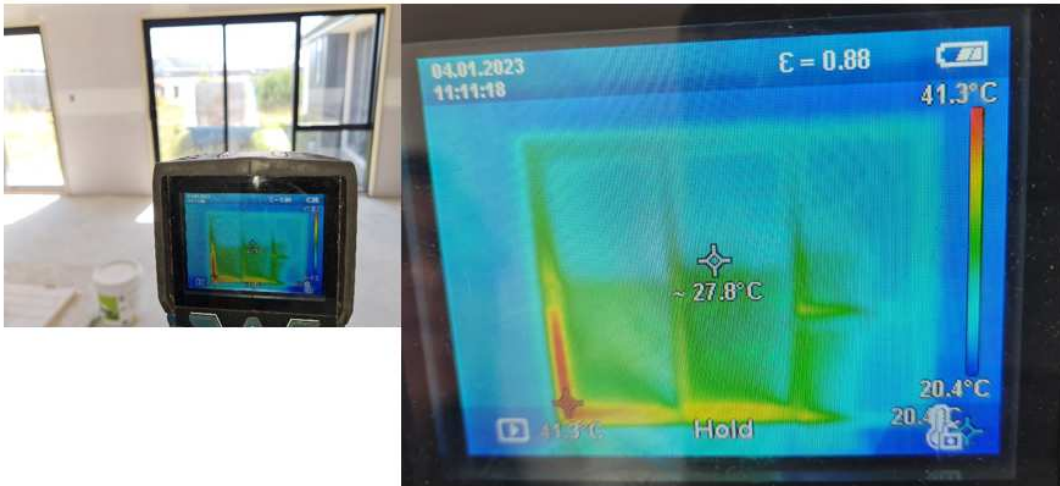
2) Thermal images (see Figure 5, Figure 6, Figure 7, Figure 8, Figure 9, Figure 10, Figure 11) of the sliding doors taken on different days showing that below:

- a) The temperature of window transoms and its joint with the fixed interlocker are relatively higher than that of the thermally broken members consistently excepting the bottom aluminium frames mentioned in Item b below. This relative higher temperature is caused by the aforementioned conduction (i.e the red line shown in Figure 4) at the joint between window transoms and the fixed interlocker due to the missing of the thermally broken strip (i.e. the missing strip mentioned in Item (1)(a)(iv))
- b) The bottom aluminium frames of the sliding doors are the hottest part of the doors consistently. Therefore, the bottom aluminium frames are suspected to be not thermally broken.

Figure 5: Thermal Image of Door at Living Room on 17 Dec 2022

Figure 6: Thermal Image of Door at Living Room on 25 Dec 2022

Figure 7: Thermal Image of Door at Lounge on 25 Dec 2022

Figure 8: Thermal Image of Door at Dining Room on 25 Dec 2022

Figure 9: Thermal Image of Door at Lounge on 4 Jan 2023

Figure 10: Thermal Image of Door at Living Room on 4 Jan 2023

Figure 11: Thermal Image of Door at Dining Room on 4 Jan 2023
