**Re: Incorrect Thermal broken Aluminum Joinery: 2 Rapare St. Job No.27363 - JSR Construction.**

- 1) The parts of the windows and doors frames do not have the thermally broken strip. These windows and doors make up 59% of the area of all the aluminium joinery products. The total area of these problematic aluminium joinery is 28.8 m sq. The total area of all aluminium joinery products is 48.6 m sq. These problematic products are shown in the following photos (note that the photos and the location plan are given at the end of this email):

- 2) The frames of the windows that we are not sure if they are thermally broken or not since the depths of those window frames seem to be smaller than others 32% of the thermally broken joinery by comparing the distances between the frames and the internal and external walls. The total area of these uncertain aluminium joinery is 4.2 m sq. (8.7 % of the total area). These products are shown in the following photos:

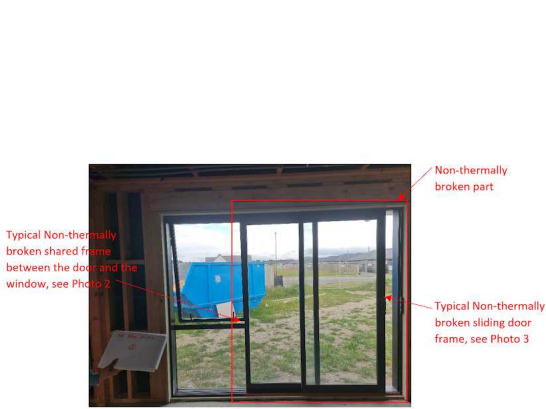
- a) Photo 1 – Indicating the non-thermally broken parts of the Sliding Door “Lounge D6” (Door number referred to the attached quote no. 27363) (Trim Size: 2130 x 2700; Area: 5.751 m sq.)

You shall provide us with all the satisfied up-to-standard thermally broken aluminium joinery. You are requested to replace and re-install all the incorrect entire window doors. Partly replacement of aluminium materials on the site is not acceptable. You are also liable for all our losses of cost including but not limited to the related material, any material reinstatements, any material variations, any time delay and any opportunity costs incurred by the correction of the aluminium windows and doors. The incorrect and uncertain products are stated below with the corresponding photos and the photo location plan (Figure 1 below). The product quote no. 27363 from your subcontractor is attached for your reference.

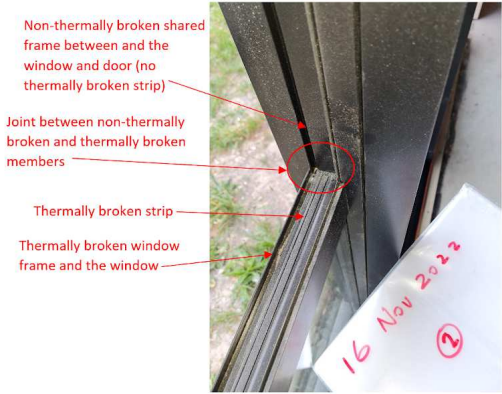
- b) Photo 2 – Typical joint between the vertical frame of the sliding door and the horizontal frame of the window shows that the shared frame between the door and the window does not have the thermally broken strip.

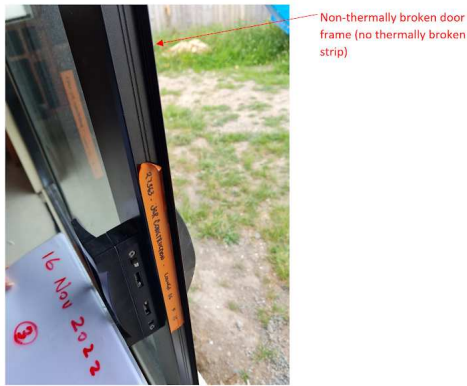
- c) Photo 3 – Typical slide door frame shows that the slide door does not have thermally broken strip
  - d) Photo 4 – Indicating the non-thermally broken parts of the Sliding Door “Living D6” (Door number referred to the attached quote no. 27363) (Trim Size: 2130 x 2700; Area: 5.751 m sq.)

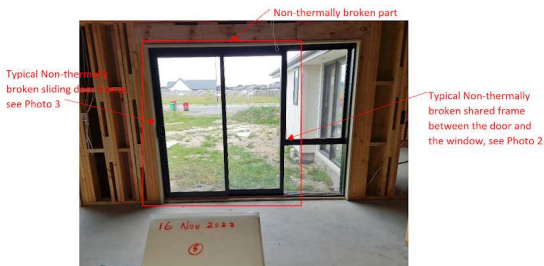
- e) Photo 5 – Indicating the non-thermally broken parts of the Sliding Door “Dining D6” (Door number referred to the attached quote no. 27363) (Trim Size: 2130 x 2700; Area: 5.751 m sq.)

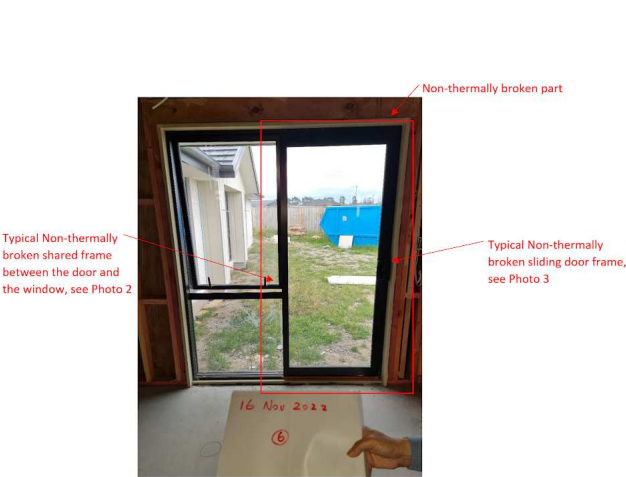
- f) Photo 6 – Indicating the non-thermally broken parts of the Sliding Door “Bedroom 3 D5” (Door number referred to the attached quote no. 27363) (Trim Size: 2130 x 1800; Area: 3.834 m sq.)

Photo 6 – Indicating the non-thermally broken parts of the Sliding Door “Bedroom 3 D5” (Door

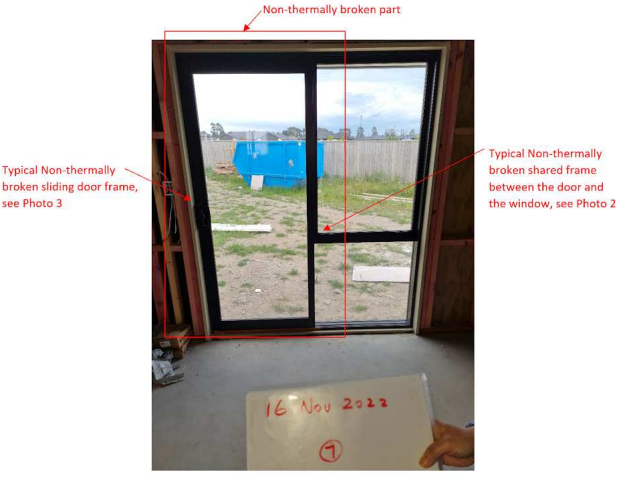
- g) Photo 7 – Indicating the non-thermally broken parts of the Sliding Door “Bedroom 2 D4” (Door number referred to the attached quote no. 27363) (Trim Size: 2130 x 1800; Area: 3.834 m sq.)

Photo 7 – Indicating the non-thermally broken parts of the Sliding Door “Bedroom 2 D4” (Door number referred to the attached quote no. 27363) (Trim Size: 2130 x 1800; Area: 3.834 m sq.)

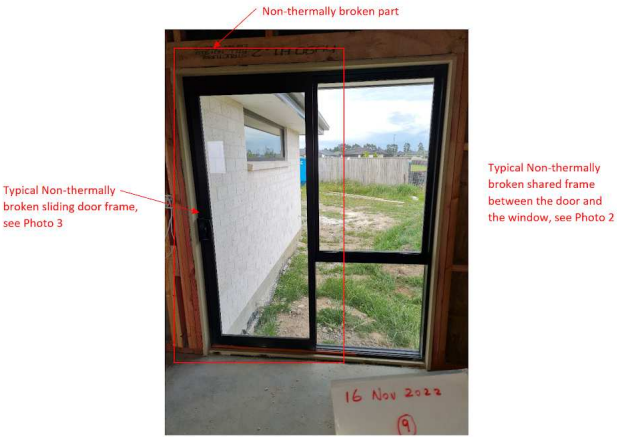
- h) Photo 9 – Indicating the non-thermally broken parts of the Sliding Door “Master Bedroom D3” (Door number referred to the attached quote no. 27363) (Trim Size: 2130 x 1800; Area: 3.834 m sq.)

Photo 9 – Indicating the non-thermally broken parts of the Sliding Door “Master Bedroom D3” (Door number referred to the attached quote no. 27363) (Trim Size: 2130 x 1800; Area: 3.834 m sq.)

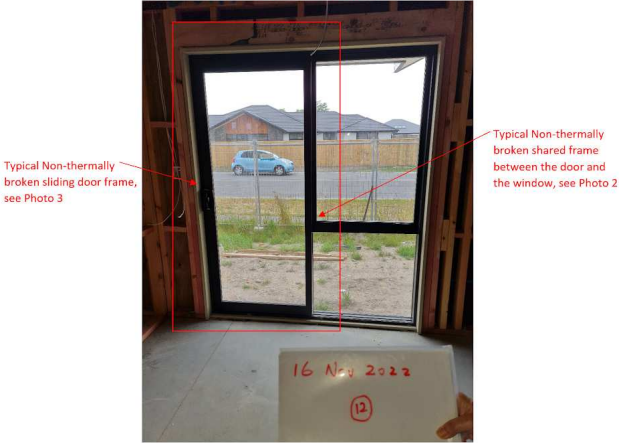
- i) Photo 12 – Indicating the non-thermally broken parts of the Sliding Door “Bedroom 4 D4” (Door number referred to the attached quote no. 27363) (Trim Size: 2130 x 1800; Area: 3.834 m sq.)

Photo 12 – Indicating the non-thermally broken parts of the Sliding Door “Bedroom 4 D4” (Door number referred to the attached quote no. 27363) (Trim Size: 2130 x 1800; Area: 3.834 m sq.)

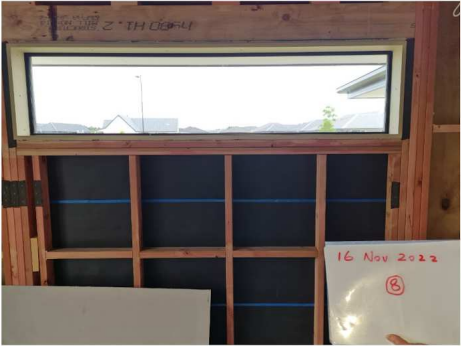
- a) Photo 8 – Indicating uncertain thermally broken window “Bedroom 2 W5” (Door number referred to the attached quote no. 27363) (Trim Size: 600 x 2400; Area: 1.37 m sq)

Photo 8 – Indicating uncertain thermally broken window “Bedroom 2 W5” (Door number referred to the attached quote no. 27363) (Trim Size: 600 x 2400; Area: 1.37 m sq.)

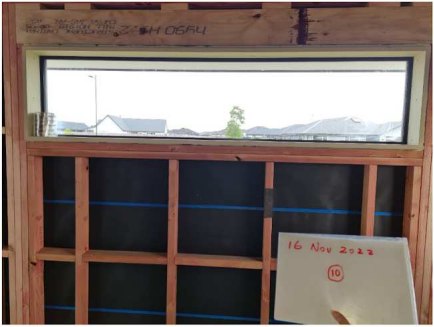
- b) Photo 10 – Indicating uncertain thermally broken window “Master Bedroom W4” (Door number referred to the attached quote no. 27363) (Trim Size: 2400; Area: 1.37 m sq)

Photo 10 – Indicating uncertain thermally broken window “Master Bedroom W4” (Door number referred to the attached quote no. 27363) (Trim Size: 600 x 2400; Area: 1.37 m sq.)

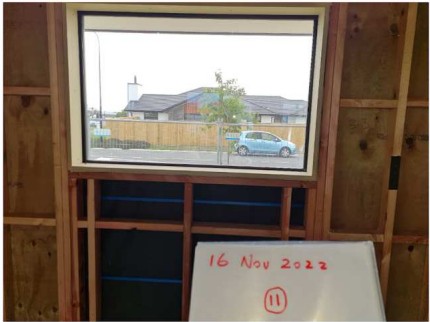
- c) Photo 11 – Indicating uncertain thermally broken window “Master Bedroom W3” (Door number referred to the attached quote no. 27363) (Trim Size: 1500; Area: 1.5 m sq)

Photo 11 – Indicating uncertain thermally broken window “Master Bedroom W3” (Door number referred to the attached quote no. 27363) (Trim Size: 1000 x 1500; Area: 1.5 m sq.)
