**Re: Incorrect Thermal broken Aluminum Joinery: 2 Rapare St. Job No.27363 - JSR Construction.**

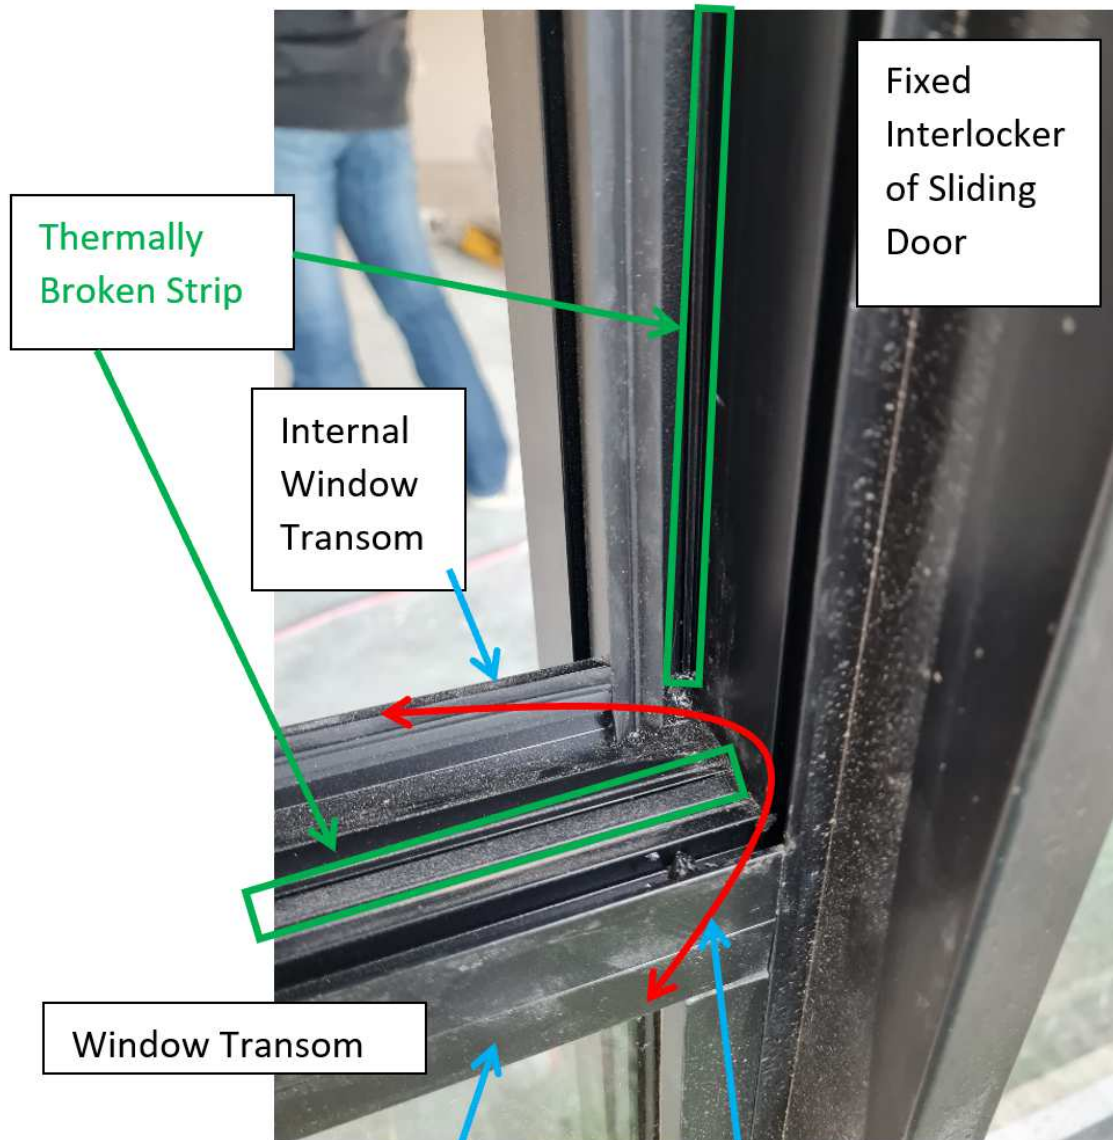
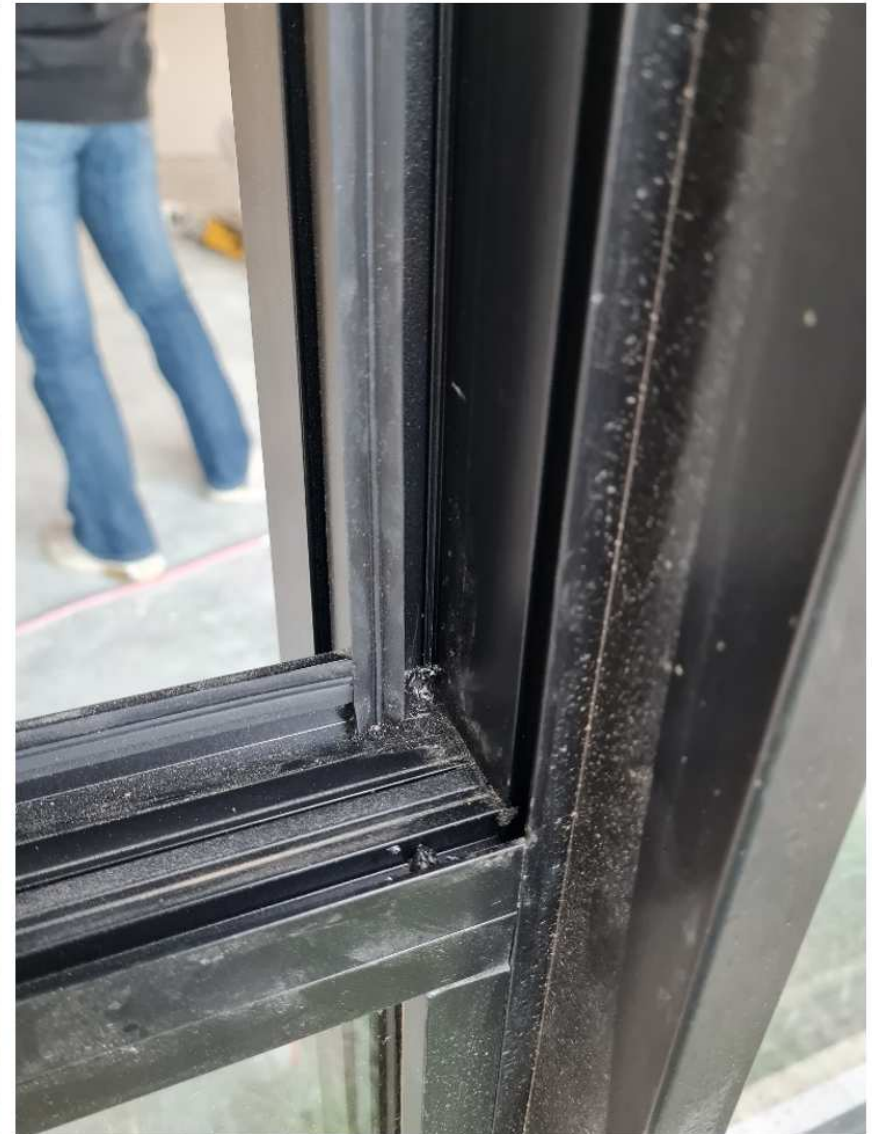
Photo 1: Path of thermal conduction at the joint of window transom and sliding-door fixed interlocker and the same photo without marking is given side by side for easy reference

Window Transom

External Window
Transom

Path of thermal conduction (red
line) between internal and
external parts of the window

In short, you are required to at least but not limited to replace the fixed interlocker and stiles with full warranty of the entire products. The details are given below.

1. You shall replace all non-thermally broken components of the sliding doors and windows which including but not limited to the stiles and fixed interlocker. There is a path of thermal conduction where it is not thermally broken at the joint of the window transom and sliding-door fixed interlocker as indicated by the red line on the marked photo as shown on Photo 1 below. The same photo without marking is given side by side for easy reference. You are required to change the fixed interlocker to have the proper thermally broken strip align with the strip on the window transom. I also took a thermal image (see Photo 2) with the sunshine reaching half the height of the sliding door. It showed that the non-thermally broken components (the joint in between the interlocker and the window transom, and the stiles) creating a thermal conduction between the internal and external parts of the thermally-broken members (e.g. bottom of the sliding door frames and the window transom).

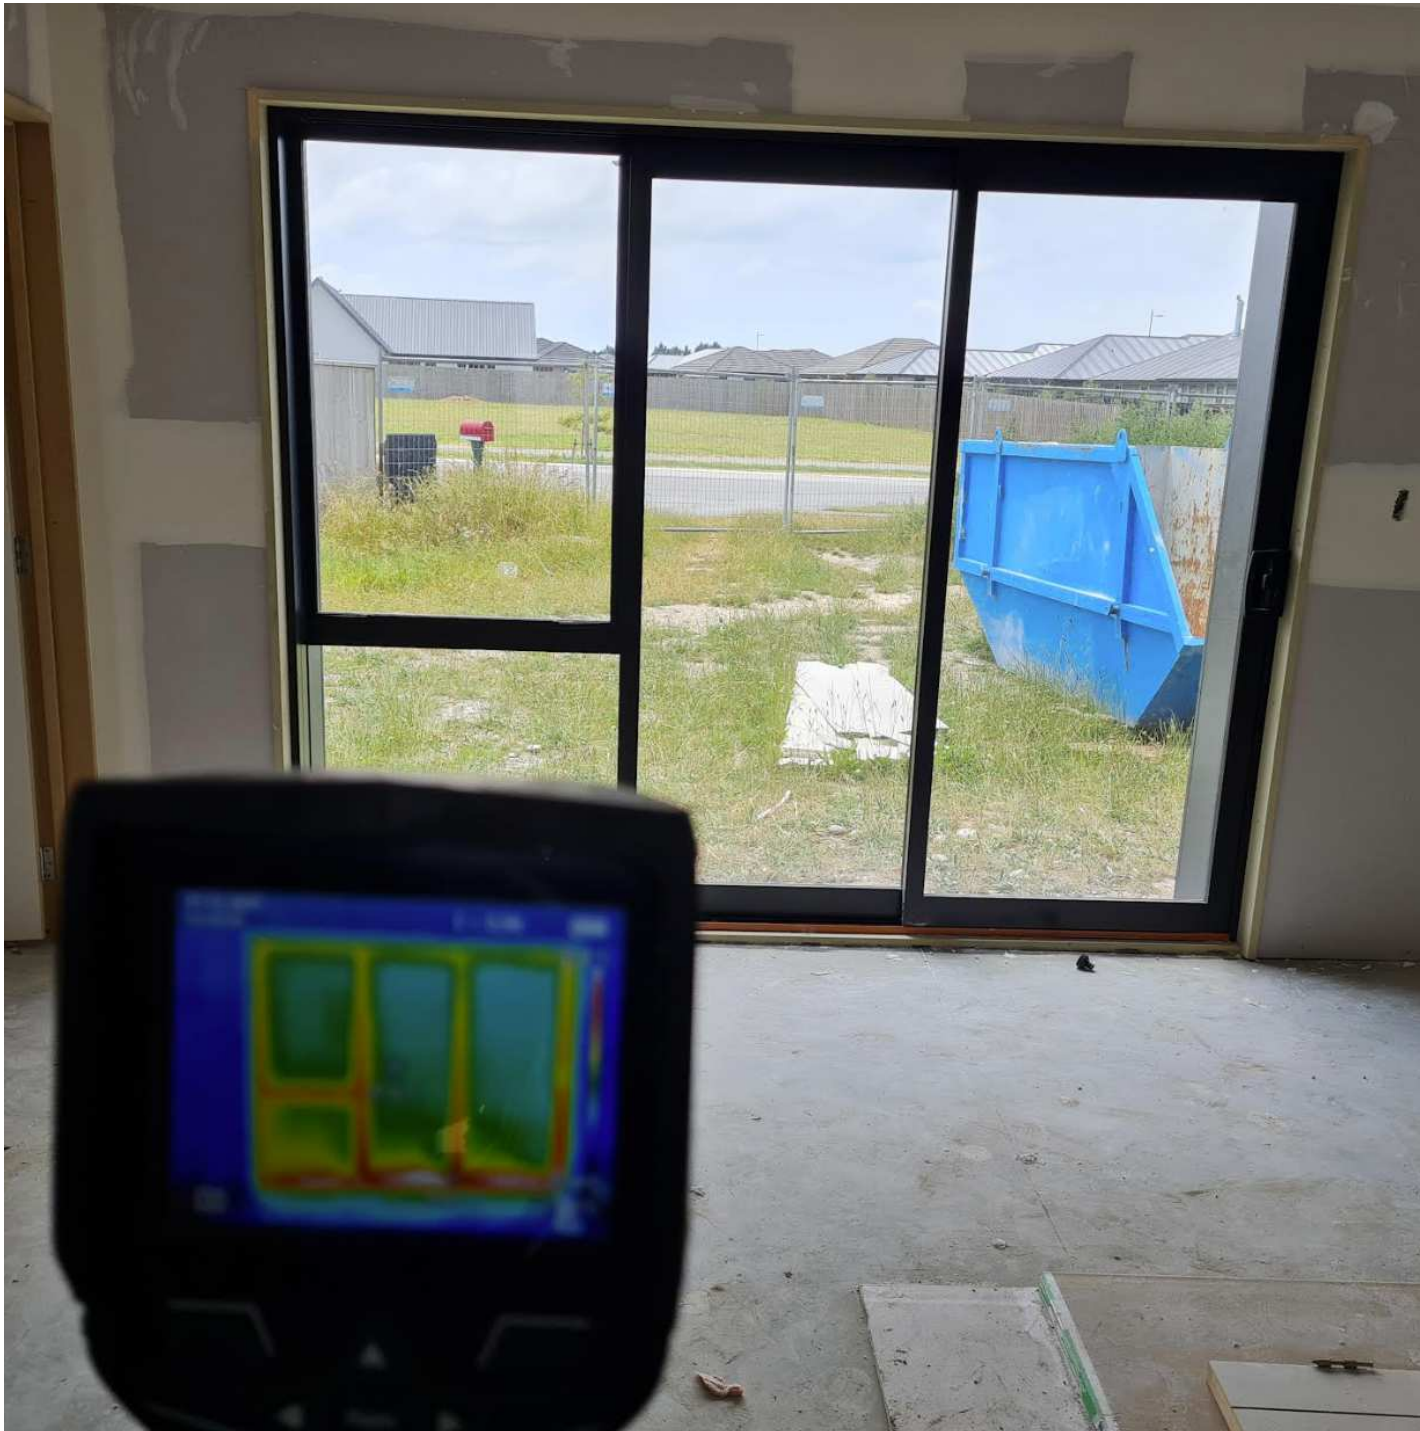
Photo 2: Thermal image of the sliding door and window with the sunshine reaching half the height of the sliding door. It showed that the non-thermally broken components (the joint in between the interlocker and the window transom, and the stile) creating a thermal conduction between the internal and external parts of the thermally-broken members (e.g. bottom of the sliding door frames and the window transom).

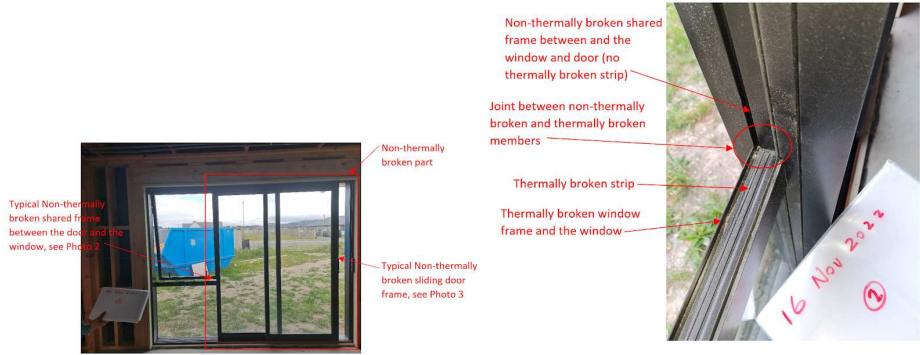
- a) Photo 1 – Indicating the non-thermally broken parts of the Sliding Door “Lounge D6” (Door number referred to the attached quote no. 27363) (Trim Size: 2130 x 2700; Area: 5.751 m sq.)

Photo 1 – Indicating the non-thermally broken parts of the Sliding Door “Lounge D6” (Door number referred to the attached quote no. 27363) (Trim Size: 2130 x 2700; Area: 5.751 m sq.)

You shall provide us with all the satisfied up-to-standard thermally broken aluminium joinery. You are requested to replace and re-install all the incorrect entire windows and doors. Partly replacement of aluminium materials on the site is not acceptable. You are also liable for all our losses of cost including but not limited to the related matters of any material reinstatements, any material variations, any time delay and any opportunity costs incurred by the correction of the aluminium windows and doors. The incorrect and uncertain products are stated below with the corresponding photos and the photo location plan (Figure 1 below). The product quote no. 27363 from your subcontractor is attached for your reference.

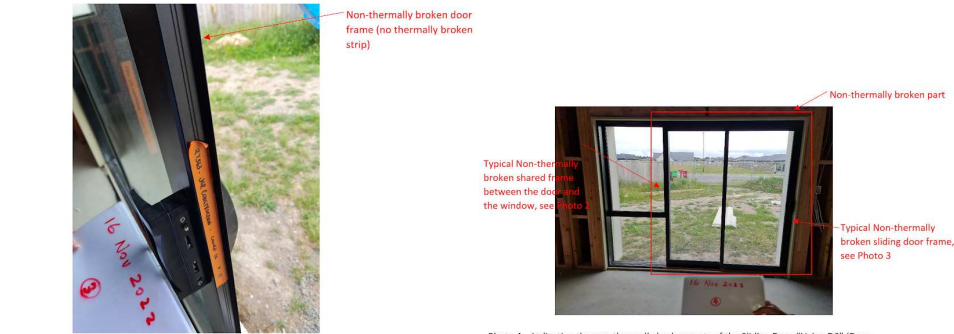
- b) Photo 2 – Typical joint between the vertical frame of the sliding door and the horizontal frame of the window shows that the shared frame between the door and the window do not have the thermally broken strip.

- c) Photo 3 – Typical slide door frame shows that the slide door does not have thermally broken strip
 - d) Photo 4 – Indicating the non-thermally broken parts of the Sliding Door “Living D6” (Door number referred to the attached quote no. 27363) (Trim Size: 2130 x 2700; Area: 5.751 m sq.)

Photo 2 – Typical joint between the vertical frame of the sliding door and the horizontal frame of the window shows that the shared frame between the door and the window do not have the thermally broken strip.

Photo 3 – Typical slide door frame shows that the slide door does not have thermally broken

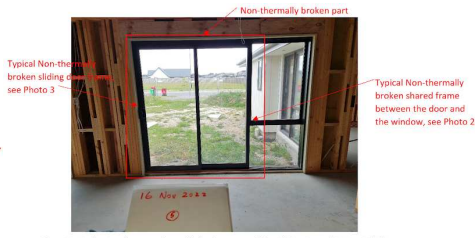
Photo 4 – Indicating the non-thermally broken parts of the Sliding Door “Living D6” (Door number referred to the attached quote no. 27363) (Trim Size: 2130 x 2700; Area: 5.751 m sq.)

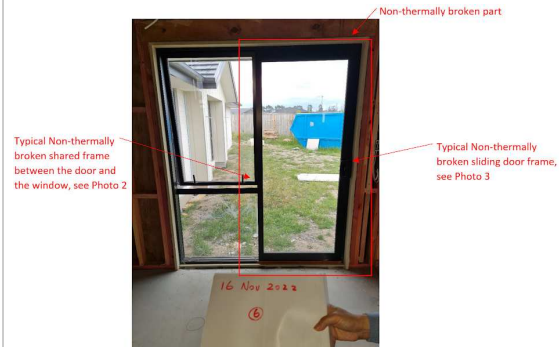
- e) Photo 5 – Indicating the non-thermally broken parts of the Sliding Door “Dining D6” (Door number referred to the attached quote no. 27363) (Trim Size: 2130 x 2700; Area: 5.751 m sq.)

Photo 5 – Indicating the non-thermally broken parts of the Sliding Door “Dining D6” (Door number referred to the attached quote no. 27363) (Trim Size: 2130 x 2700; Area: 5.751 m sq.)

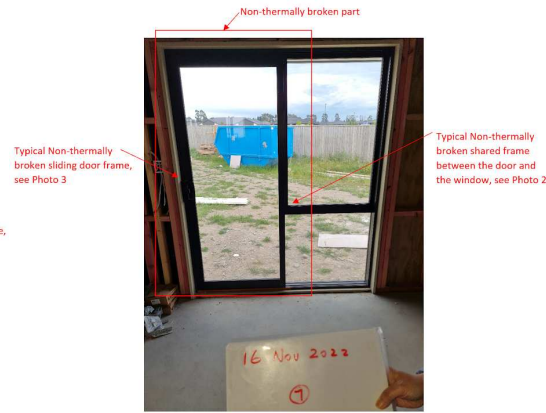
- f) Photo 6 – Indicating the non-thermally broken parts of the Sliding Door “Bedroom 3 D5” (Door number referred to the attached quote no. 27363) (Trim Size: 2130 x 1800; Area: 3.834 m sq.)

Photo 6 – Indicating the non-thermally broken parts of the Sliding Door “Bedroom 3 D5” (Door number referred to the attached quote no. 27363) (Trim Size: 2130 x 1800; Area: 3.834 m sq.)

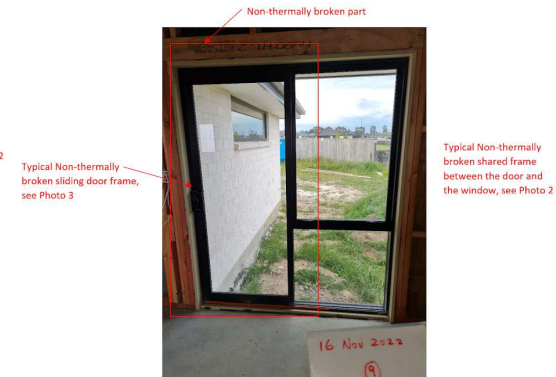
- g) Photo 7 – Indicating the non-thermally broken parts of the Sliding Door “Bedroom 2 D4” (Door number referred to the attached quote no. 27363) (Trim Size: 2130 x 1800; Area: 3.834 m sq.)

Photo 7 – Indicating the non-thermally broken parts of the Sliding Door “Bedroom 2 D4” (Door number referred to the attached quote no. 27363) (Trim Size: 2130 x 1800; Area: 3.834 m sq.)

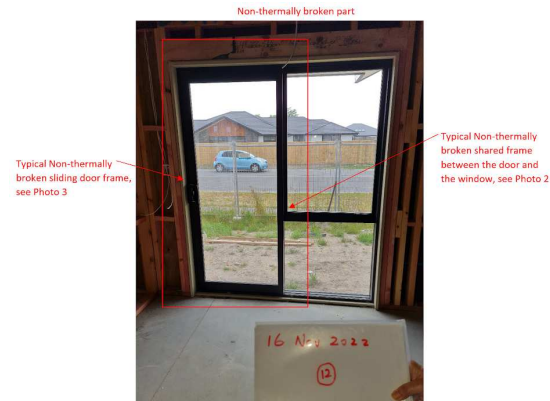
- h) Photo 9 – Indicating the non-thermally broken parts of the Sliding Door “Master Bedroom D3” (Door number referred to the attached quote no. 27363) (Trim Size: 2130 x 1800; Area: 3.834 m sq.)

Photo 9 – Indicating the non-thermally broken parts of the Sliding Door “Master Bedroom D3” (Door number referred to the attached quote no. 27363) (Trim Size: 2130 x 1800; Area: 3.834 m sq.)

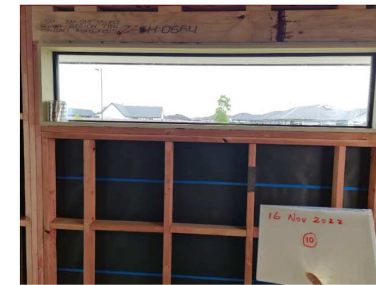
- a) Photo 8 – Indicating uncertain thermally broken window “Bedroom 2 W5” (Door number referred to the attached quote no. 27363) (Trim Size: 600 x 2400; Area: 1.37 m sq)

Photo 8 – Indicating uncertain thermally broken window “Bedroom 2 W5” (Door number referred to the attached quote no. 27363) (Trim Size: 600 x 2400; Area: 1.37 m sq.)

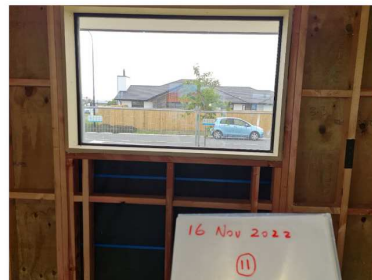
- b) Photo 10 – Indicating uncertain thermally broken window “Master Bedroom W4” (Door number referred to the attached quote no. 27363) (Trim Size: 600 x 2400; Area: 1.37 m sq)
- c) Photo 11 – Indicating uncertain thermally broken window “Master Bedroom W3” (Door number referred to the attached quote no. 27363) (Trim Size: 1000 x 1500; Area: 1.5 m sq)

Photo 10 – Indicating uncertain thermally broken window “Master Bedroom W4” (Door number referred to the attached quote no. 27363) (Trim Size: 600 x 2400; Area: 1.37 m sq.)
