**Re: Incorrect Thermal broken Aluminum Joinery: 2 Rapare St. Job No.27363 - JSR Construction.**

- 1) The parts of the windows and doors frames do not have the thermally broken strip. These windows and doors make up 59% of the area of all the joinery products. The total area of these problematic aluminium joinery is 28.8 m sq. The total area of all aluminium joinery products is 48.6 m sq. These products are shown in the following photos (note that the photos and the location plan are given at the end of this email):

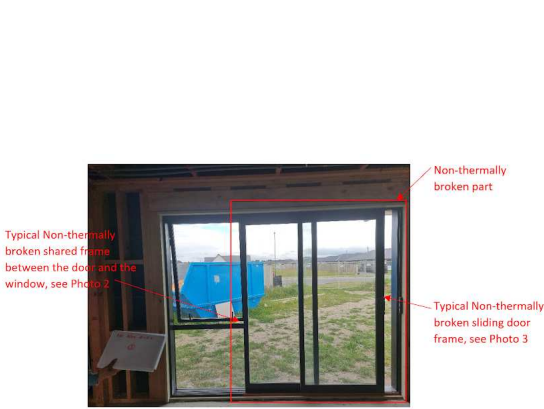
- a) Photo 1 – Indicating the non-thermally broken parts of the Sliding Door “Lounge D6” (Door number referred to the attached quote no. 27363) (2130 x 2700; Area: 5.751 m sq.)

You shall provide us with all the satisfied up-to-standard thermally broken aluminium joinery. You are requested to replace and re-install all the incorrect entire window and doors. Partly replacement of aluminium materials on the site is not acceptable. You are also liable for all our losses of cost including but not limited to the related the any material reinstatements, any material variations, any time delay and any opportunity costs incurred by the correction of the aluminium windows and doors. The and uncertain products are stated below with the corresponding photos and the photo location plan (Figure 1 below). The product quote no. 27363 from your subcontractor attached for your reference.

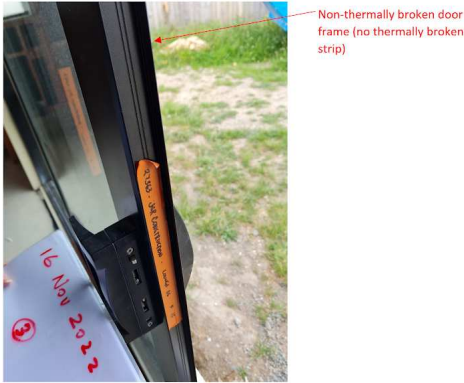
- b) Photo 2 – Typical joint between the vertical frame of the sliding door and the horizontal frame of the window shows that the shared frame between the door and the window do not have the thermally broken strip.

Photo 2 – Typical joint between the vertical frame of the sliding door and the horizontal frame of the window shows that the shared frame between the door and the window do not have the thermally broken strip.

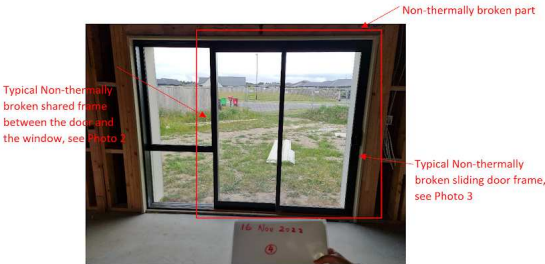
1. All the stiles of the sliding doors are not thermally broken (referring to the photo 3 in my email on Nov 20, 2022 at 10:06 PM)
2. All the fixed interlockers of the sliding doors are missed a thermally-broken strip (referring to the photo 2 in my email on Nov 20, 2022 at 10:06 PM). Note that these fixed interlockers also a part of the adjacent windows.

- c) Photo 3 – Typical slide door frame shows that the slide door does not have thermally broken strip
  - d) Photo 4 – Indicating the non-thermally broken parts of the Sliding Door “Living D6” (Door number referred to the attached quote no. 27363) (Trim 2130 x 2700; Area: 5.751 m sq.)

Photo 3 – Typical slide door frame shows that the slide door does not have thermally broken

You are requested to replace all the entire windows and doors which are partially non thermally broken. The warranty of the affected products has to be valid after the replacement.

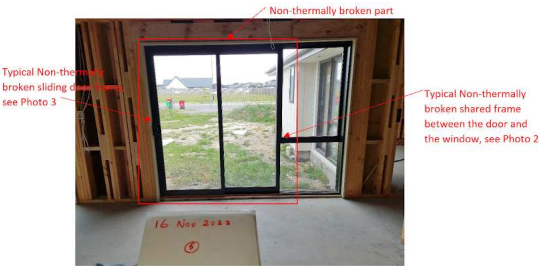
Photo 4 – Indicating the non-thermally broken parts of the Sliding Door “Living D6” (Door number referred to the attached quote no. 27363) (Trim Size: 2130 x 2700; Area: 5.751 m sq.)

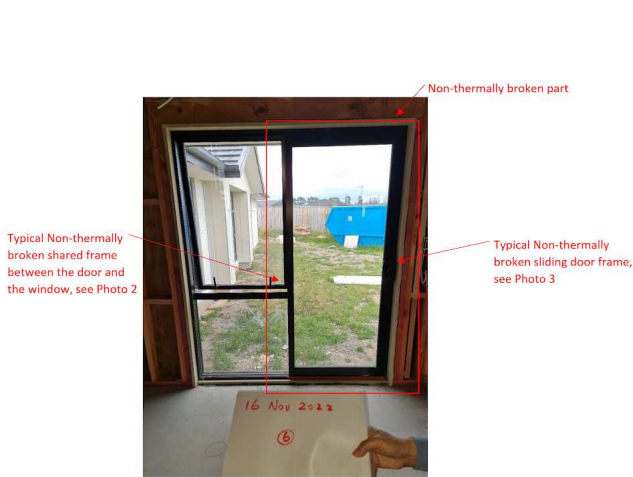
- e) Photo 5 – Indicating the non-thermally broken parts of the Sliding Door “Dining D6” (Door number referred to the attached quote no. 27363) (2130 x 2700; Area: 5.751 m sq.)

Photo 5 – Indicating the non-thermally broken parts of the Sliding Door “Dining D6” (Door number referred to the attached quote no. 27363) (Trim Size: 2130 x 2700; Area: 5.751 m sq.)

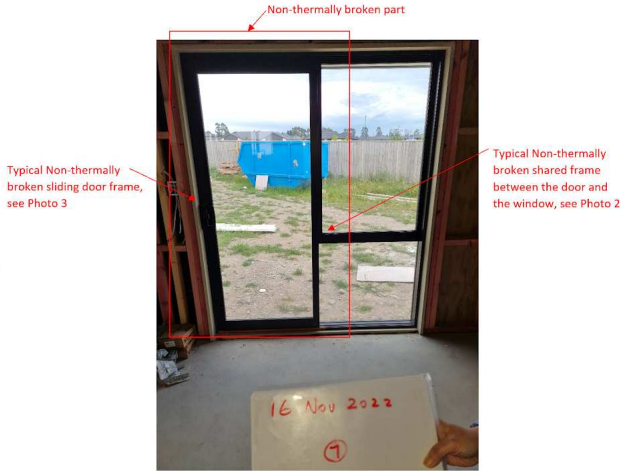
- f) Photo 6 – Indicating the non-thermally broken parts of the Sliding Door “Bedroom 3 D5” (Door number referred to the attached quote no. 27363) (2130 x 1800; Area: 3.834 m sq.)

Photo 6 – Indicating the non-thermally broken parts of the Sliding Door “Bedroom 3 D5” (Door

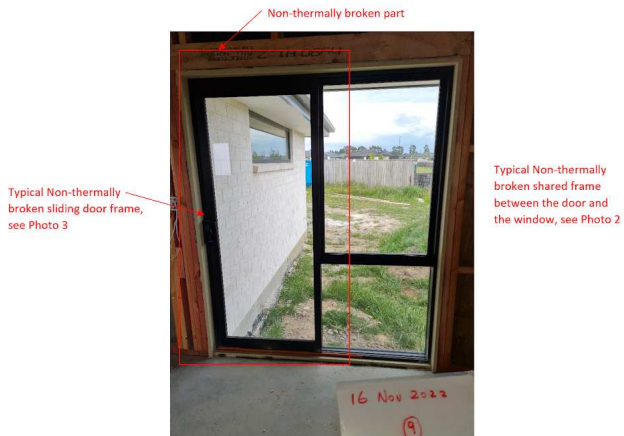
- g) Photo 7 – Indicating the non-thermally broken parts of the Sliding Door “Bedroom 2 D4” (Door number referred to the attached quote no. 27363) (2130 x 1800; Area: 3.834 m sq.)

Photo 7 – Indicating the non-thermally broken parts of the Sliding Door “Bedroom 2 D4” (Door number referred to the attached quote no. 27363) (Trim Size: 2130 x 1800; Area: 3.834 m sq.)

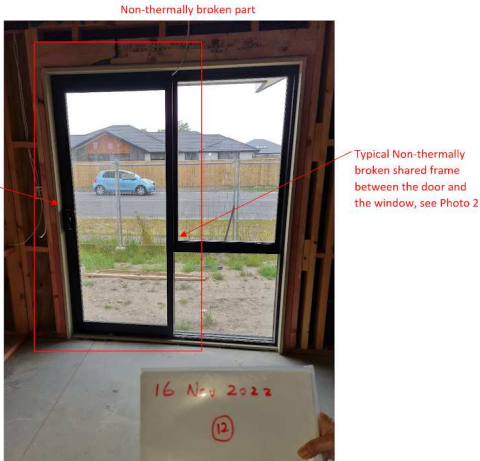
- h) Photo 9 – Indicating the non-thermally broken parts of the Sliding Door “Master Bedroom D3” (Door number referred to the attached quote no. 27363) (Trim Size: 2130 x 1800; Area: 3.834 m sq.)

Photo 9 – Indicating the non-thermally broken parts of the Sliding Door “Master Bedroom D3” (Door number referred to the attached quote no. 27363) (Trim Size: 2130 x 1800; Area: 3.834 m sq.)

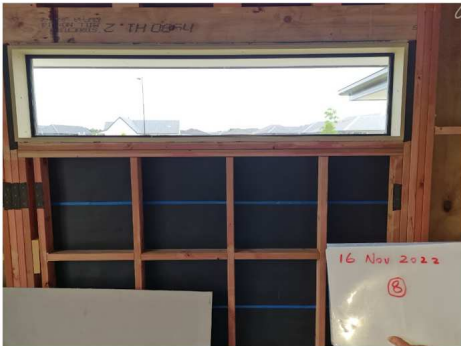
- i) Photo 12 – Indicating the non-thermally broken parts of the Sliding Door “Bedroom 4 D4” (Door number referred to the attached quote no. 27363) (Trim Size: 2130 x 1800; Area: 3.834 m sq.)

Photo 12 – Indicating the non-thermally broken parts of the Sliding Door “Bedroom 4 D4” (Door number referred to the attached quote no. 27363) (Trim Size: 2130 x 1800; Area: 3.834 m sq.)

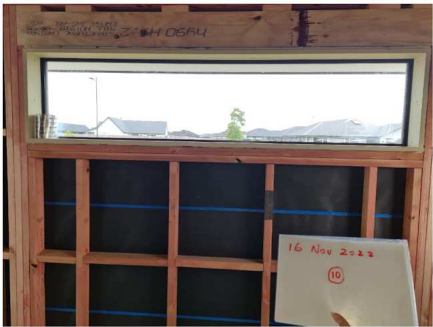
- 2) The frames of the windows that we are not sure if they are thermally broken or not since the depths of those window frames seems to be shallower than others 32% of the thermally broken joinery by comparing the distances between the frames and the internal and external walls. The total area of these aluminium joinery is 4.2 m sq. (8.7 % of the total area). These products are shown in the following photos:

- a) Photo 8 – Indicating uncertain thermally broken window “Bedroom 2 W5” (Door number referred to the attached quote no. 27363) (Trim Size: 600 x 2400; Area: 1.37 m sq)

Photo 8 – Indicating uncertain thermally broken window “Bedroom 2 W5” (Door number referred to the attached quote no. 27363) (Trim Size: 600 x 2400; Area: 1.37 m sq.)
