# The collapse of Space building

B. CAICEDO\*, E. ALONSO†, C. MENDOZA‡ and J. ALCOVERRO†

On 12 October 2013, the 24-storey high ‘Space’ building collapsed in Medellín, Colombia. The building had a reinforced concrete structure founded on large-diameter piles with enlarged bases. During and after construction the building exhibited structural problems and excessive settlements of some piles. Because of the evidence of structural damage, the building was evacuated on 11 October 2013, 1 day before the collapse. Isolated large-diameter piles excavated in a firm, high-plasticity saprolitic residual clay, supported building columns. Building collapse was triggered by a significant increase of the vertical load transmitted by some columns, which, in turn, is explained by widely different settlements experienced by neighbouring piles and the resulting loading transfer mechanisms. The first part of the paper presents the results of the field exploration and laboratory tests, as well as the structural and architectural layout, including the construction process and other forensic aspects that could influence the collapse of the structure. Afterwards, the joint structure–foundation–soil num

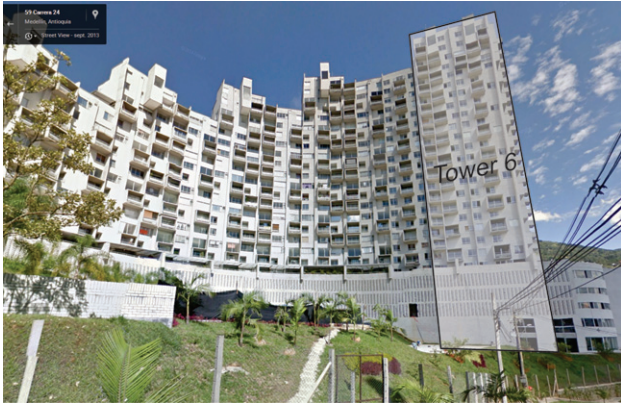
Fig. 1. Space building a few days before the collapse of the sixth tower (from Google Maps, Street View, September 2013)

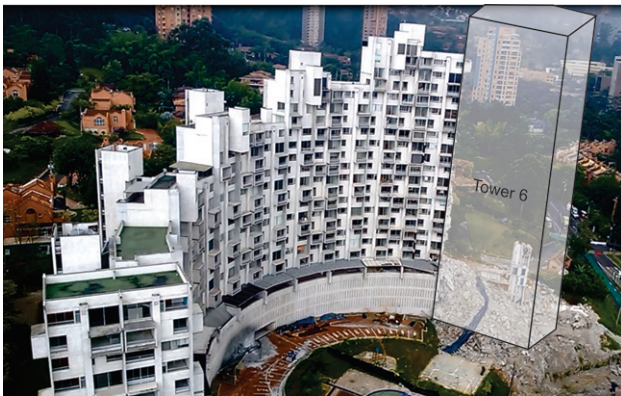
Fig. 2. Space building a few days after the collapse of Tower 6

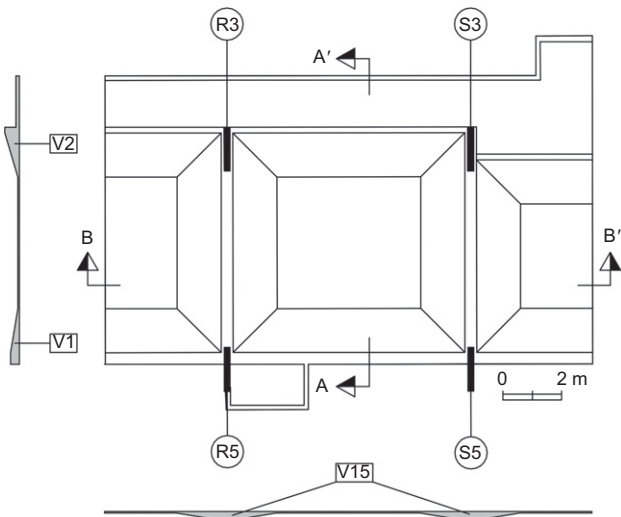
Fig. 3. Floor slab contributing to columns R3, R5, S3 and S5 of a typical floor of Tower 6. Plan view and two vertical cross-sections

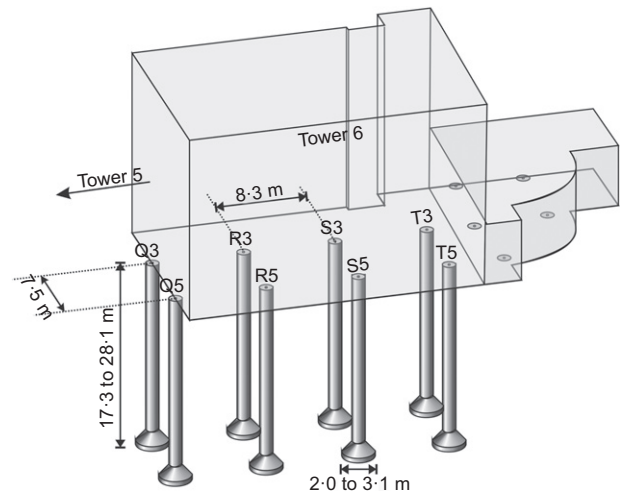
Fig. 4. Scheme of the original design of the pile foundation of Tower 6 of the Space building. Actual caisson lengths and base diameters depend on the soil encountered during construction; see Table 3 and Figs 19 and 20

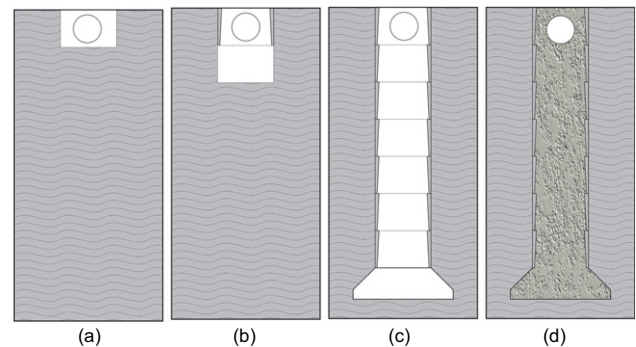
where the soil has high variability, making it difficult for mechanised construction. Fig. 5 shows a schematic representation of the construction process of a caisson pillar foundation. The following steps describe the construction process.

- The construction begins with a handmade cylindrical excavation of the desired diameter, 1.2 m in the case of Space building, whose depth is usually 1 m, see Fig. 5(a).
- The walls of the excavated cylindrical opening are protected by means of a truncated cone shield made of

Fig. 5. Construction process of the foundation caissons: (a) manual excavation of the first section; (b) placing the concrete reinforcement of the first section and manual excavation of the second one; (c) manual excavation and reinforcement of the subsequent sections and excavation of the widened base; (d) concrete filling

concrete. The process continues with the next step of excavation, as shown in Fig. 5(b).

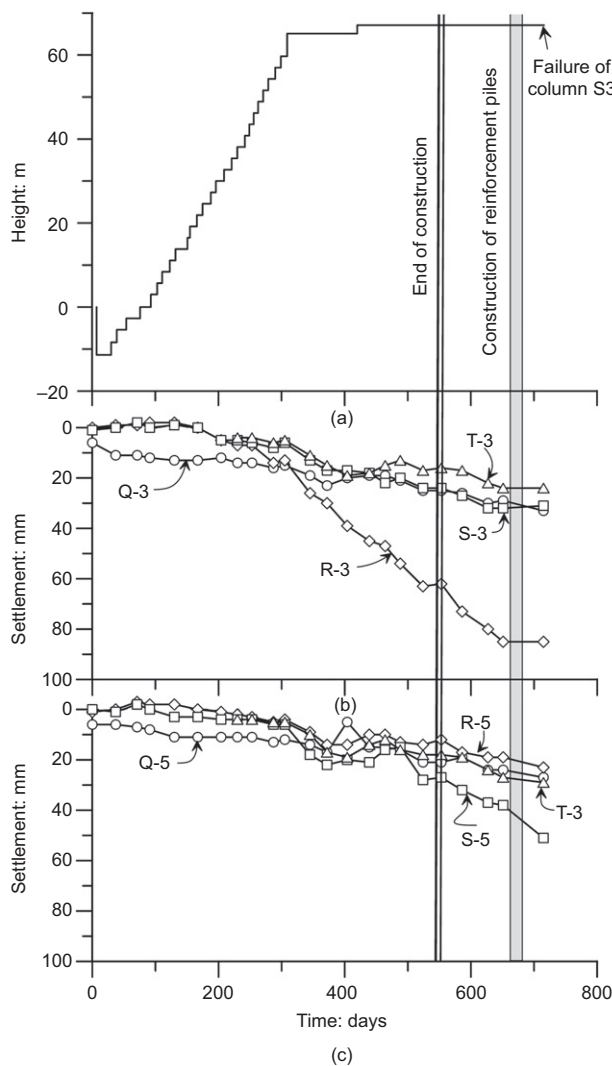
Fig. 6. (a) Progression of the height of the building (structure). (b), (c) Settlements along axes 3 and 5

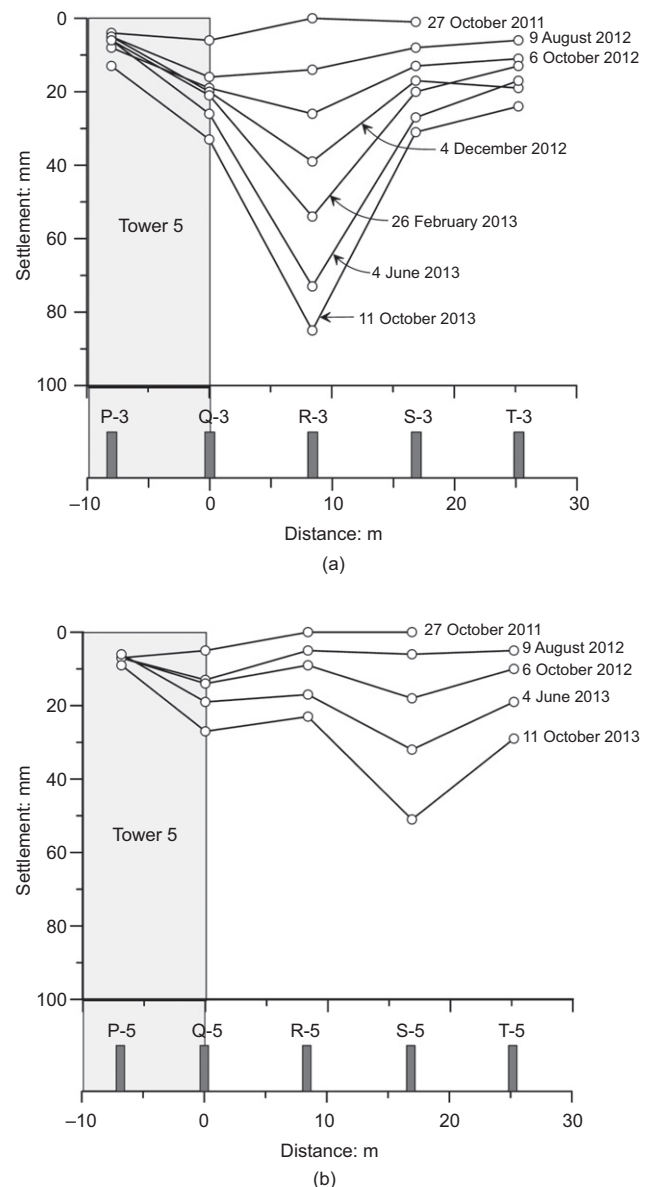
Fig. 7. Settlements along axes 3 and 5

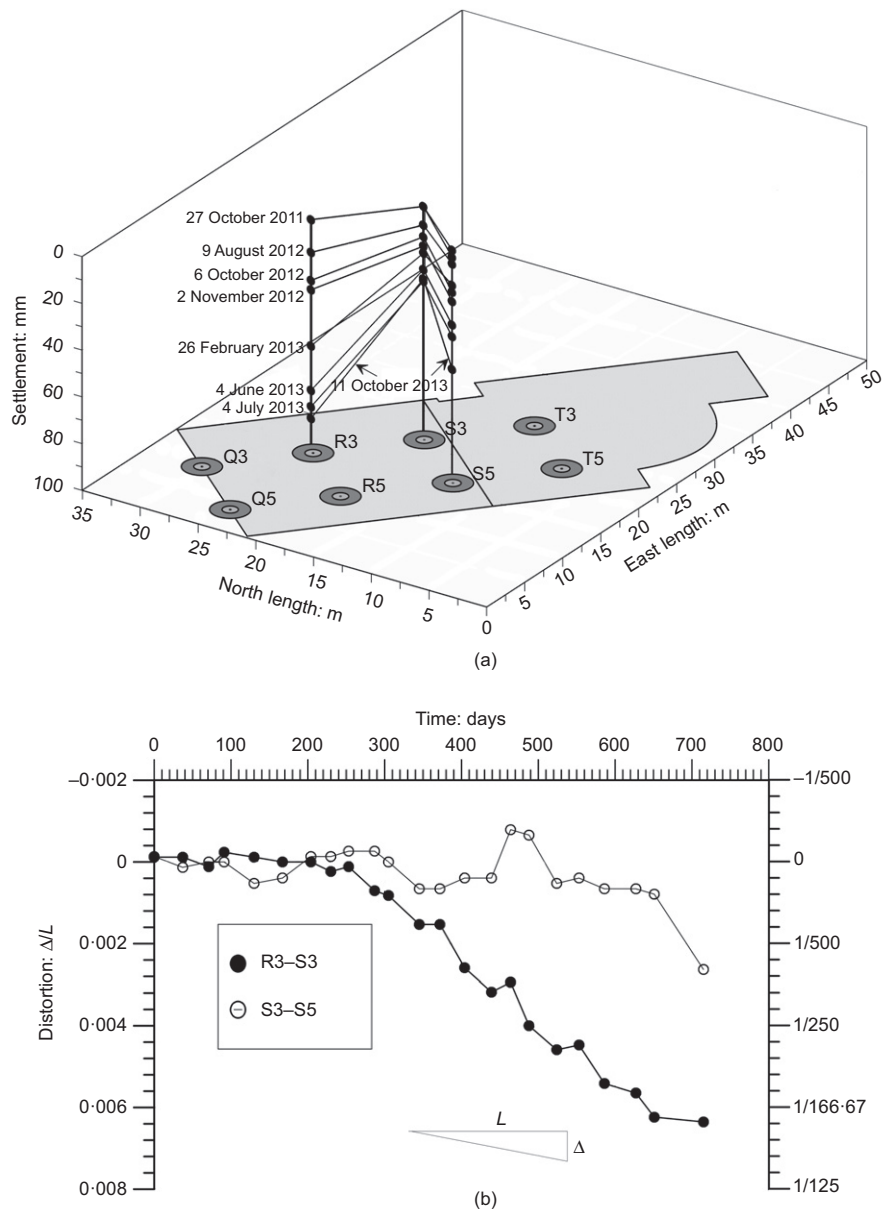
Consider in Fig. 8(a) the interaction between columns R3, S3 and S5. R3 and S5 experienced the largest recorded settlements at the end of construction (85 and 50 mm, respectively), whereas S3 remained at a low value similar to the other columns of Tower 6. Therefore, column S3 is affected by the largest relative differential settlements in two perpendicular directions ( $1/157$  in the R3–S3 direction and  $1/380$  in the S3–S5 direction) at the end of construction. The angular distortion evolved in time in the manner shown in Fig. 8(b).

In the case of R3–S3, the angular distortion remained negligible up to day 250 from the beginning of construction, when the tower reached a height of 40 m. Beyond this time, the distortion increased rapidly, showing a linear trend with time, until the crutching piles supporting pile R3 became effective. This behaviour is an indication of the exhaustion of the bearing capacity of pile R3 when the height of the tower reached 40 m. The S3–S5 angular distortion remained at a

Fig. 8. Differential settlements between pile S3 and piles R3 and S5

very low value up to the end of the tower construction. It accelerated during the last 2 months before failure for reasons which remain unclear.

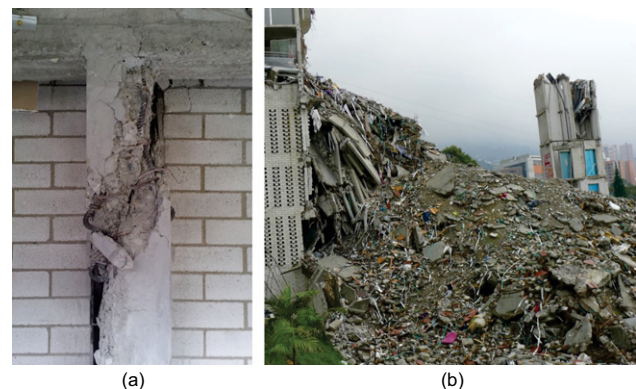
As a result, a significant load transfer occurred from piles R3 and S5 towards pile S3. This effect, quantified later, explains the observed structural failure in column S3 1 day before the collapse of Tower 6 (Fig. 9(a)). It is believed that the collapse of column S3 prompted the massive failure of the entire tower (Fig. 9(b)).

Fig. 9. (a) Column S3, 4th floor of Tower 6, on 11 October 2013 (building collapse: 12 October 2013 at 20.20 h). (b) Floor slabs piled up after collapse

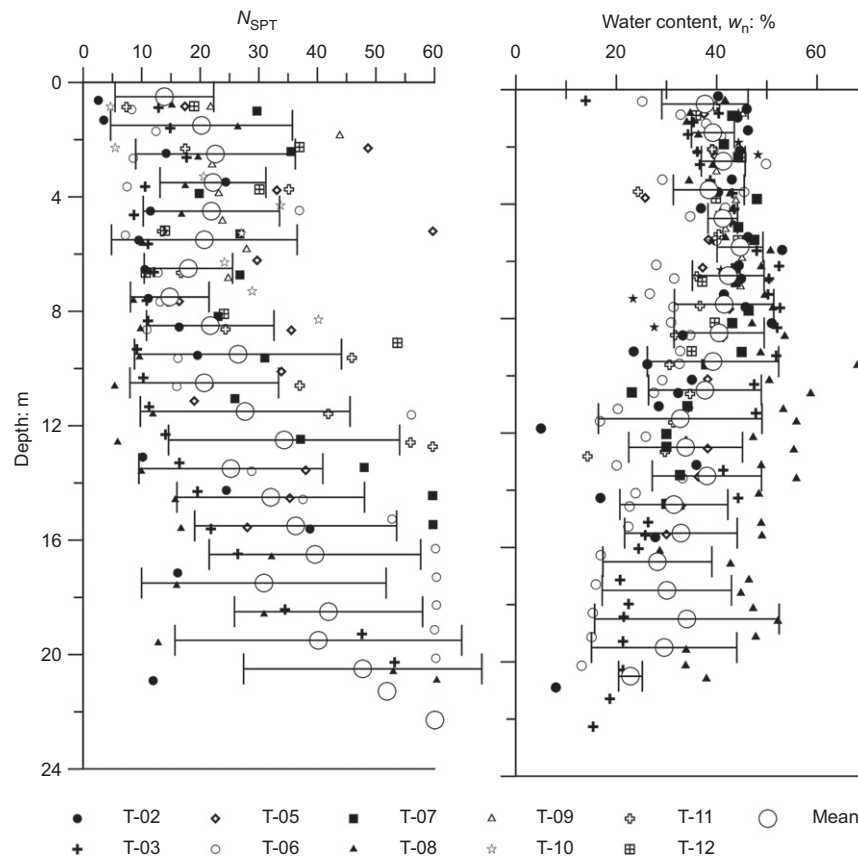
with depth of  $N_{SPT}$  and water content at the site of the Space building complex is shown in Fig. 10. Large dispersions of values are observed, which, down to a depth of about 20 m, essentially correspond to a layer of saprolite overlain by a 10 m

Fig. 10. Variation with depth of  $N_{SPT}$  and the natural water content at the site of the Space building complex for all boreholes carried out before construction

thick layer of colluvium. In the saprolitic level, the average standard penetration test (SPT) blow count,  $N_{ave}$ , increases with depth from  $N_{ave} = 20$ –22, at a depth of 10 m, to  $N_{ave} = 50$ , at depths of 20–22 m. However, the risk of finding levels of soft to medium strength remains high in the entire building area.

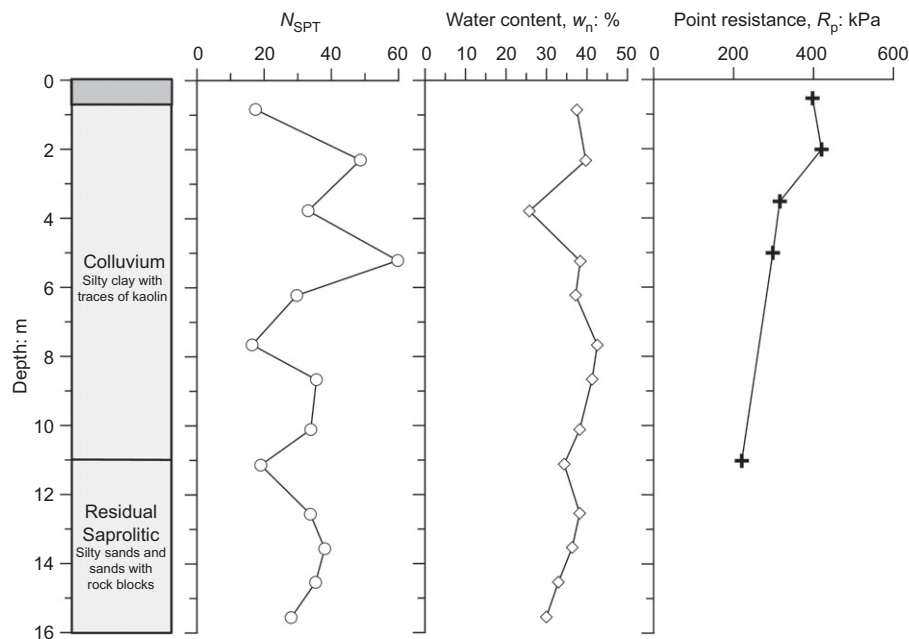
Fig. 11. Variation with depth along borehole T05 of  $N_{SPT}$ , the natural water content and the penetration strength ( $R_p$ ) determined with a hand penetrometer on recovered cores

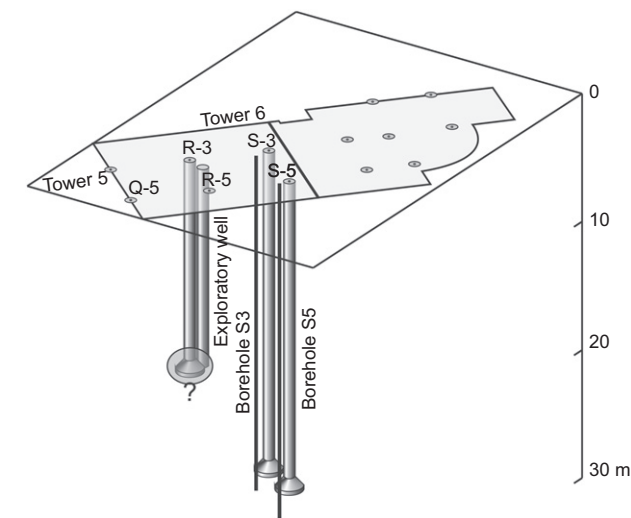
Fig. 12. Location of the large-diameter exploratory well and boreholes S3 and S5 drilled after the collapse of Tower 6

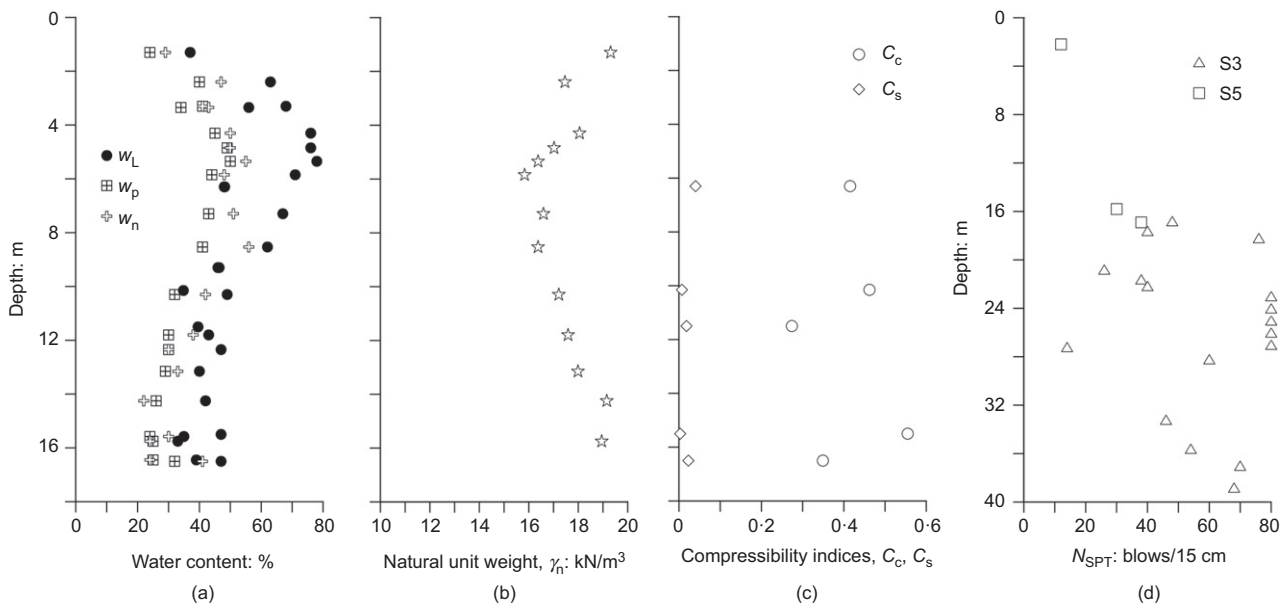
Figure 13 shows the distribution of the basic identification parameters determined in the tests. The fines content in all samples exceed 70% and the soils are high-plasticity silts (MH) in the upper 10 m, followed by medium-plasticity silts (ML) at greater depths. The liquid limit was in the entire profile larger than 40% and values of 70–80% were measured at depths of 3 to 7 m. Unit weight ( $\gamma_{\text{sat}}$ ) is correlated with plasticity: values of the order of  $\gamma_{\text{sat}} = 16 \text{ kN/m}^3$  are found in

Fig. 13. Distribution with depth in boreholes S3 and S5 of: (a) Atterberg limits and water content; (b) unit weight; (c) compressibility indices; (d) SPT blow count

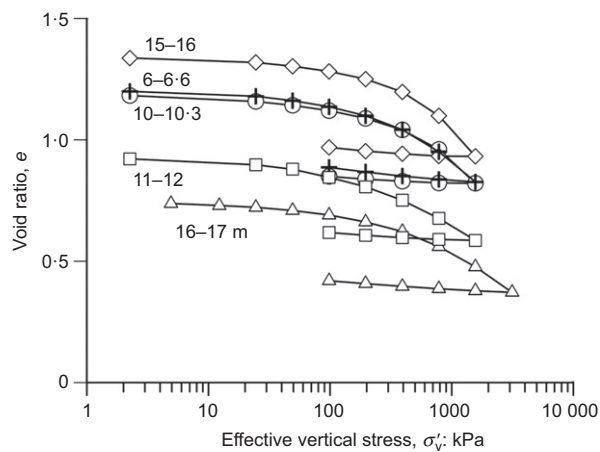
Fig. 14. Oedometric tests on undisturbed samples taken at four depth intervals in the exploratory well

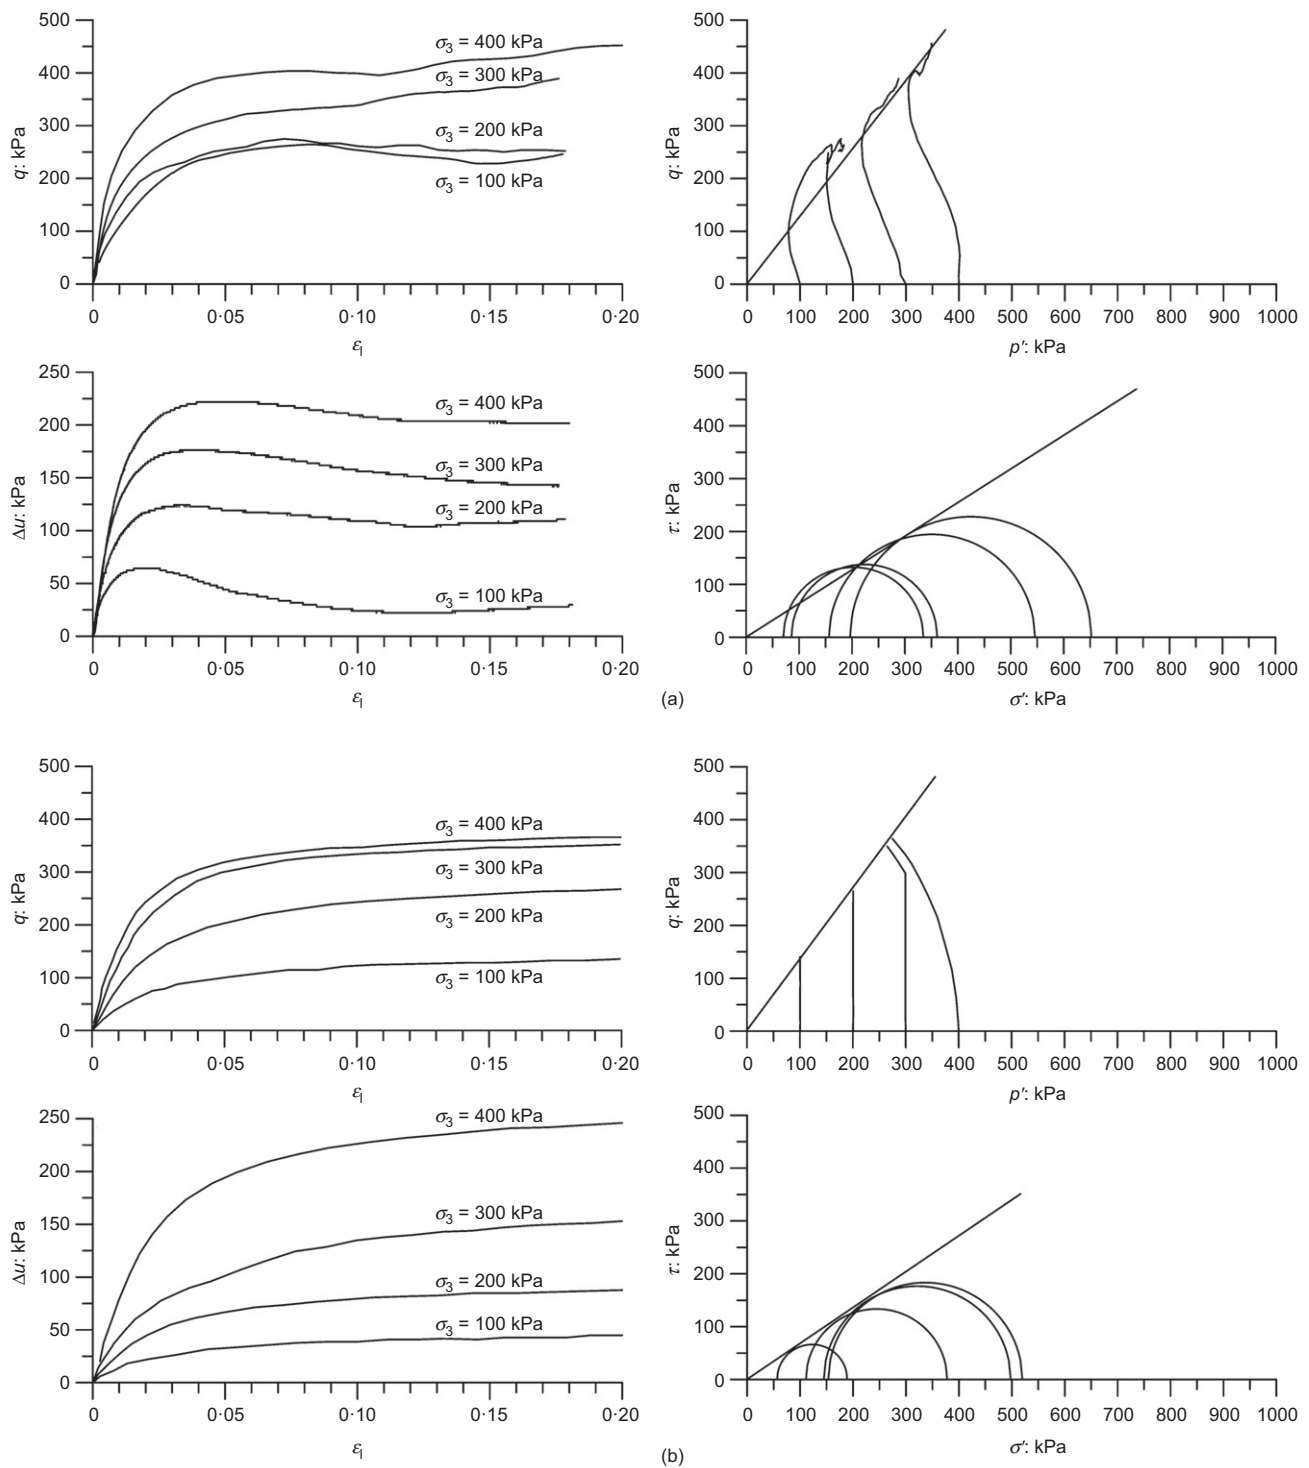
Fig. 15. Consolidated undrained triaxial tests on samples from the exploratory caisson at a depth close to 16.5 m: (a) test results; (b) hardening soil model predictions.  $\sigma_3$ , confining stress;  $\varepsilon_1$ , axial strain;  $q$ , deviator stress;  $p'$ , effective mean stress;  $\Delta u$ , increase in pore pressure;  $\tau$ , shear stress

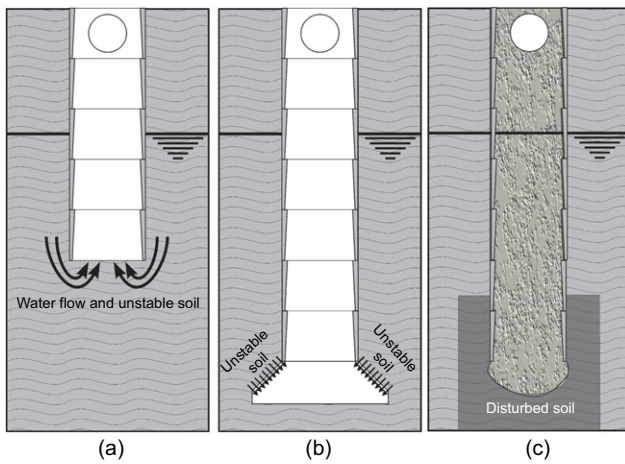
Figure 16 describes the problems of the construction of the pillar R3 and the difficulties encountered during the excavation of the inspection well. The construction process followed in pile R3 is described as follows.

- (a) When excavating below the groundwater level, water flowed into the excavation. This situation led to

instability of the walls and bottom of the excavation; see Fig. 16(a).

Fig. 16. Schematic representation of the difficulties encountered during construction of the foundation piles: (a) flow of water and soil into the excavation; (b) falling of the soil above the widened base; (c) pile without the widened base with disturbed soil around the base

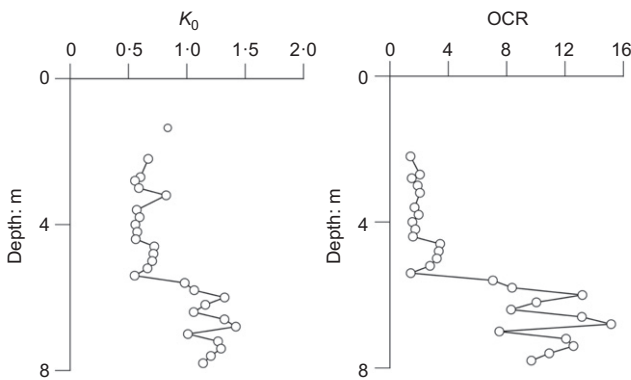
Fig. 17.  $K_0$  and OCR profiles measured by Mendoza (2013) in a residual soil of Brasilia

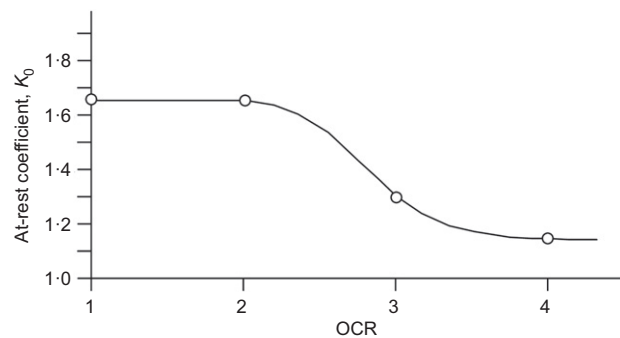
It was realised that alternative values of the ( $K_0$ , OCR) pair, plotted in Fig. 18, led to a similar acceptable match of the triaxial tests. Moreover, changing the adopted ( $K_0$ , OCR) values, following Fig. 18, had a negligible effect on the pile foundation response.

Fig. 18. ( $K_0$ , OCR) combinations which lead to an acceptable reproduction of triaxial tests and an essentially similar response of the pile foundation

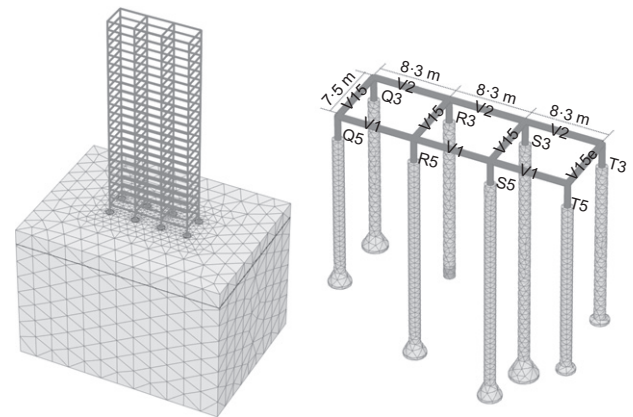
Fig. 19. Finite-element model of Tower 6 of the Space building

Regarding the building structure, each typical floor has ten beams and eight columns modelled using elastic beam elements that sustain axial, shear forces and bending moments. The beam–column framework is connected to the eight foundation piles (Fig. 19).

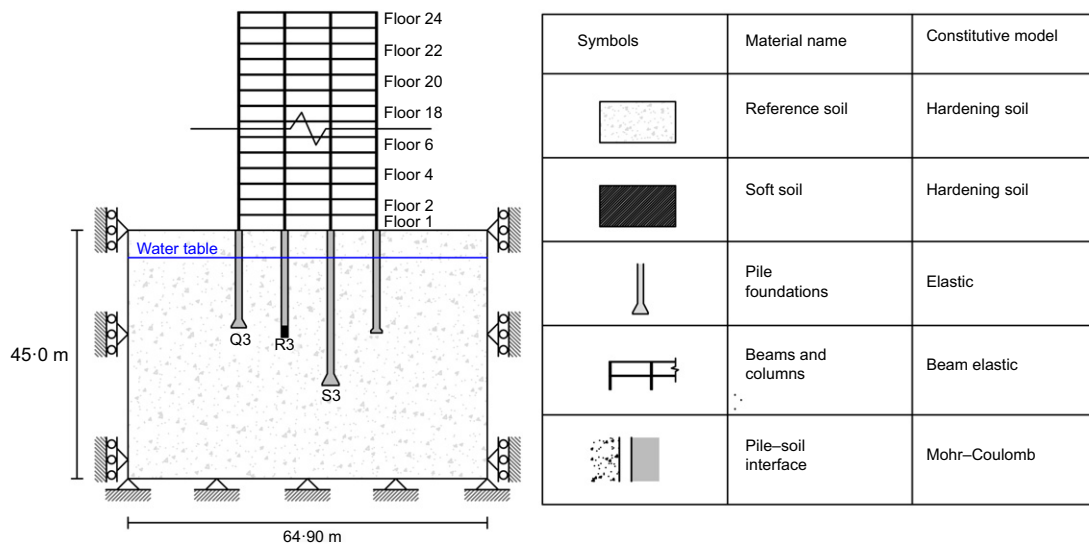
Fig. 20. Cross-section along axis 3, boundary conditions of finite-element analyses and constitutive models for materials involved

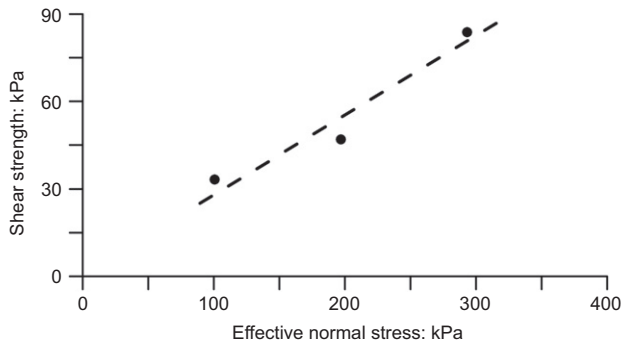
**Fig. 21. Residual friction envelope measured in a ring shear test**

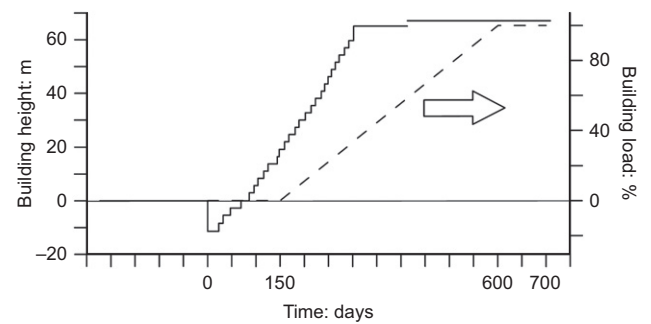
**Fig. 22. Evolution of the building height (structure) and the total load applied on foundation**

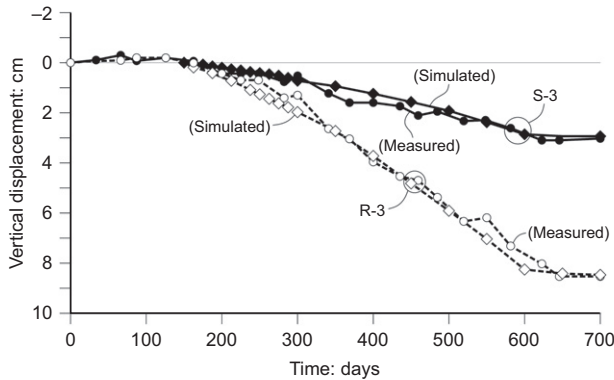
This section compares the data of settlement monitoring and the results obtained from the finite-element method simulation. In general, the computed evolutions of the pile settlements reproduce quite satisfactorily the corresponding recorded evolutions. Particularly accurate (Fig. 23) are the results of the evolution of the settlement of piles R3 (no enlarged base) and S3 (the column where the first symptoms of column exhaustion were observed: Fig. 9(a)).

**Fig. 23. Measured and computed evolutions of displacements for piles R3 and S3**

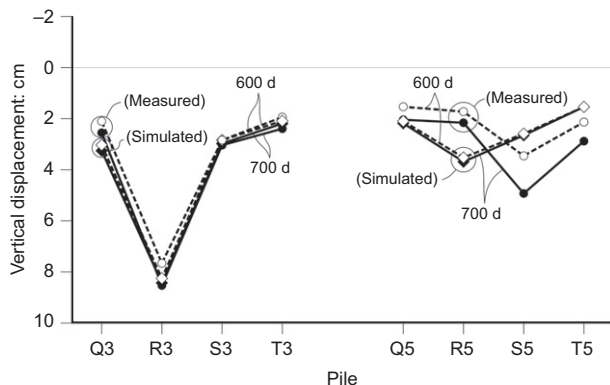
**Fig. 24. Measured and computed distributions of pile displacements at 600 days (floor 24) and 700 days (100 days after floor 24)**

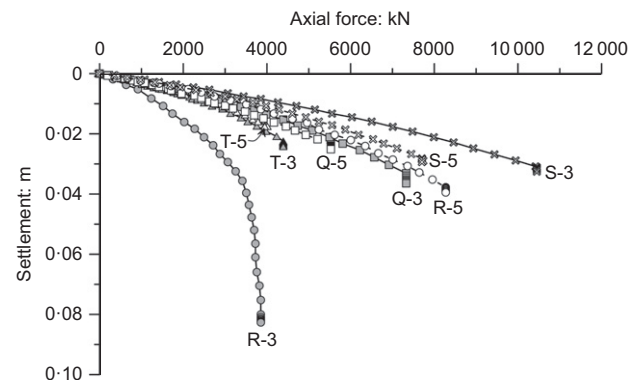
Figure 25 presents the simulated settlement–load curves of all piles. Results show that pile R3 (no enlarged base) reached its ultimate capacity at a rather small load. Other piles can withstand larger loads, except piles T3 and T5, which have smaller footing enlargements. Results shown in Fig. 25 indicate that pile R3 failed because of the lack of bearing support at the base. The calculated limiting load for R3 is around 3500 kN for a settlement of 0.035 m. It is in a state of failure and settlements increase fast for small load increments.

**Fig. 25. Calculated displacement–force curves of piles**

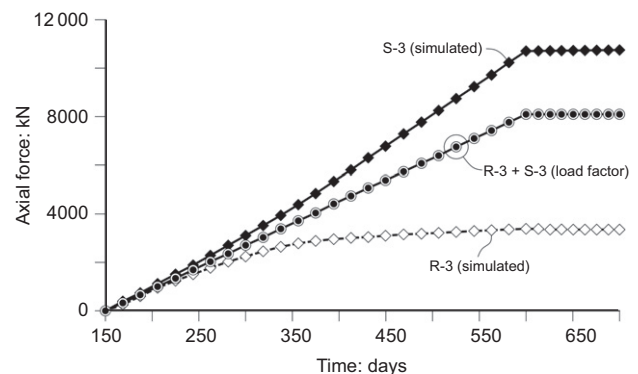
Because of the reduced bearing capacity of pile R3 due to the lack of footing widening and the soft soil under the base, the structure of the building transferred additional load to piles connected with pile R3. A comparison of the theoretical pile loads computed with proportional load factors and the results of the numerical model in the vicinity of pile R3 along axis 3 is summarised as follows.

- (a) The column over pile R3 experiences a load decrease of 60% compared with the load obtained using the corresponding loading factor.

**Fig. 26. Evolution of the forces applied to the piles R3 and S3, compared with the corresponding forces obtained using a loading factor (since the loading factor for pile R3 is the same as the factor for pile S3, the two evolution curves coincide)**

- (b) The column founded on pile S3 experiences a load increase of 28% compared with the load obtained using the corresponding loading factor.
- (c) The column founded on pile Q3 experiences a load increase of 32% compared with the load obtained using the corresponding loading factor.

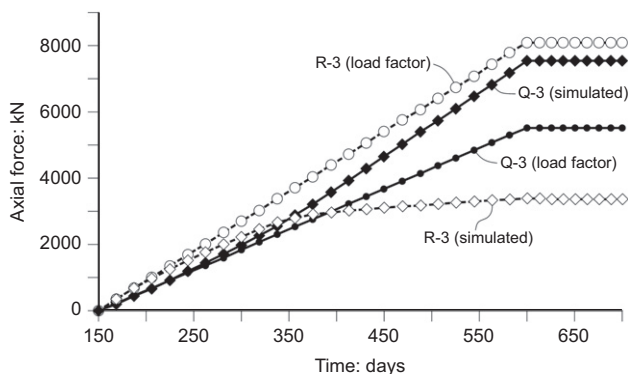
Fig. 27. Evolution of the forces applied to the piles R3 and Q3 compared with the corresponding forces obtained using a load factor

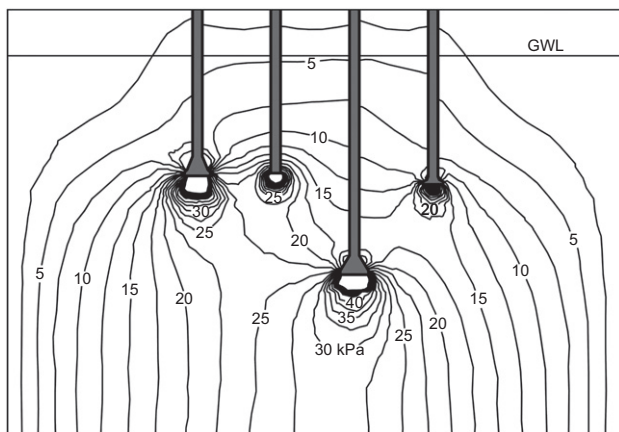
Fig. 28. Distribution of excess pore water pressures on the vertical plane through the centres of piles Q3, R3, S3 and T3 at 600 days (floor 24)

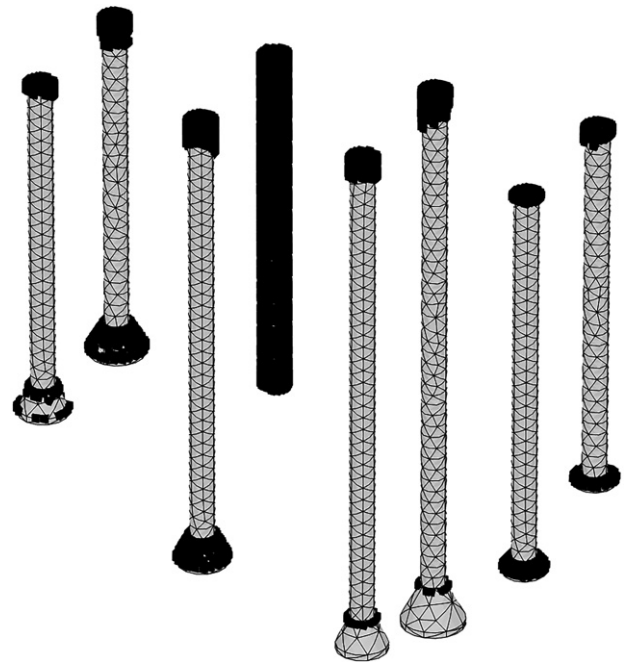
respectively. In the first case (Fig. 29) shear yielding is massive in pile R3. The upper parts of all piles had reached a degraded strength and soil under the enlarged bases also experience some yielding.

Fig. 29. Distribution of failure points on the pile-soil interfaces of piles Q3, R3, S3, T3, Q5, R5, S5 and T5 at 375 days (floor 12)

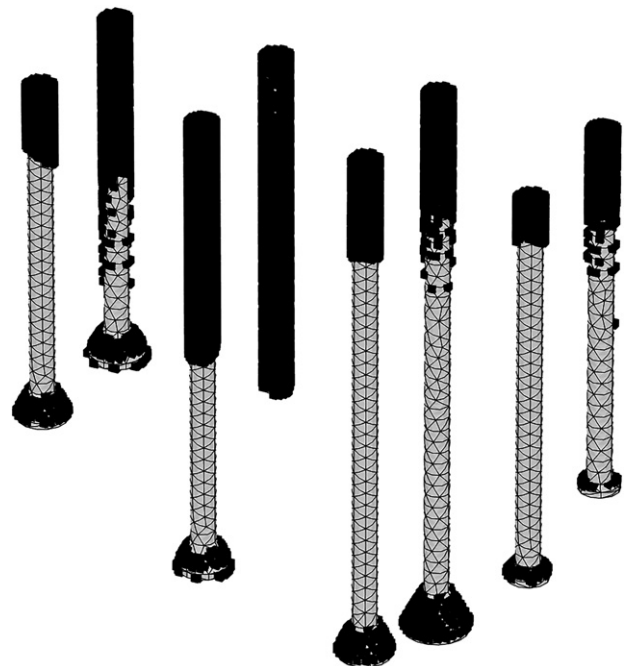
Fig. 30. Distribution of failure points on the pile-soil interfaces of piles Q3, R3, S3, T3, Q5, R5, S5 and T5 at 600 days (floor 24)
