# CENTER FOR DISASTER RISK REDUCTION AND COMMUNITY DEVELOPMENT STUDIES (CDRR&CDS)

## Seismic Vulnerability of Bhutanese Vernacular Buildings

Nimesh Chettri (Member, CDRR&CDS)  
Tshewang Nidup (Member, CDRR&CDS)  
College of Science & Technology  
26<sup>th</sup> July, 2022

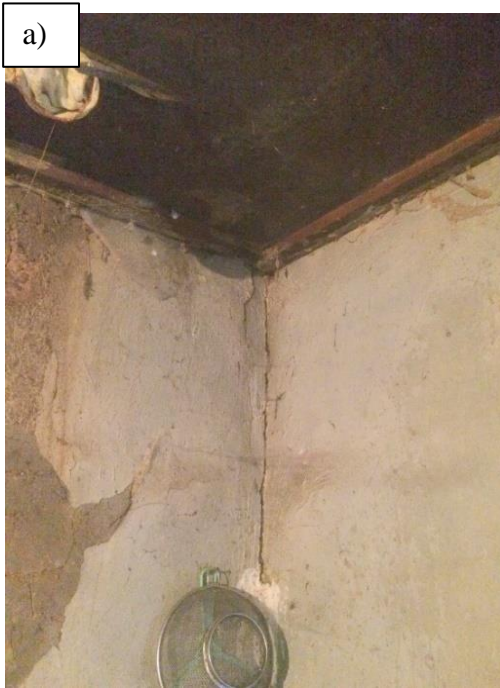
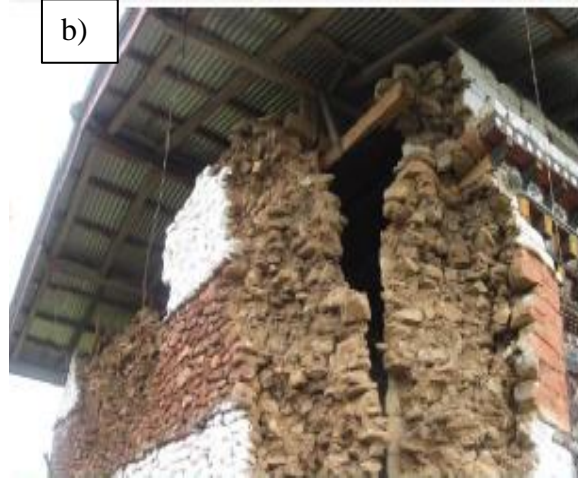
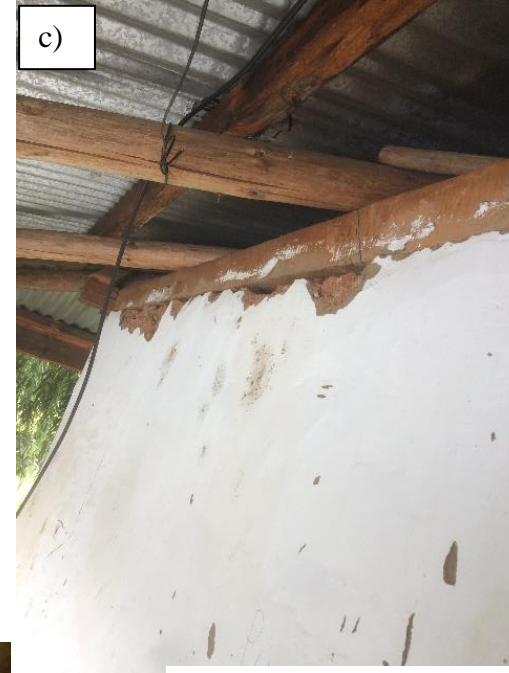
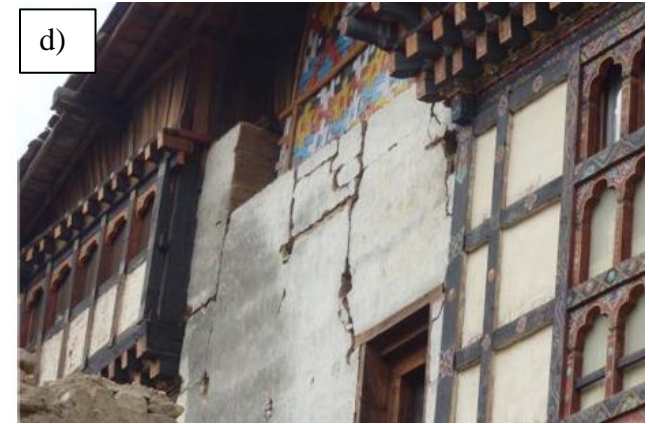
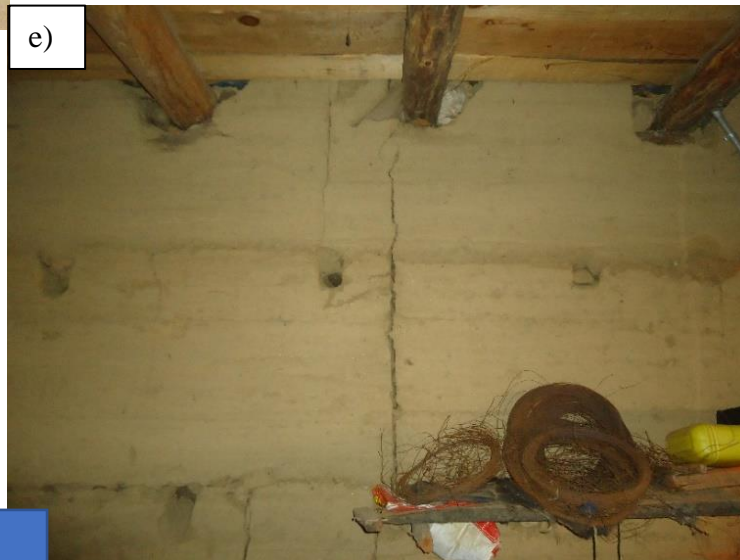
# Key damages and Interpretations

- **Load path irregularity, structural integrity, lack of aseismic components** are among the most significant factors that trigger or aggravate damage to Bhutanese masonry buildings.

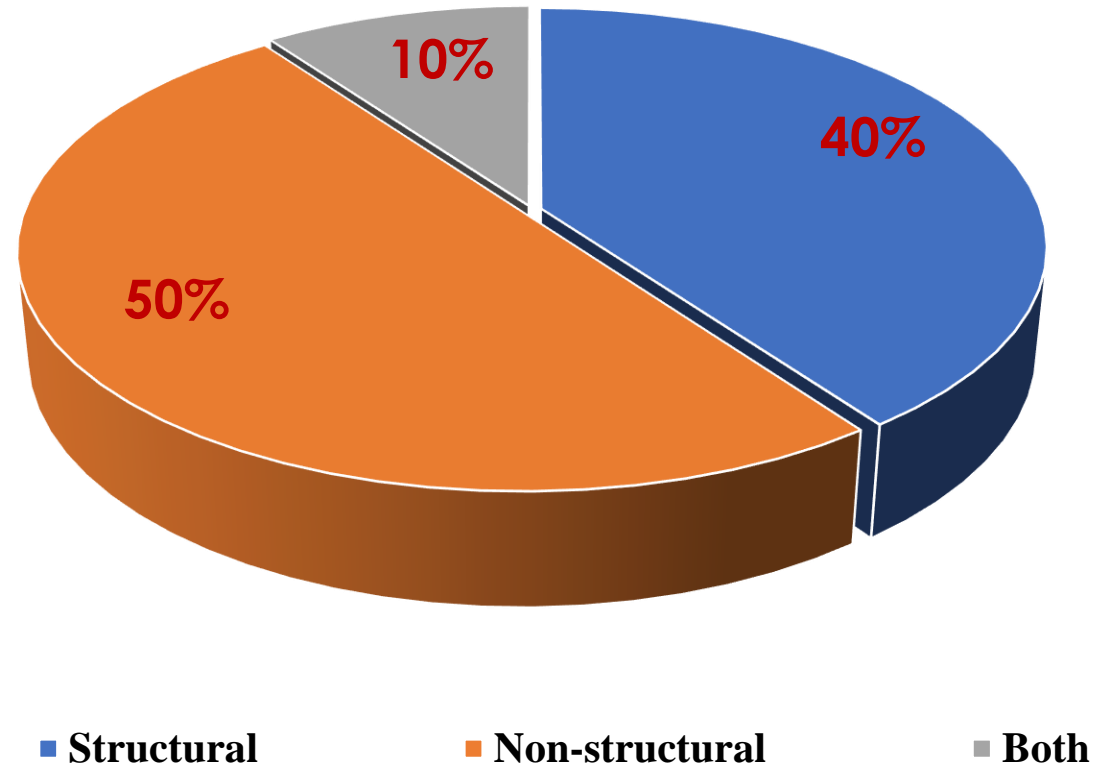
## INJURIES BY TYPE OF OBJECT (People Injured by Objects)

M. Petal, 2004: Research findings from 1999; Kocaeli earthquake
