EE 494 S01  
Internship  
FINAL SUMMARY REPORT

Banner Engineering. Internship

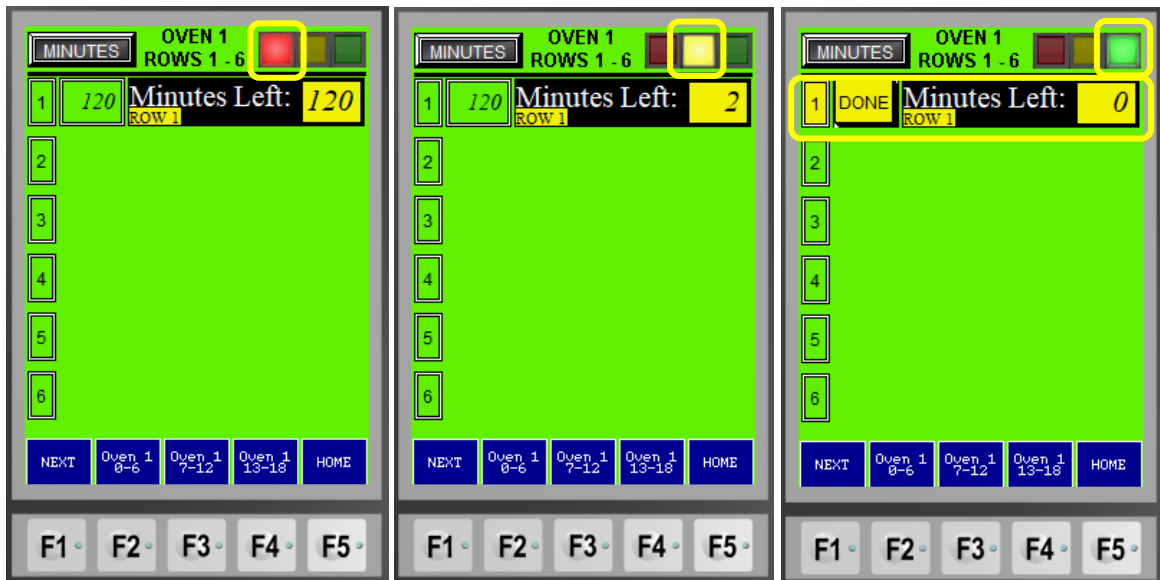
Figure 3: Timer started

The timer indicates the status of the tray, by using red, yellow and green light. Red light will turn on once the time has been entered, yellow will turn on when 2 minutes is left, and green will turn on when the heating is done, Fig.3. Furthermore, it will display the user entered time, time left, will display done once the heating is done on the home screen and oven screen, Fig.5.

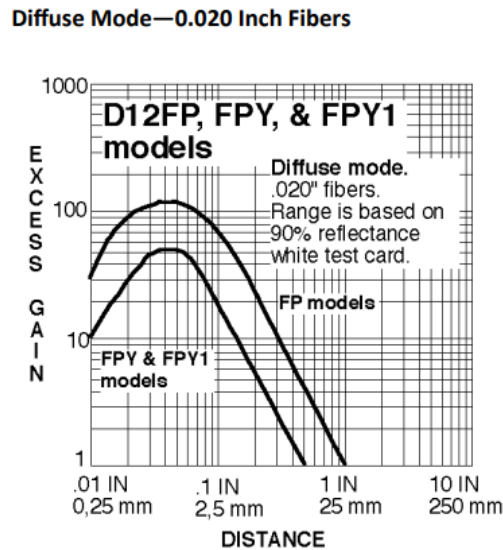
Figure 9: Distance vs gain

The sensors are calibrated for fixed gain/distance ratio. Since, the fiber-optic sensors are very sensitive to the distance, Fig.9, hence with the slightest increase in distance, the gain also must increase. And in this case, if the fixture is pulled up then this causes sensor fault, and the safety controller locks the fixture.
