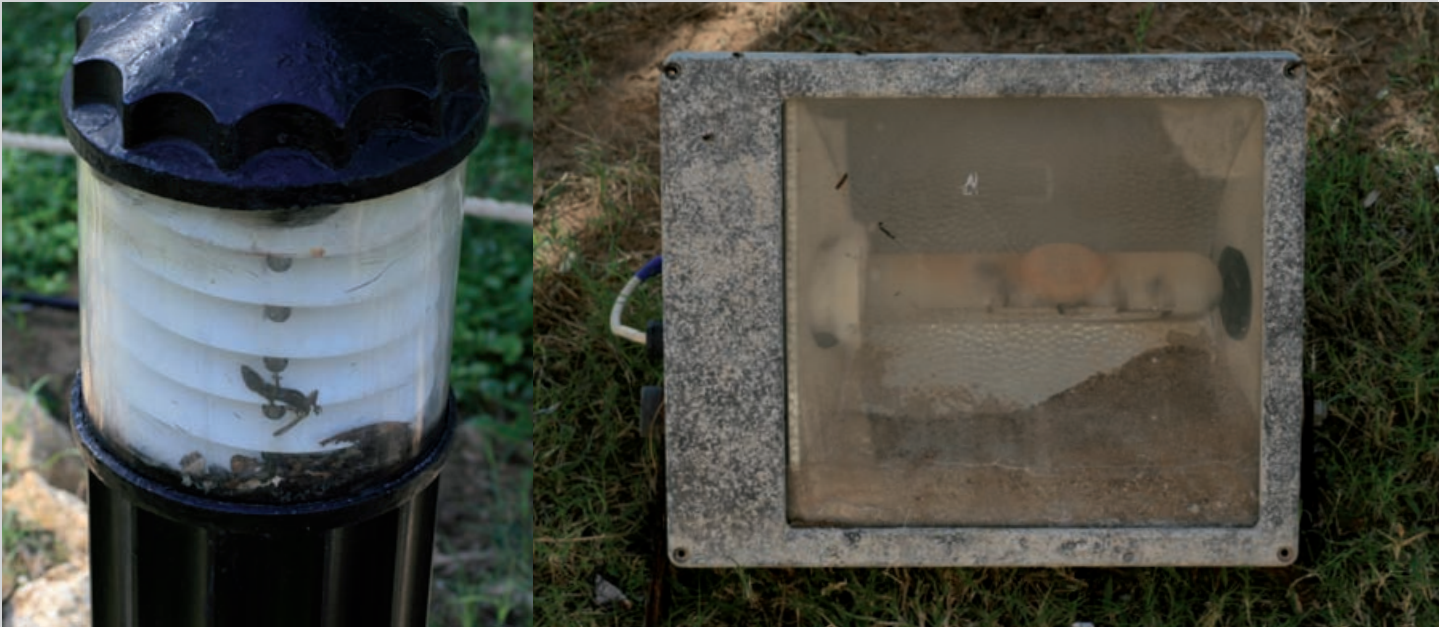
Figures 151, 152

Figure 151: Bollard showing dirt and wildlife inside an IP rated environment.

Figure 152: The luminaire is filled with sand and not performing anymore as designed. A replacement would be required.

The above samples are found in Abu Dhabi city, all the fixtures are in use and/or the circuits switched on during the night. The maintenance gets more and more difficult for a client as more luminaires are installed. Therefore it is advised to design carefully and not to use more luminaires than needed. This will ease the maintenance efforts of the client dramatically.
