PROJECT:		HERRON ISLAND DOLPHIN REPLACEMENT	
TITLE:		MONOPILE - DONUT STYLE	
DESIGNED BY:	GRD	PROJECT NO:	154034.01
DRAWN BY:	JDO	DATE:	JANUARY 2016
CHECKED BY:		SCALE:	NOTED

PROJECT: HERRON ISLAND DOLPHIN REPLACEMENT		
TITLE: PLASTIC PILE CLUSTER STYLE		
DESIGNED BY: GRD	PROJECT NO: 154034.01	SHEET NO:
DRAWN BY: JDO	DATE: JANUARY 2016	
CHECKED BY:	SCALE:	NOTED

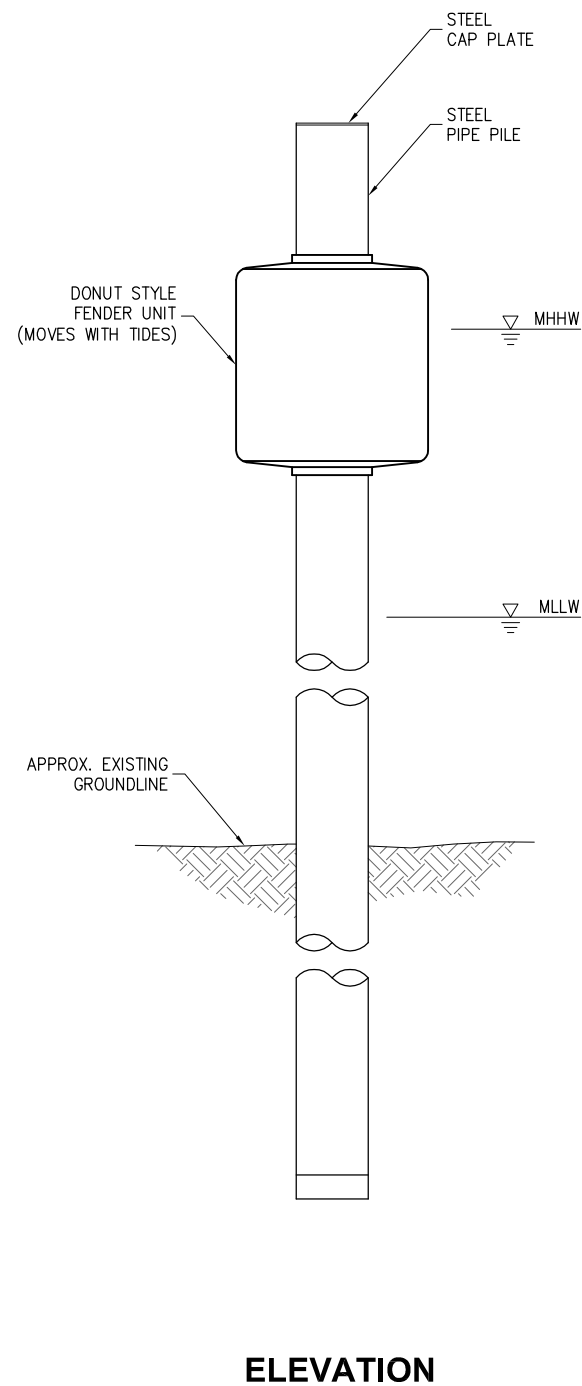
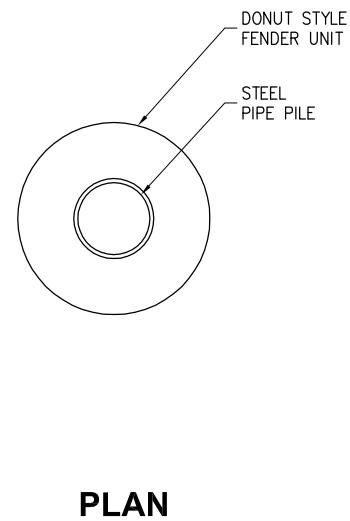
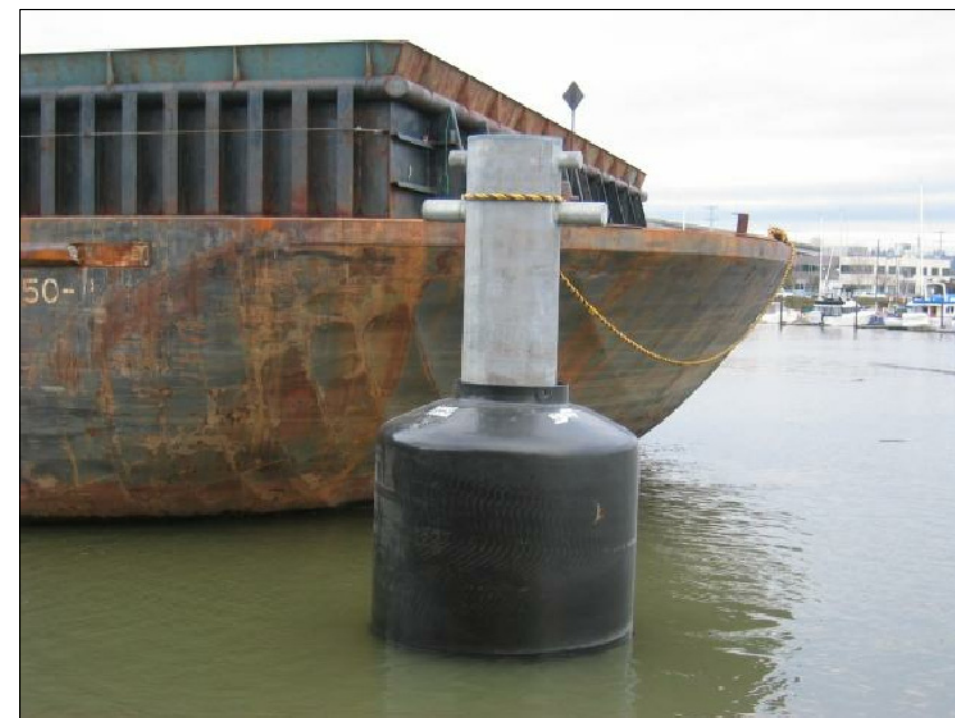
PROS	CONS
SMALL CONSTRUCTION FOOTPRINT (SINGLE PILE)	ONLY WORKS WHERE ADEQUATE OVERBURDEN EXISTS (MAINLAND TERMINAL)
SIMPLE CONSTRUCTION METHOD (UNLESS PILE INSTALLATION REQUIRES DRILLING, SOCKETING, IMPACT DRIVING)	EXPENSIVE PILE SOCKETING AND IMPACT DRIVING WOULD BE NEEDED IN SHALLOW OVERBURDEN (ISLAND TERMINAL)
ASSEMBLY (AFTER PILE INSTALLATION) VERY SIMPLE	ENERGY ABSORPTION SIGNIFICANTLY DEPENDENT ON TIDE LEVEL.
RELATIVELY LOW COST	DONUT FENDER UNIT IS SPECIALTY ITEM AND COSTLY. COULD BE DIFFICULT TO REPLACE IF DAMAGED
	SOFT SURFACE SOILS COULD BE PROBLEMATIC SINCE DOLPHIN DEPENDS ENTIRELY ON LATERAL SUPPORT
	REPAIR OF DAMAGE OFTEN REQUIRES REPLACEMENT
	LARGE DIAMETER PILE REQUIRES ADDITIONAL PERMITTING EFFORTS
	ESTIMATE 8 MONTHS TO PERMIT
	PARTIAL B.E. REQUIRED. MARINE MAMMAL AND BIRD MONITORING REQUIRED. MAJOR CONSULTATION WITH NMFS AND USFWS REQUIRED.

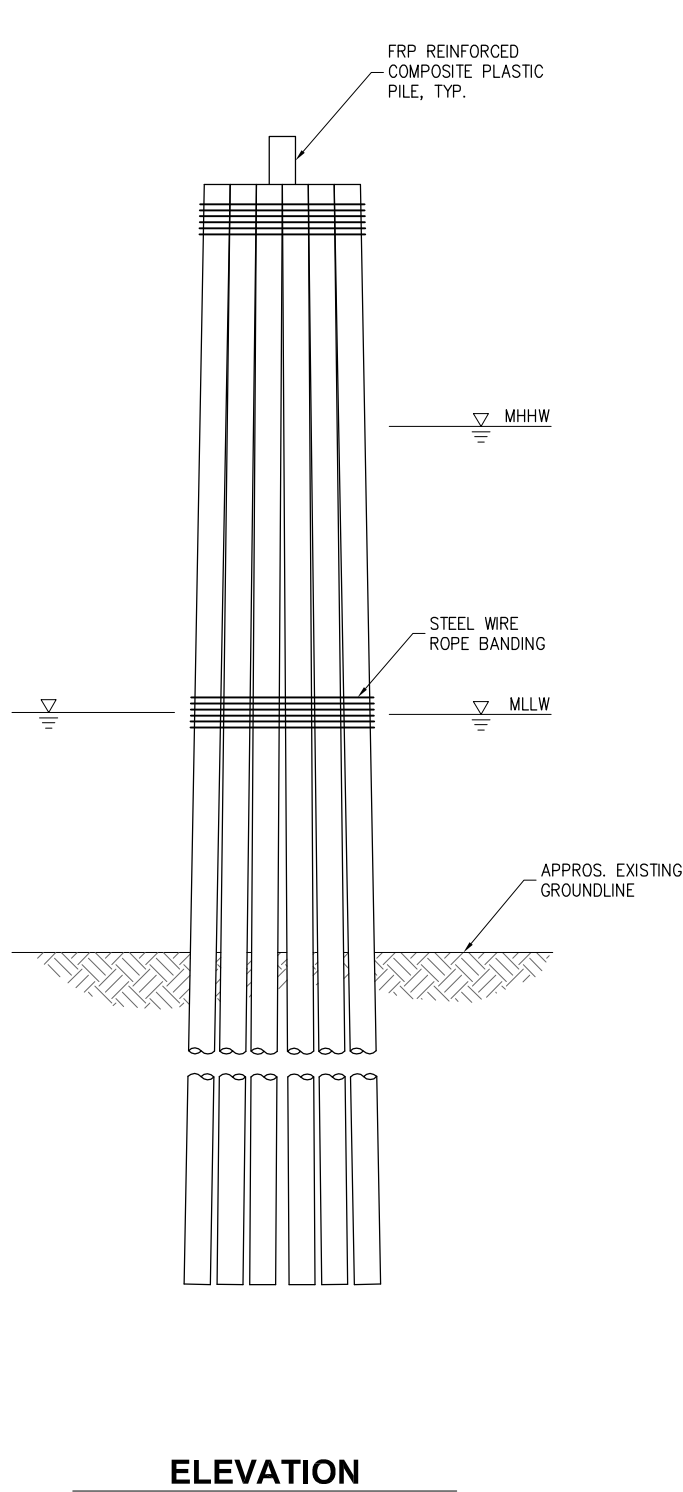
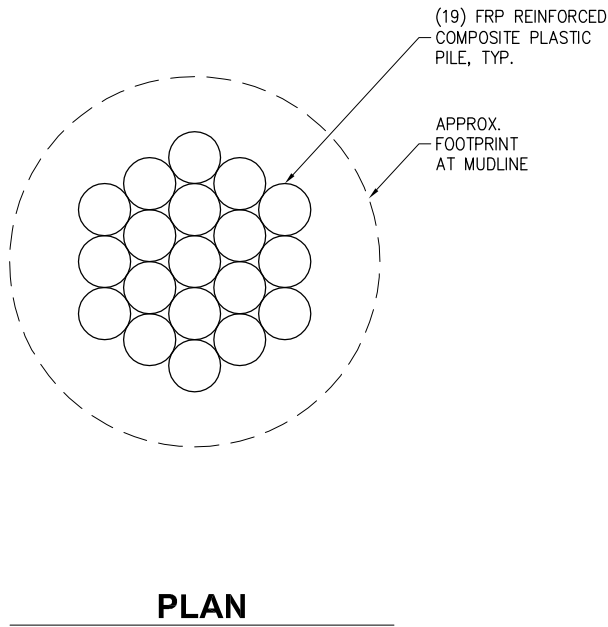
PROS	CONS
SIMPLE CONSTRUCTION METHOD	COMPOSITE PLASTIC PILES ARE A SPECIALTY ITEM, OFTEN DIFFICULT TO PROCURE WITH INCONSISTENCY FROM MANUFACTURES/VENDORS
CAN BE USED AT BOTH TERMINALS	LEAD TIME AVAILABILITY AND COST OF MATERIALS NOT ALWAYS CONSISTENT
VIBRO INSTALL OF ALL PILES POSSIBLE PERMIT	WEAR AND CORROSION OF WIRE ROPE BANDING
SIMILAR FUNCTION AND FEEL TO EXISTING CLUSTER PILE DOLPHINS	REPAIR OF DAMAGE OFTEN REQUIRES REPLACEMENT
NO CORROSION IN PLASTIC PILES TO DEAL WITH	MANY PILES NEEDED (4x OTHER OPTIONS) REQUIRES ADDITIONAL PERMITTING EFFORT
	ESTIMATE 8-10 MONTHS TO PERMIT
	FULL B.E. REQUIRED. MARINE MAMMAL MONITORING REQUIRED. MAJOR CONSULTATION WITH NMFS REQUIRED AND MODERATE CONSULTATION WITH USFW NEEDED
