Rebate offers will be calculated based on the amount of sidewalk adjacent to the property that is in need of repair. A trained City representative will visit the eligible site to determine which elements of the sidewalk are in need of repair and the cost to bring it into compliance with City requirements. Based upon ADA criteria, the representative will determine the required scope of work and corresponding rebate offer.

The rebate amount is based on the following table of values

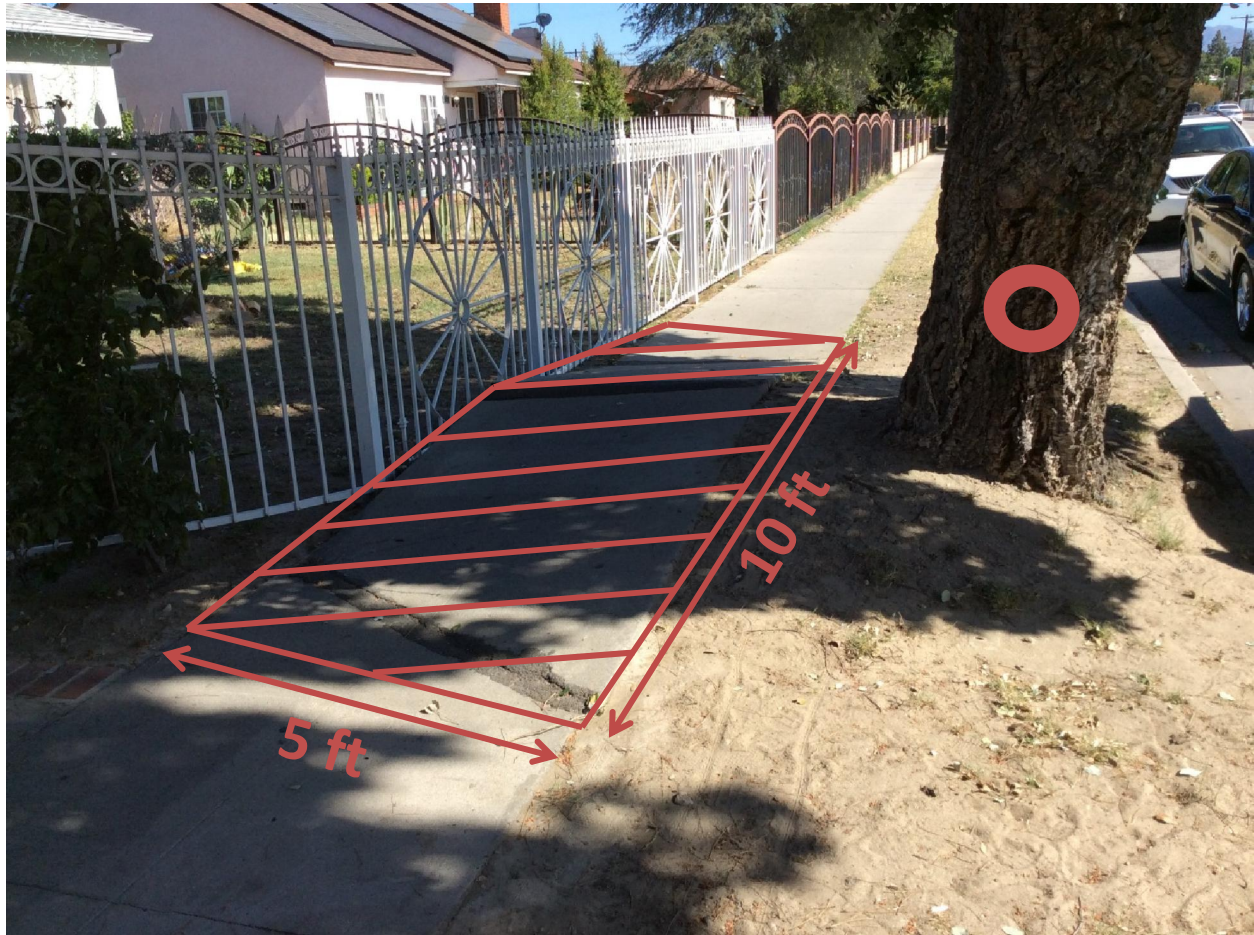
Example 1 – Field Assessment

In this example the section of sidewalk shown in the red cross-hatched area, measuring 5ft x 10ft, does not meet City requirements and is in need of repair. A City Arborist has also determined that a tree removal is required at this location. The estimate to perform the construction necessary to bring the sidewalk into compliance with City requirements is calculated as follows:

Sidewalk = 5ft x 10ft = 50ft² of sidewalk in need of replacement

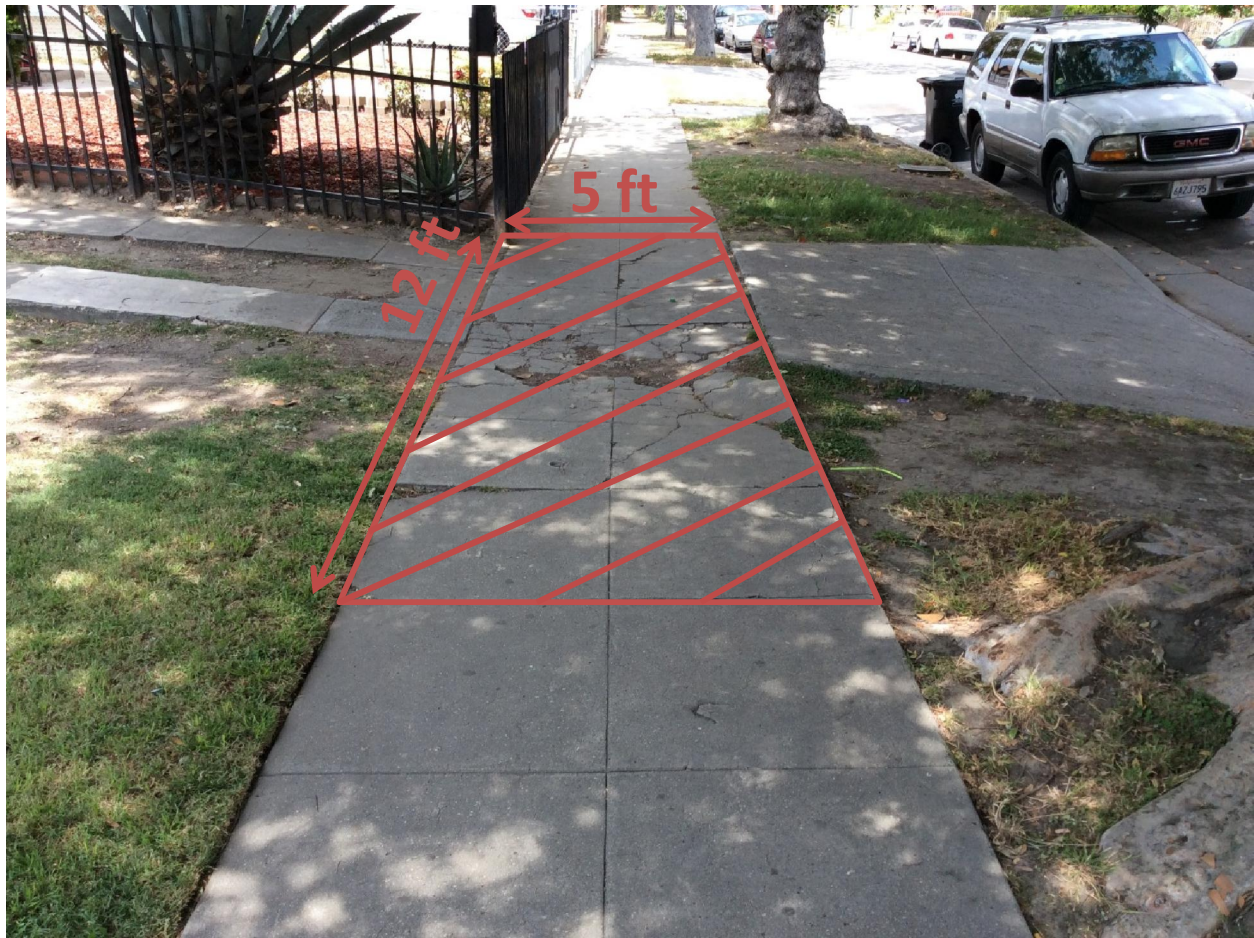
Example 2 – Field Assessment

In this example the section of sidewalk shown in the red cross-hatched area, measuring 5ft x 12ft, does not meet City requirements and is in need of repair. The estimate to perform the construction necessary to bring the sidewalk into compliance with City requirements is calculated as follows:

Sidewalk = 5ft x 12ft = 60ft² of sidewalk in need of replacement

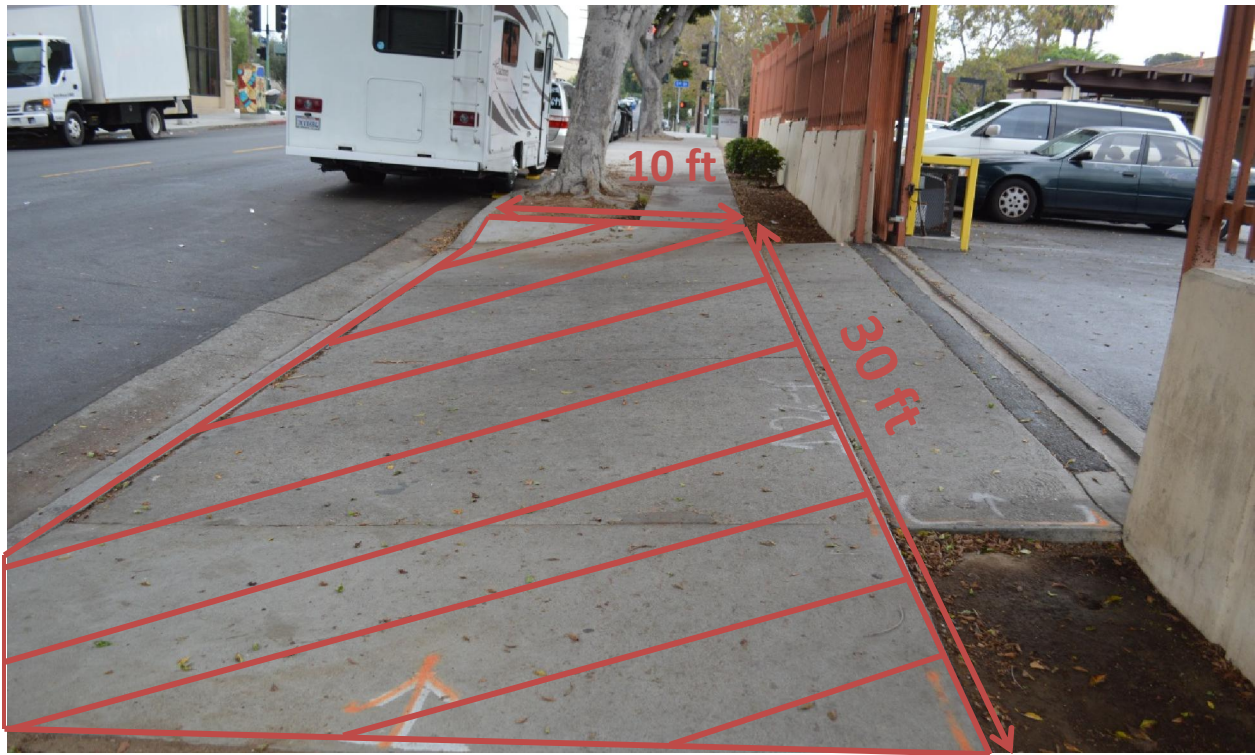
Example 5– Field Assessment

In this example the driveway shown in the red cross-hatched area, measuring 10ft x 40ft, does not have an ADA accessible crossing and needs repair to meet City requirements. The City inspector has also found a utility pullbox and an additional 100 ft² of sidewalk in need of replacement on the other side of the property. The estimate to perform the construction necessary to bring the sidewalk into compliance with City requirements is calculated as follows:

Sidewalk = 100ft² of sidewalk in need of replacement

Driveway = 5ft x 30ft = 150ft² of driveway in need of replacement

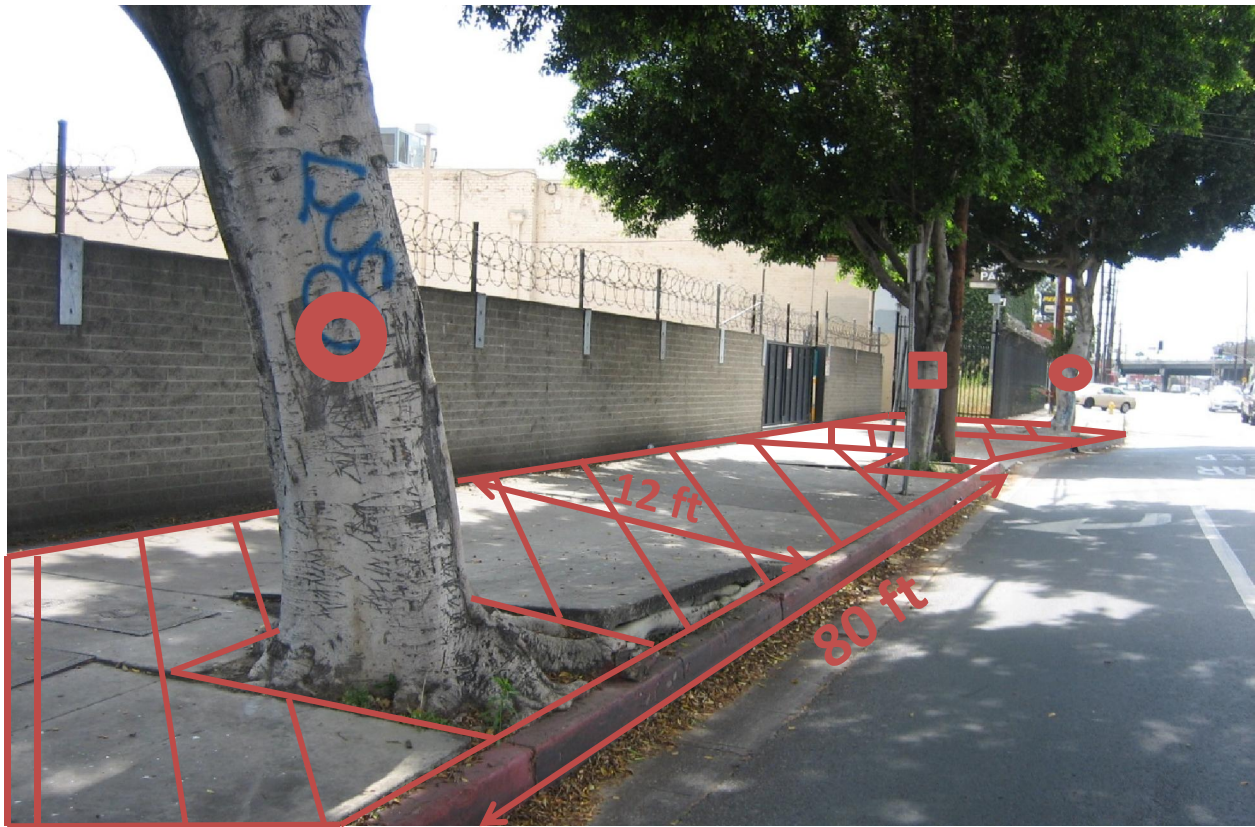
Example 6 – Sample Assessment

In this example there are two sidewalk sections and a driveway shown in the red cross-hatched areas that do not meet City requirements and are in need of repair. The larger sidewalk section measures 80ft x 12ft and contains two tree wells. The smaller sidewalk section measures 10ft x 14ft and contains one tree well. The driveway measure 12ft x 20ft and does not have an ADA compliant crossing. A City Arborist has also determined that two tree removals are required at this location and the third tree requires 20 LF of root pruning. There are also two utility boxes in the sidewalk that will need replacement. The estimate to perform the construction necessary to bring the sidewalk into compliance with City requirements is calculated as follows:

Large Sidewalk Area = 12ft x 80ft = 960ft²

Small Sidewalk Area = 10ft x 14ft = 140ft²

Total Sidewalk Area = 960ft² + 140ft² = 1100ft²

Tree Wells = 4ft x 6ft x 3 Tree Wells = 72ft²

Sidewalk = 1100ft² - 72ft² = 1028ft² of sidewalk in need of replacement
