City of Los Angeles Sidewalk Repair Program
Consulting Arborist Direction

DATE: July 15, 2015

LOCATION: 1. Fire Station 6, 326 N. Virgil Ave, Los Angeles
2. Fire Station 10, 1335 S. Olive St, Los Angeles
3. Fire Station 17, 1601 S. Santa Fe Ave, Los Angeles

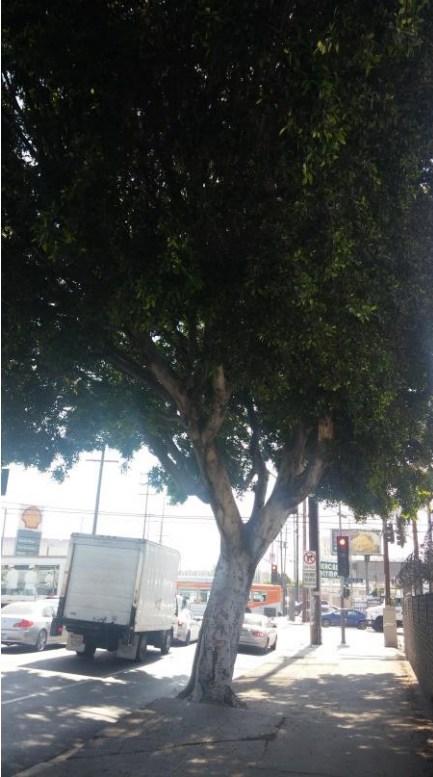
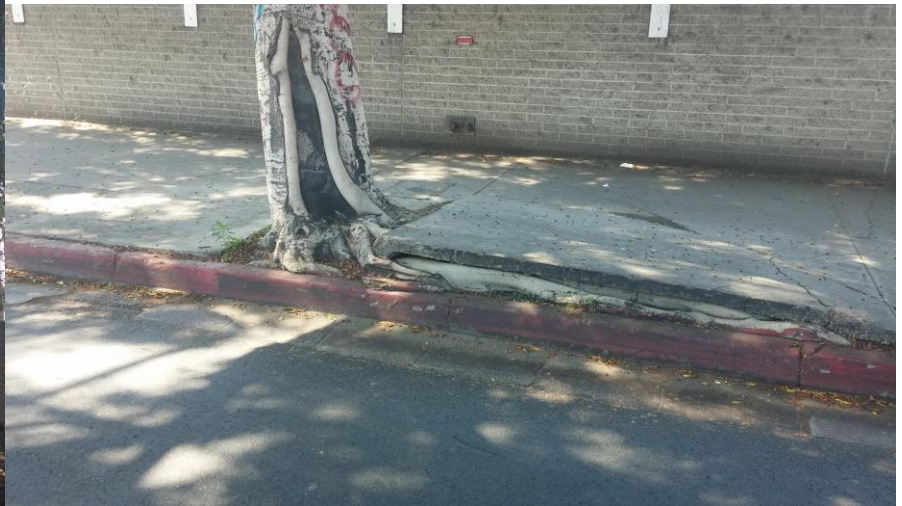
Tree #1 – Ficus (*F. nitida*) 27"x40'. Large roots lifting sidewalk. Significant trunk decay on north side.

12, 13. Ficus with large roots lifting sidewalk and trunk decay.

On Olympic, starting at Santa Fe and going west. The first Ficus should be removed due to significant structural root damage necessary to facilitate sidewalk repairs. The second Ficus should have the tree well expanded 2 ft. east and west. It may be root shaved and crown reduced. The third Ficus should be removed due to significant structural root damage necessary to facilitate sidewalk repairs.

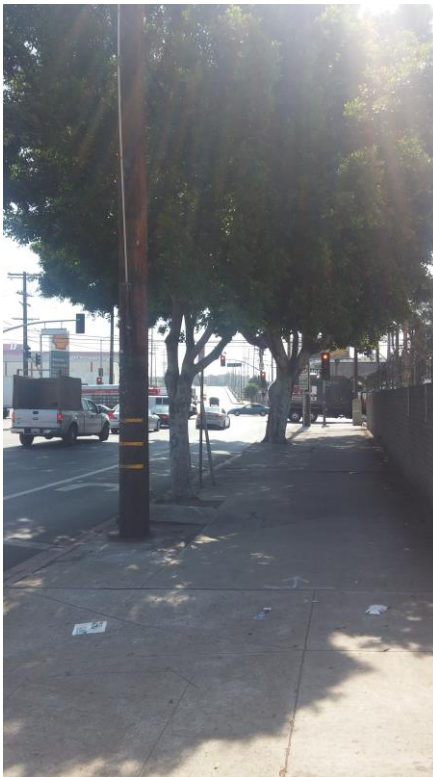
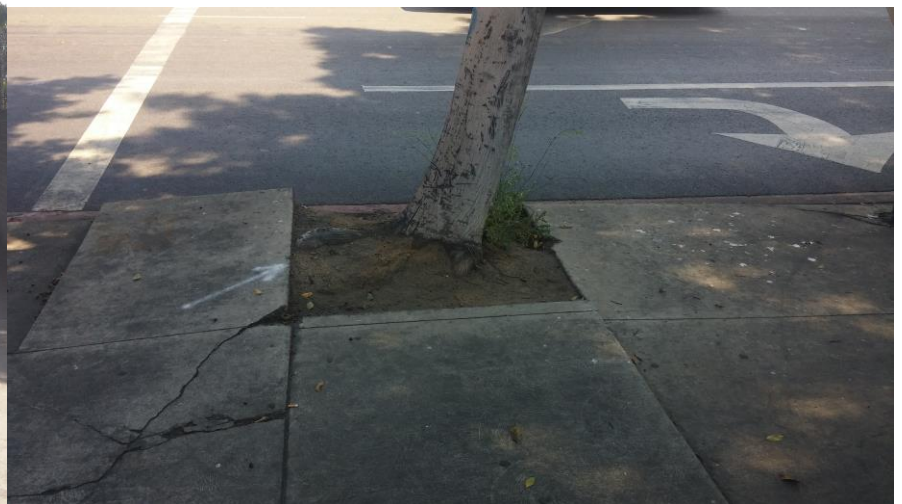
Tree #2 – Ficus (*F. nitida*) 11"x30'. Some root lifting.

14, 15. Ficus with some sidewalk lifting.

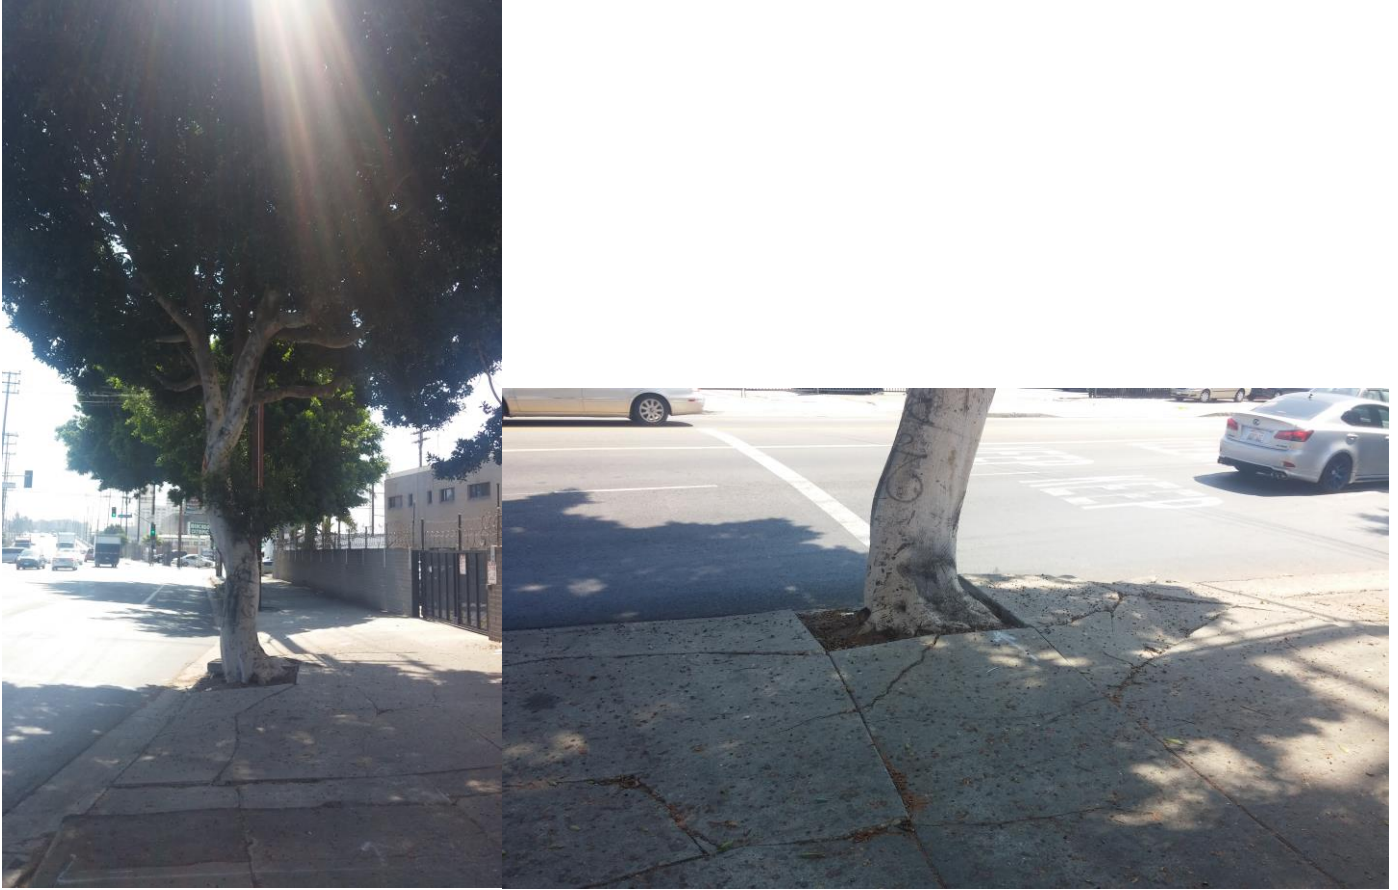
Tree #3 – Ficus (*F. nitida*) 17"x35'. Large roots lifting sidewalk and into driveway. Trunk damage on street side.

16, 17. Ficus with roots lifting sidewalk near driveway.
