City of Los Angeles Sidewalk Repair Program
Consulting Arborist Direction

DATE: July 15, 2015

LOCATION: 1. Fire Station 6, 326 N. Virgil Ave, Los Angeles

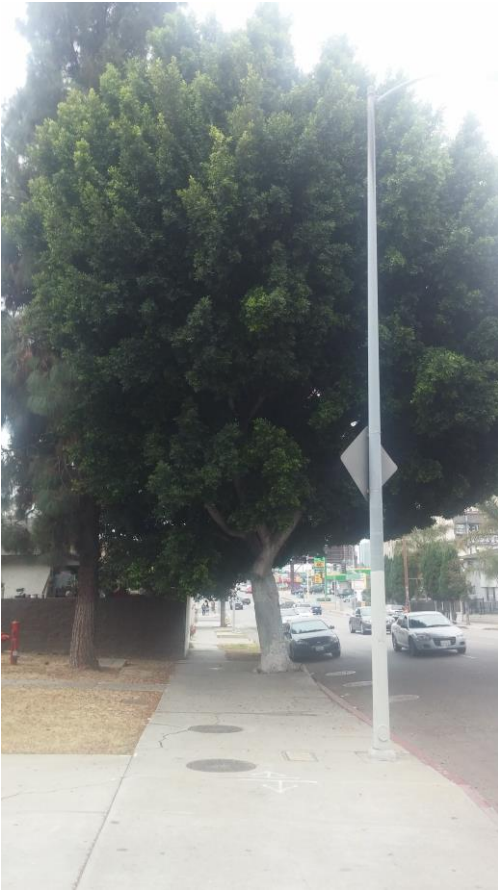
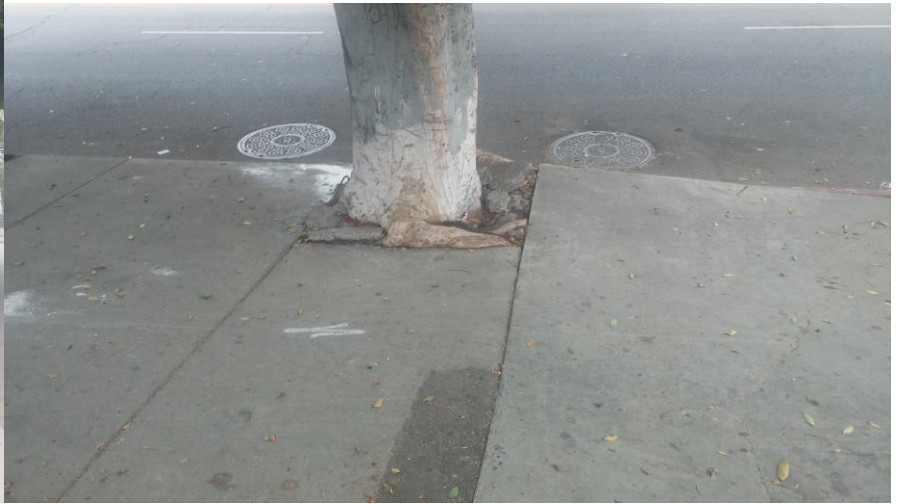
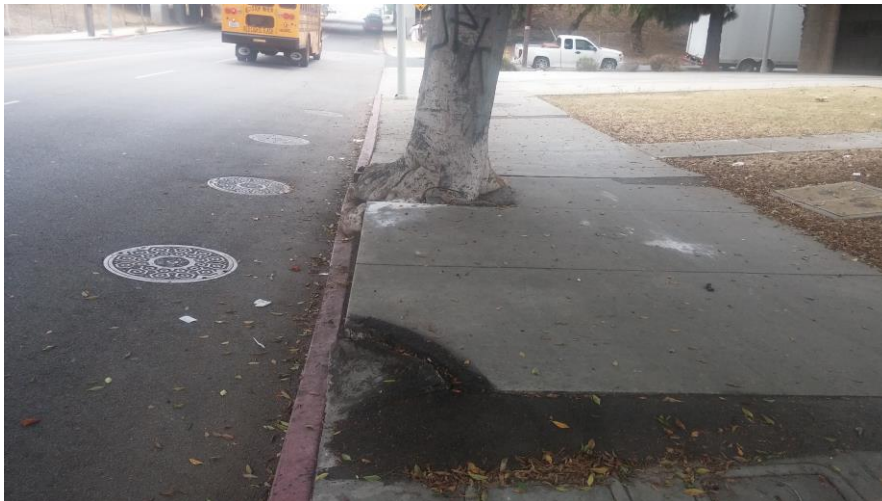
2, 3. Ficus on Virgil.

Tree #1 (on Virgil) – Ficus (*F. nitida*) 20"x45 ft. Potential for expanding tree wells north and south to reduce root damage for sidewalk repair. Evaluate when roots are exposed.

The one Ficus on Virgil should be evaluated when roots are exposed. Possible root shave and tree well expansion. The two Ficus on Oakwood should be removed due to significant structural root damage necessary to facilitate sidewalk repairs.

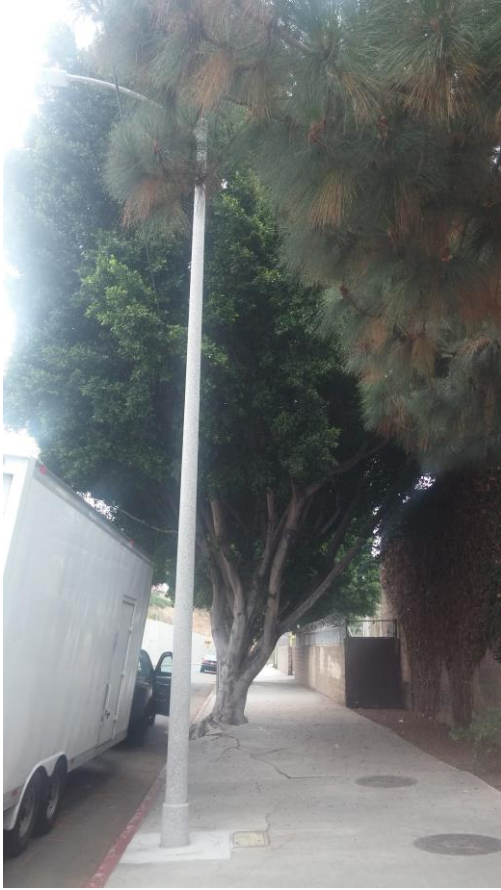
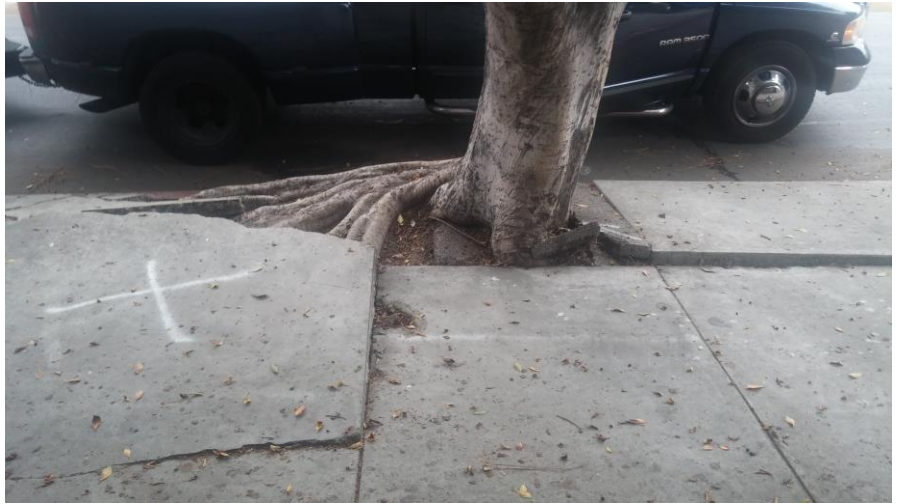
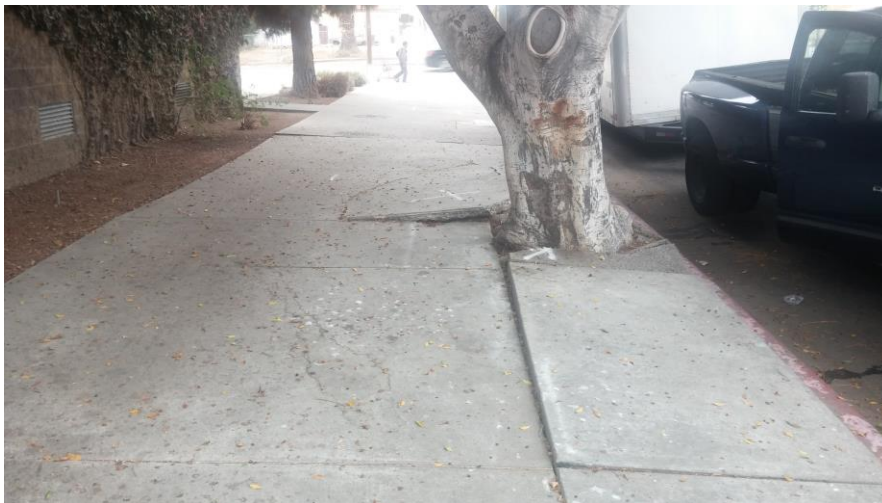
4, 5, 6. Ficus on Oakwood.

Tree #2 (on Oakwood) – Ficus (*F. nitida*) 25"x50 ft. Large roots lifting concrete. Crown lean to south.

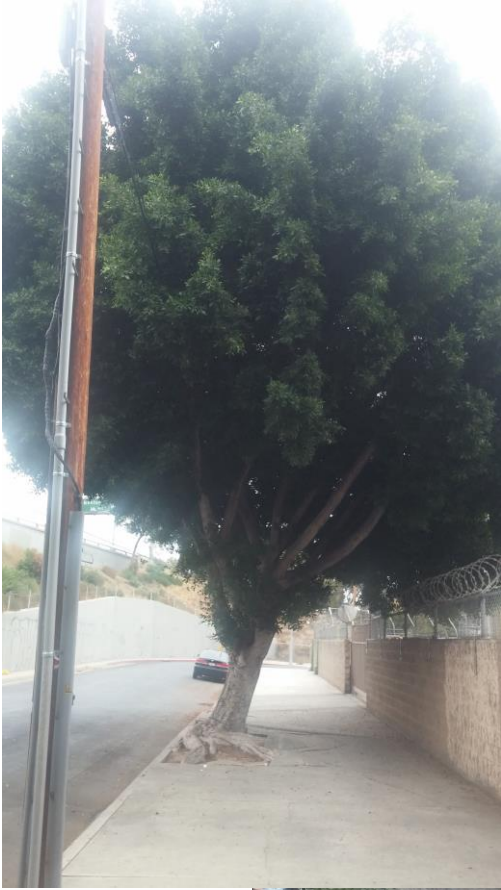
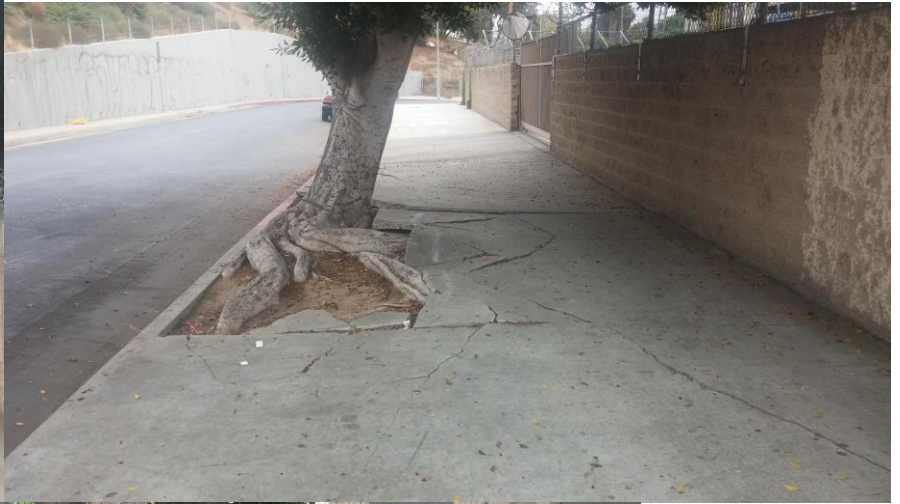
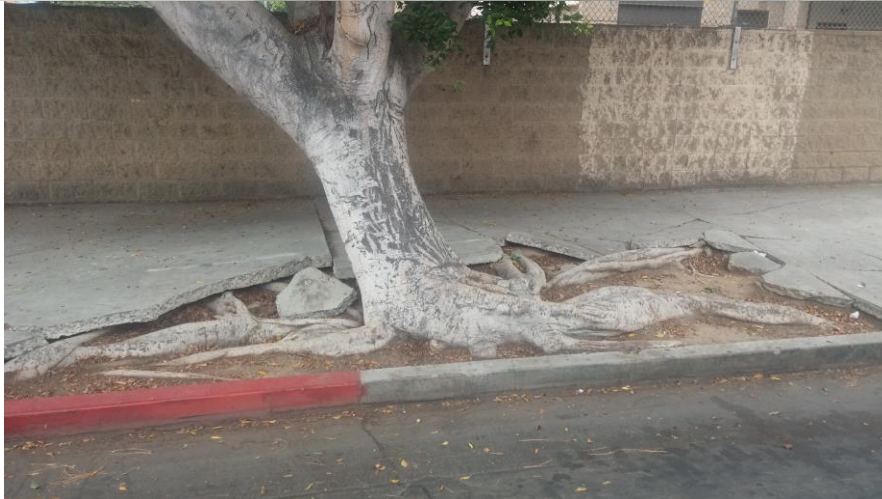
7, 8, 9. Second Ficus on Oakwood.

Tree #3 (on Oakwood) – Ficus (*F. nitida*) 25"x50 ft. Large roots lifting concrete. Crown lean to south.
