## 11. Case Study

### Post–Tropical Cyclone Gita Mission in Tonga

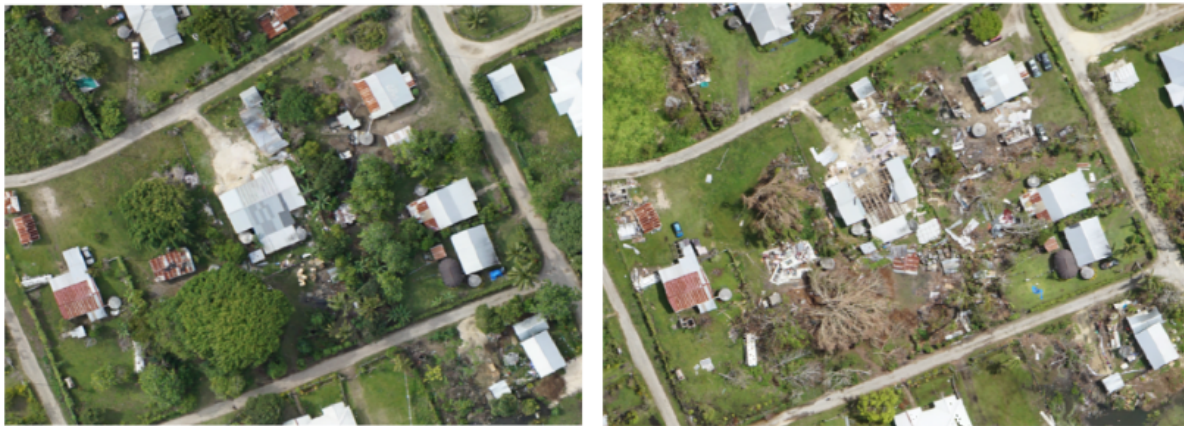
Figure 1: alt\_text

*Figure 15 Images showing pre- and post-event status of the same structures.*

Moreover, the collection of baseline data only a few months before Tropical Cyclone Gita hit Tonga proved to be invaluable. It not only provided usable data for post-disaster comparison, thus facilitating accurate damage assessments; it also acted as a trial run for the actual disaster, thus enabling the development of procedures, location of suitable flight areas, and rectification of problems. Figure 15\_ shows an example of the same structure before and after the Cyclone.

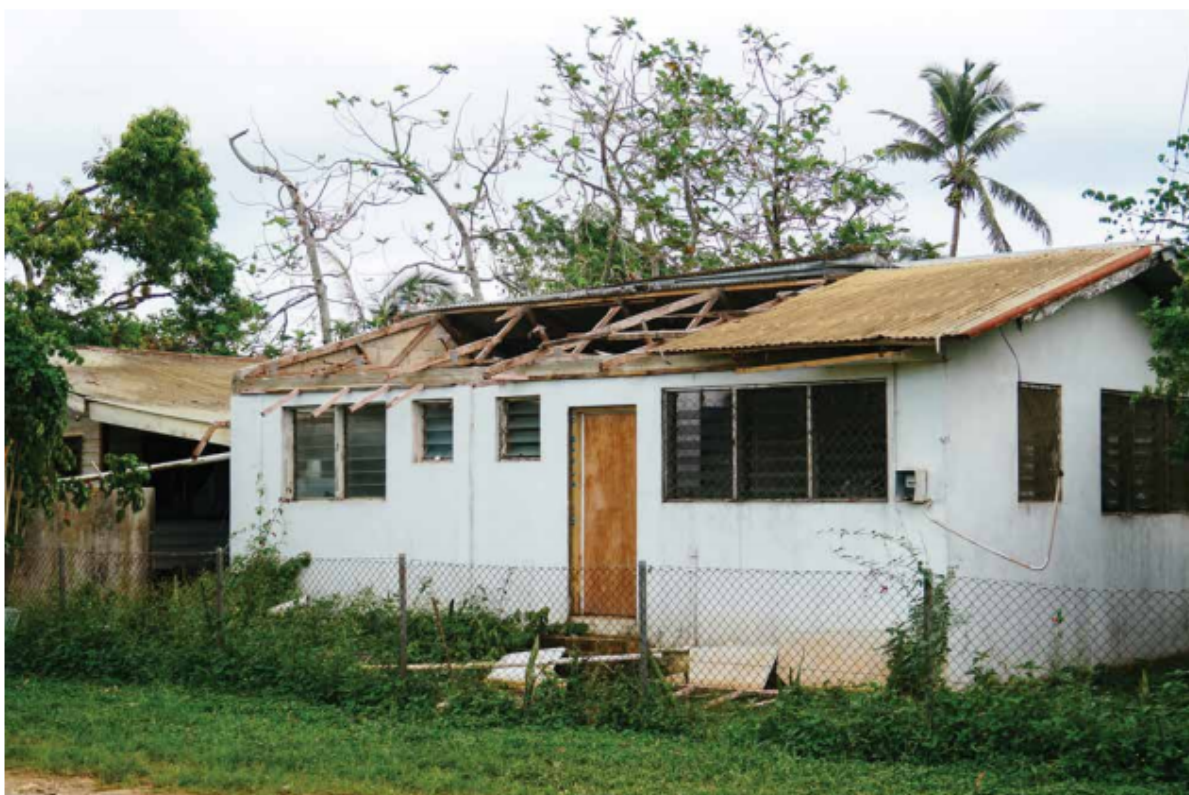
Figure 2: alt\_text

- *Crowdsourced building damage assessment by the Humanitarian OpenStreetMap Team (HOT).* The pre- and post-event UAV images were used to carry out a crowdsourced damage assessment. A small subset of volunteers from HOT were tasked with doing the visual interpretation of the damage to housing. A simple classification scheme was used: houses that appeared to be more than 50 percent damaged were labeled “destroyed,” and those that appeared to be less than 50 percent damaged were labeled “damaged” (Figure 16 ).

*Figure 16 A house destroyed by Tropical Cyclone Gita in Longolongo village, Tongatapu, Tonga.*

Photo: Malani Wolfgramm/World Bank. Damaged home in Longolongo, Tongatapu.
