11. Case Study: Post–Tropical Cyclone Gita Mission in Tonga

Collection of post-cyclone UAV data

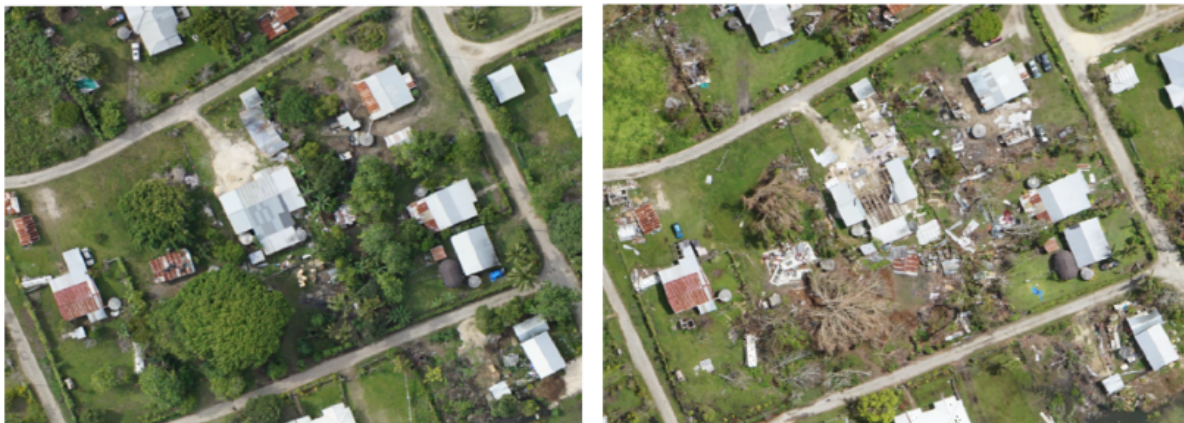
Figure 1: alt_text

Figure 15 Images showing pre- and post-event status of the same structures.

Moreover, the collection of baseline data only a few months before Tropical Cyclone Gita hit Tonga proved to be invaluable. It not only provided usable data for post-disaster comparison, thus facilitating accurate damage assessments; it also acted as a trial run for the actual disaster, thus enabling the development of procedures, location of suitable flight areas, and rectification of problems. Figure 15_ shows an example of the same structure before and after the Cyclone.

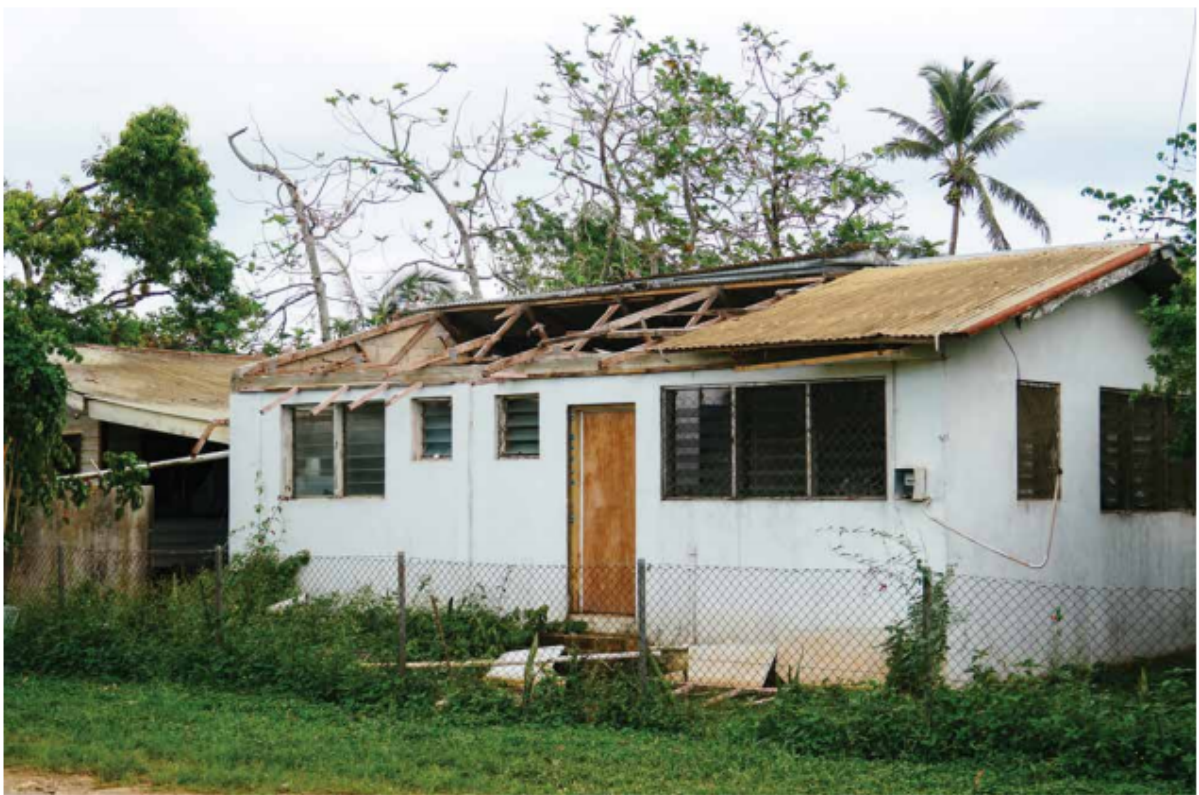
Figure 2: alt_text

- **_Crowdsourced building damage assessment by the Humanitarian OpenStreetMap Team (HOT).**^{**}
^{**} **_The pre- and post-event UAV images were used to carry out a crowdsourced damage assessment.** A small subset of volunteers from HOT were tasked with doing the visual interpretation of the damage to housing. A simple classification scheme was used: houses that appeared to be more than 50 percent damaged were labeled “destroyed,” and those that appeared to be less than 50 percent damaged were labeled “damaged” (Figure 16).

Figure 16 A house destroyed by Tropical Cyclone Gita in Longolongo village, Tongatapu, Tonga.

Photo: Malani Wolfgramm/World Bank. Damaged home in Longolongo, Tongatapu.
