FIGURE 3-1a
Bathymetric Map of Gowanus Canal
Upper Canal
Gowanus Canal Remedial Investigation
Brooklyn, New York

FIGURE 3-3
 Cross Section of Bathymetric Differences 2003-2010
 Gowanus Canal Remedial Investigation
 Brooklyn, New York

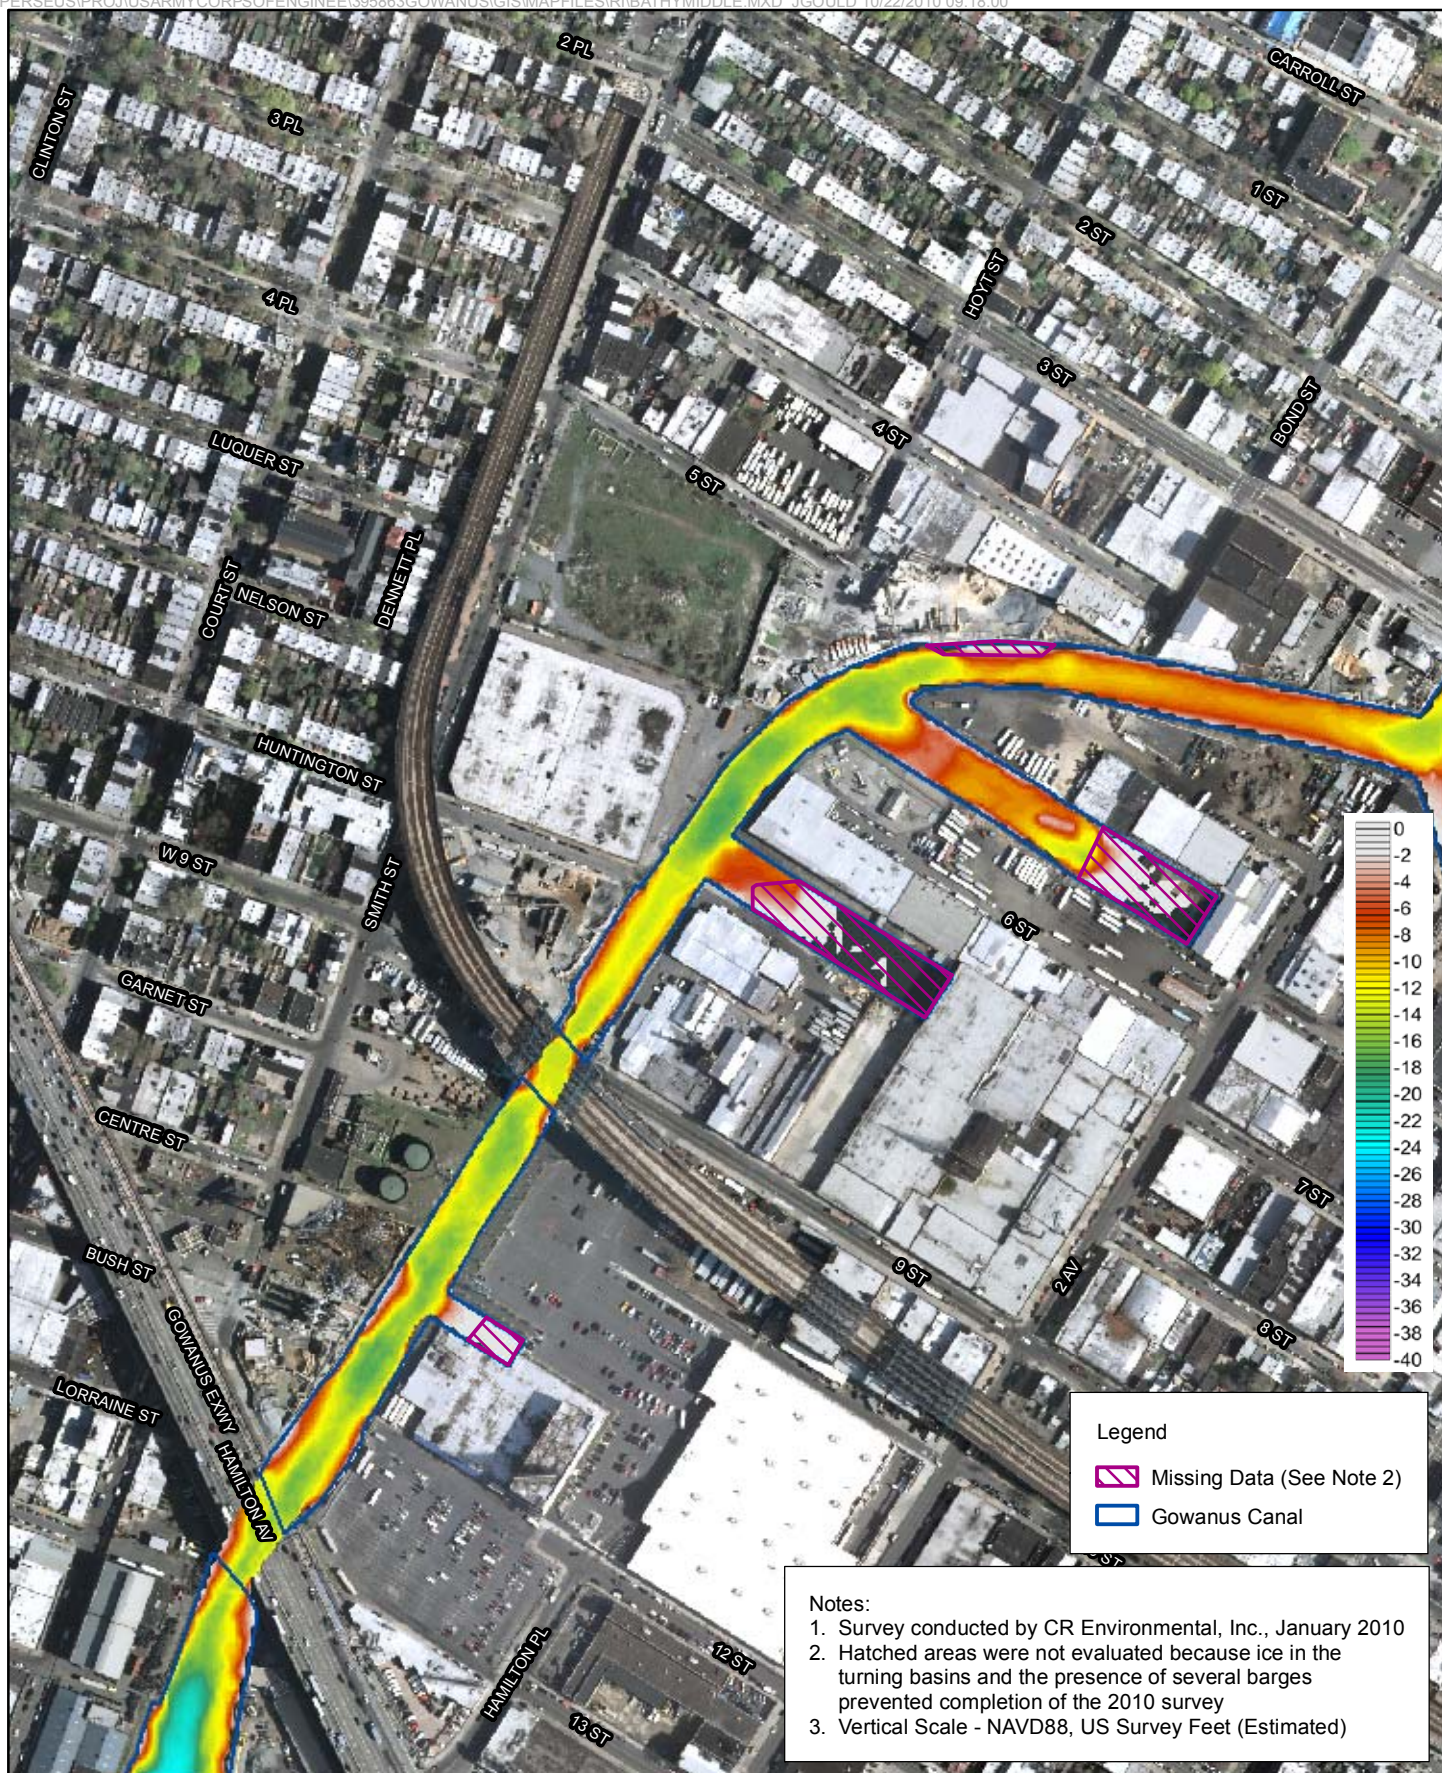
FIGURE 3-1b
Bathymetric Map of Gowanus Canal
Middle Canal
Gowanus Canal Remedial Investigation
Brooklyn, New York

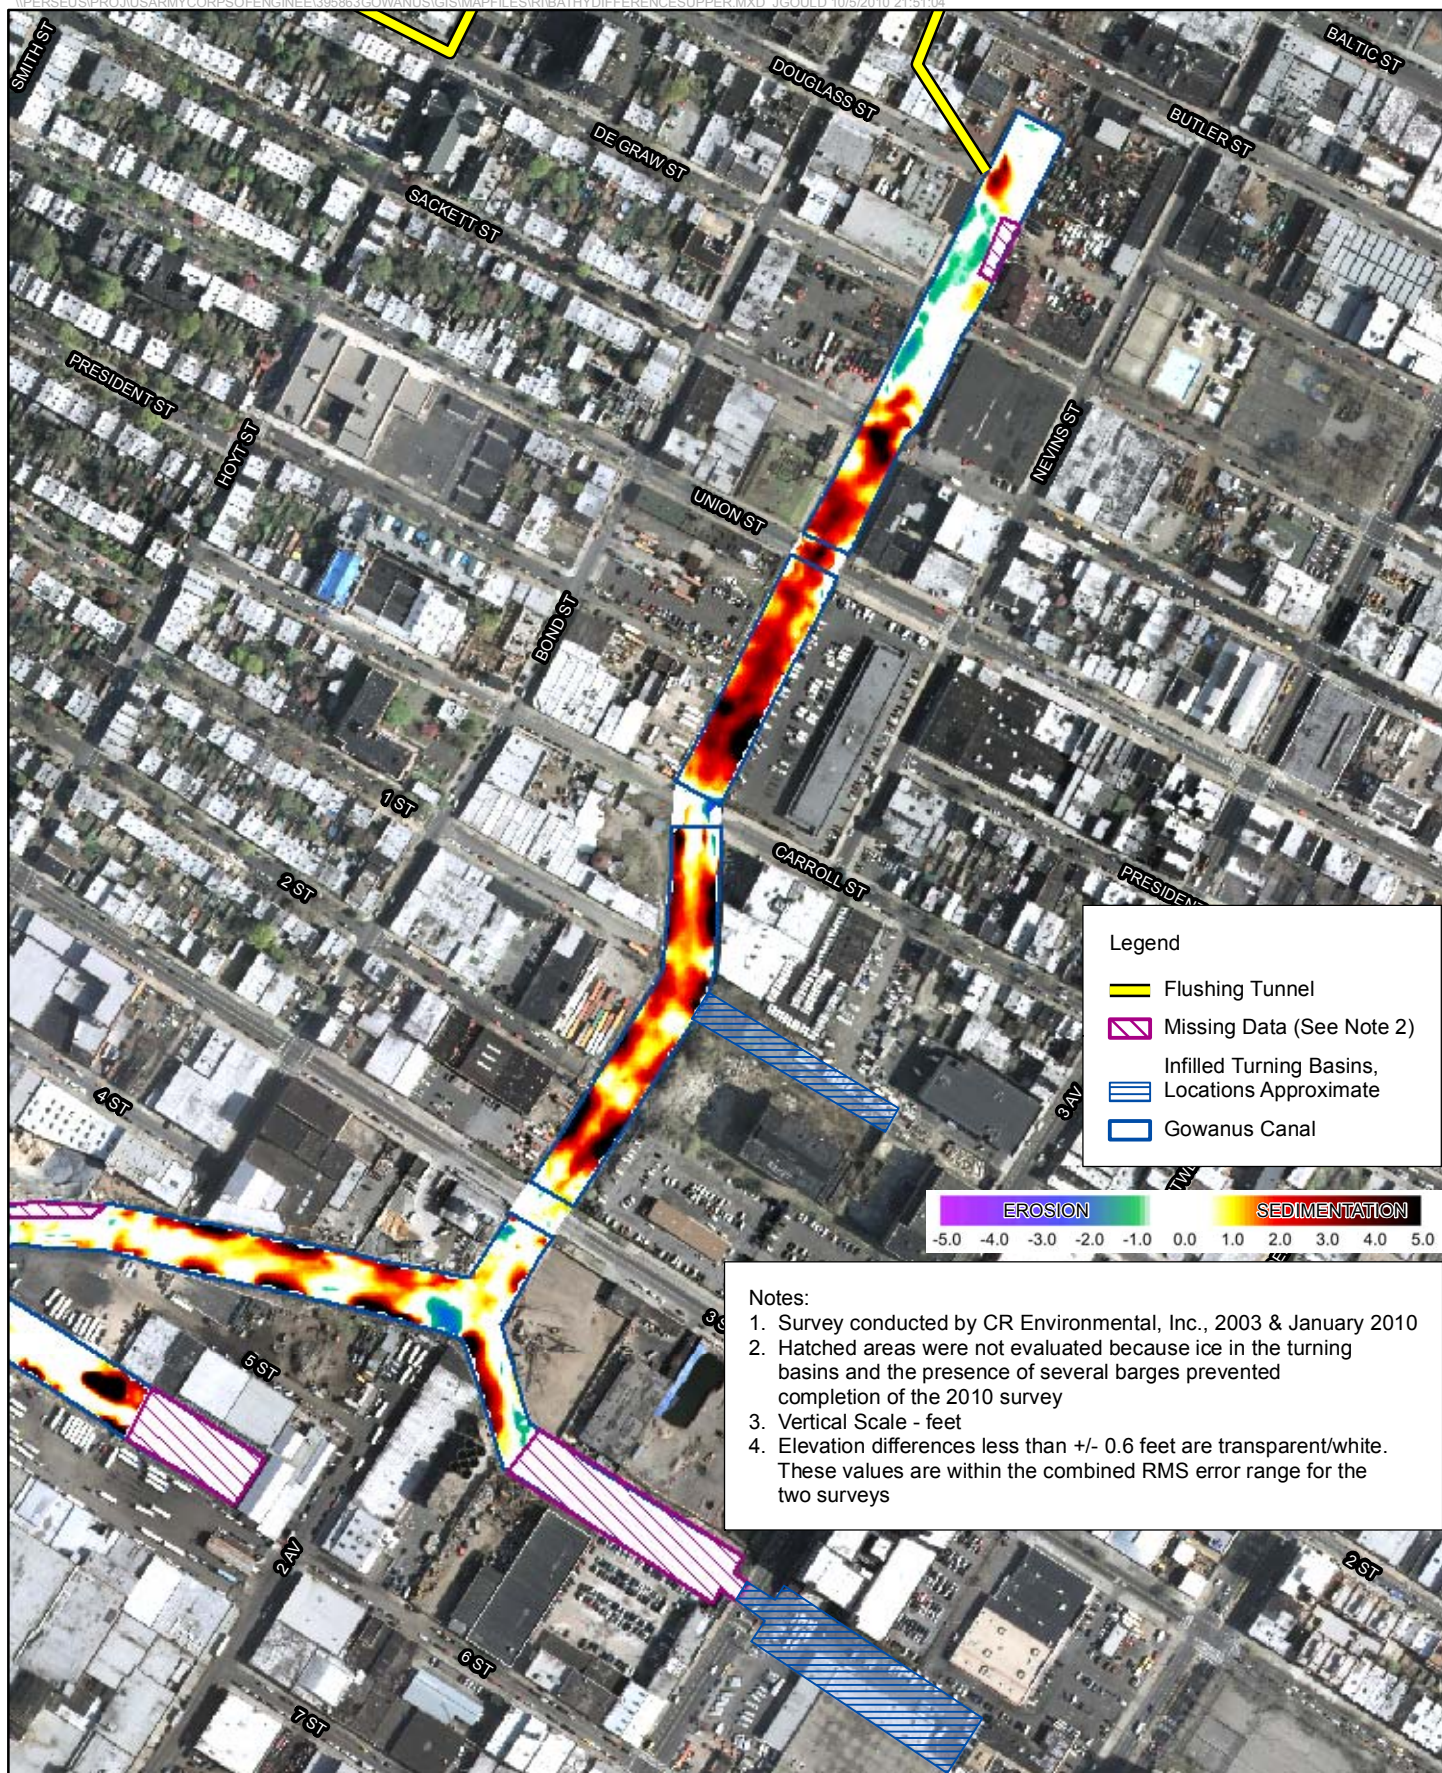
FIGURE 3-2a
Plan View of Bathymetric Differences 2003 - 2010
Upper Canal
Gowanus Canal Remedial Investigation
Brooklyn, New York

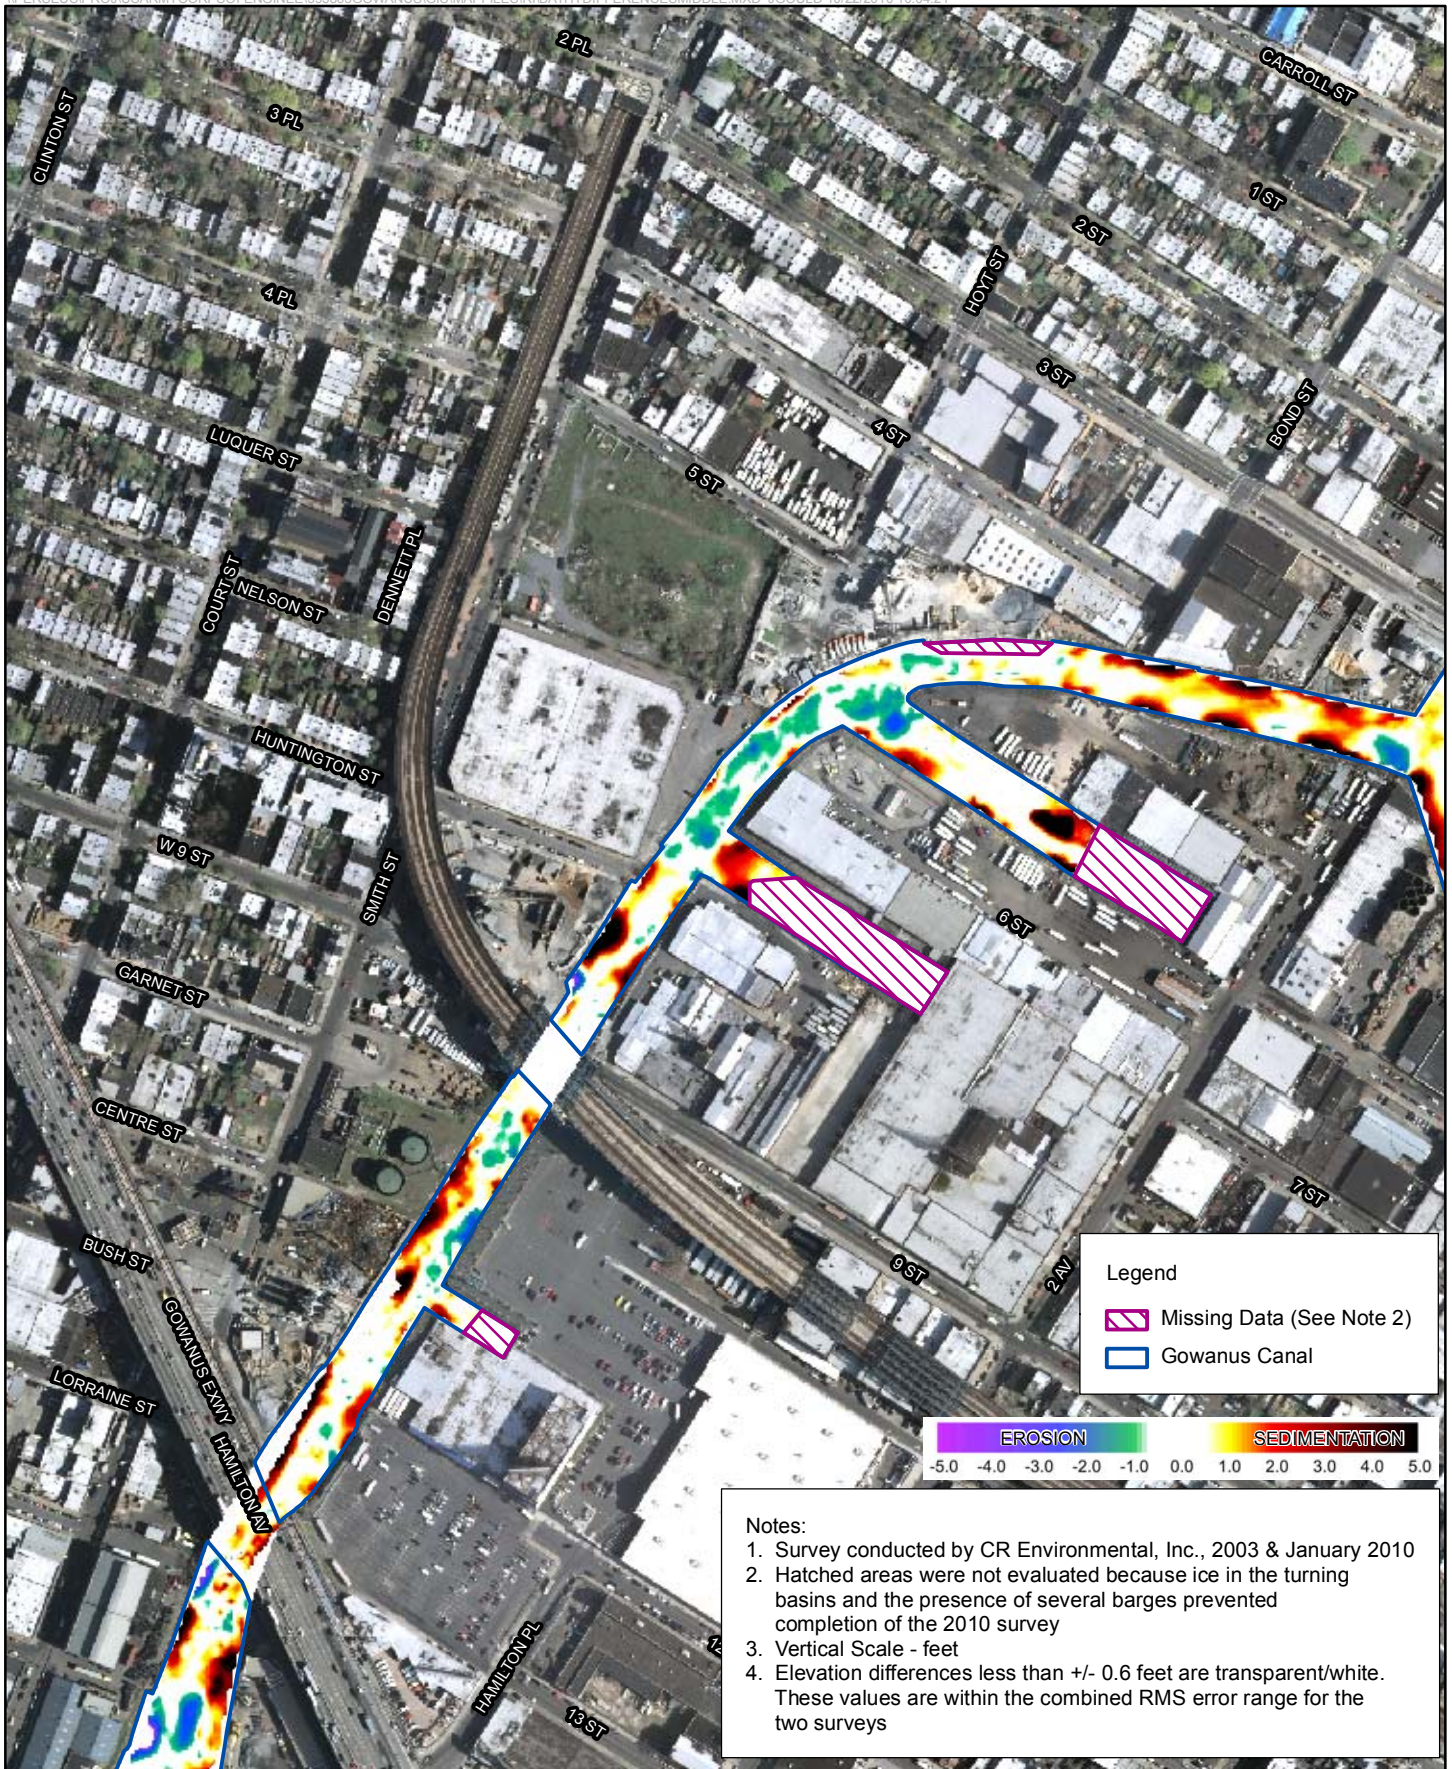
FIGURE 3-2b
Plan View of Bathymetric Differences 2003 - 2010
Middle Canal
Gowanus Canal Remedial Investigation
Brooklyn, New York

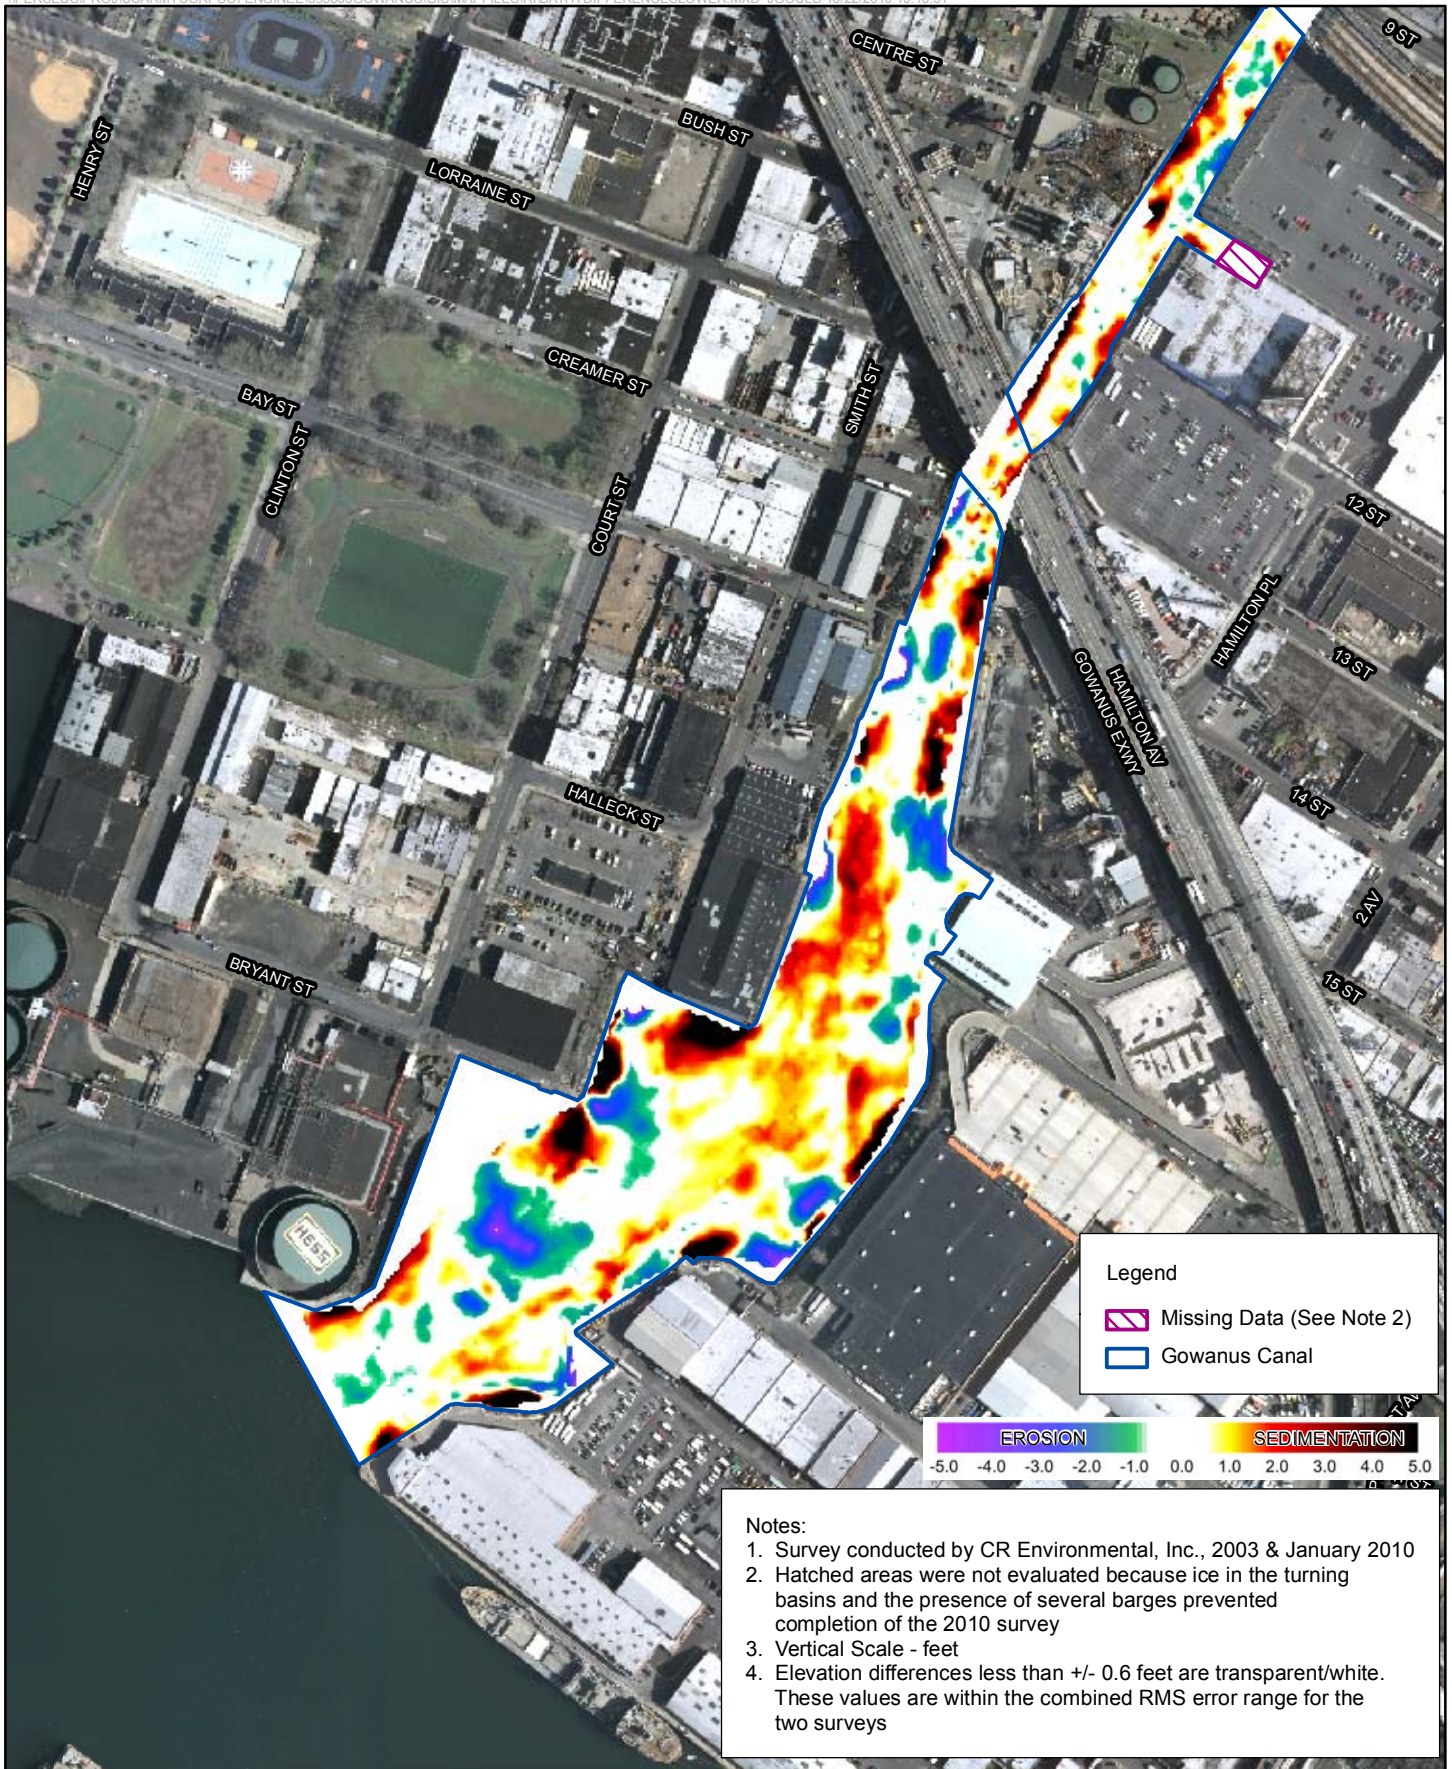
FIGURE 3-2c
Plan View of Bathymetric Differences 2003 - 2010
Lower Canal
Gowanus Canal Remedial Investigation
Brooklyn, New York

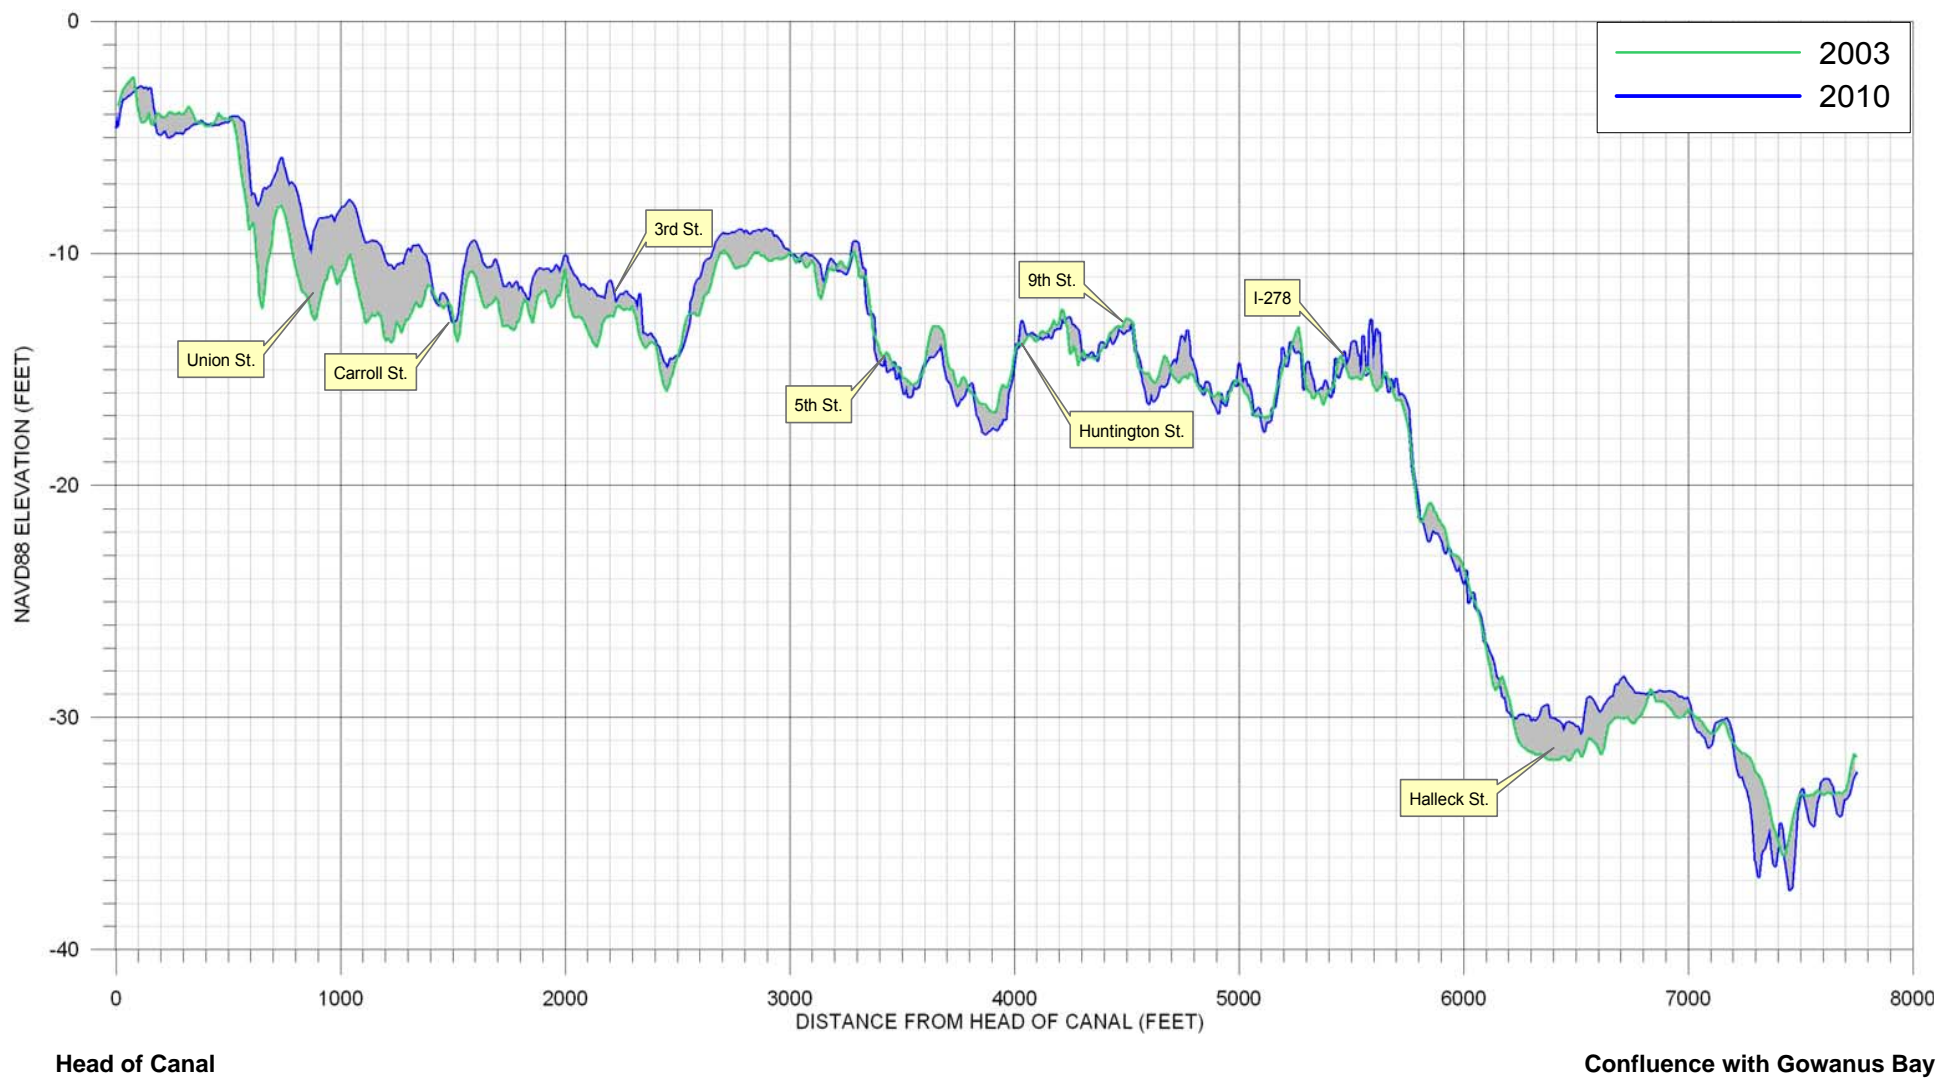
Notes:
 Approximately 100x vertical exaggeration used to illustrate small differences in elevation.
 Survey data collected by CR Environmental, Inc (East Falmouth, Massachusetts) on June 25, 2003 and January 5, 2010
