**Errata**  
**October 30, 2006**

The CTI-RX5D100v2 (version 2) datasheet is a correct working datasheet (Please check the version number, top right hand corner of the datasheet).

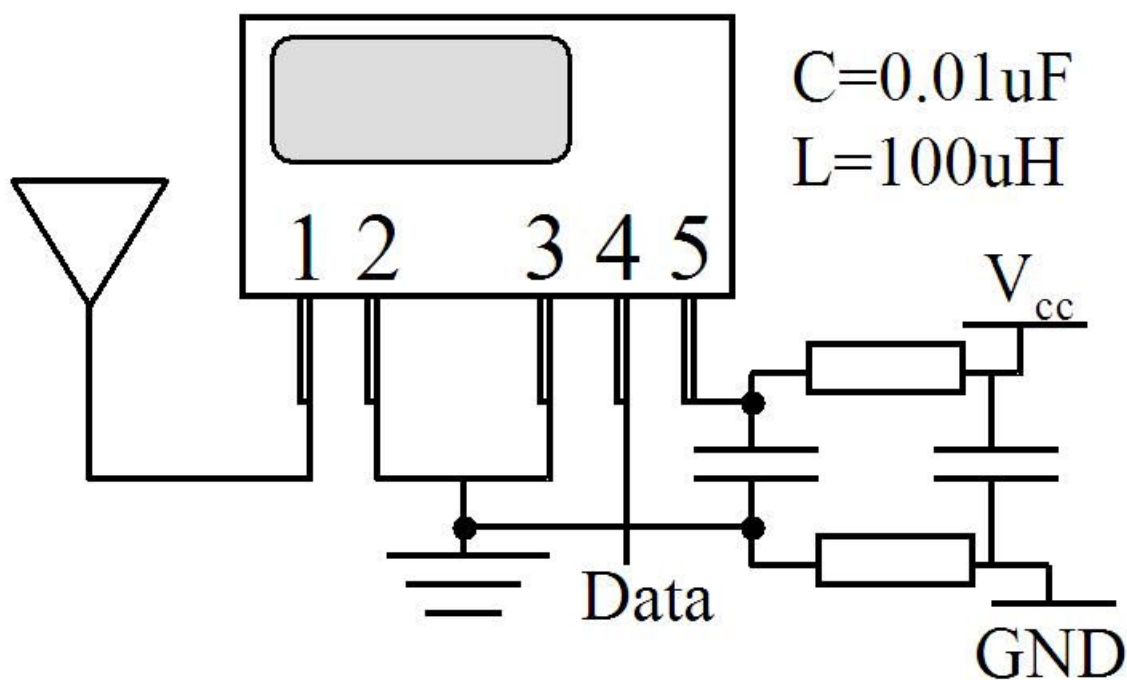
However, the previous version of the datasheet, (which was posted on the Yahoo group), e.g., CTI-RX5D100 datasheet was wrong. It provided schematic for the external capacitors and inductor connection. Apparently, there was a mismatch of the pins, which in fact can cause problem to potentially damage the external inductor.

Note the pin assignment from the datasheet: Pin 2 and P3 both are connected to the GND, while Pin 5 is connected to Vcc, hence the corrected schematics should follow, as shown in the figure below.
