失效案例库需提供的信息（表格形式）

信息	损坏软管不可逆变化失效分析
事故名称	软管结构的失效
事故时间	2015 年
事故地点	斯洛伐克共和国
产 品 制 造 商信息（包 括名称、地 址等）	本研究中的耐压软管用于传输液压流体，流体为液压用油或含酒精液体。
失效设备	液压软管
失效部件	软管 EN 857 2SC
应用环境	低/中压液压系统，内部介质为矿物油和植物油，水，空气，惰性气体； -40℃到+100℃（最大+125℃，间断）
失效形式	开裂
失效机理	疲劳
失 效 材 料 类型	合成橡胶；高耐磨钢
失 效 材 料 信息（包括 成分、力学 性能等）	底层为合成橡胶； 加强层为高耐磨钢； 外层为黑色合成橡胶
事故概览	某样品软管发现内加强层的退化，容易引起软管的破裂从而引起重大操作事故，不仅威胁机器运行，同时会对操作人员和环境造成损害。此类软管在危险条件下工作，失效的可能性越来越大。
失 效 分 析 目的	研究者们对于软管失效分析的实验研究做了大量工作，本文通过计算机模拟的方式进一步分析软管工作中的受力状态，明确失效原因。
分析方法/ 测试项目	肉眼观察；计算机断层扫描（Metrotom1500）
分析结果	<u>失效软管的外观观察</u>  图 1 所示样品液压软管，移除表面的橡胶层，同时加强层出现

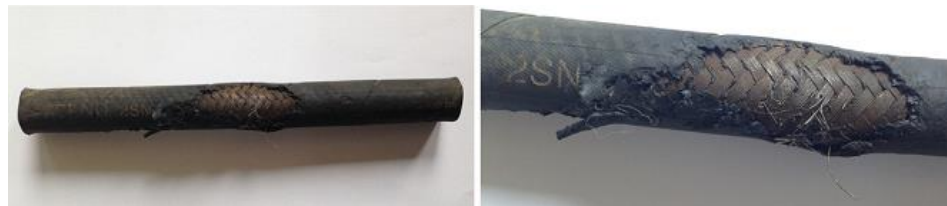
损坏。这种损伤是液压机构在操作期间，由于液压软管的循环弯曲所致。损伤在局部区域存在，不发生延伸。

由于表面的橡胶材料逐步分离，造成不规则的边缘。整个破坏过程是由于一个初始裂纹的诱导，这个裂纹在弯曲区域中逐渐扩大。

橡胶外胶层断开后弯曲区域逐渐扩大。通过肉眼检查，可以看出这些损害不是由于较高的操作温度，因为位于软管表面上各个点并没有检测到表面裂纹和微裂纹。卷绕金属加强结构的破坏较微小，它也是循环弯曲的结果。

图 1 液压软管外胶层的损坏

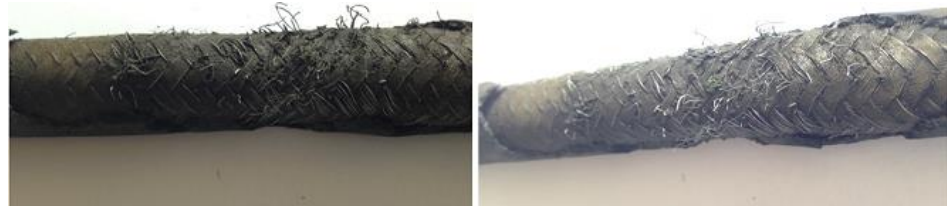
图 2 液压软管外胶层并伴有内部增强层的损坏

另一个样品软管（图 2），破坏较样品 1 更为严重，缺陷区域更大，几乎分布于整个圆周上，外层覆盖橡胶几乎全部被分离，内部加强金属结构很明显暴露出来，在弯曲、磨损等多种因素作用下，破坏区域的边缘是不规则的，该区域的扩展表明是在一个强烈和长期的破坏过程下的结果。失效过程是从软管表面传递到内部金属加强结构，该加强结构是为了保证必要的强度，弹性和耐久性。

图 2 显示了加强结构的大范围破坏，有磨损的金属线，在某些点，破坏过程通过加强层传递到内部软管结构。

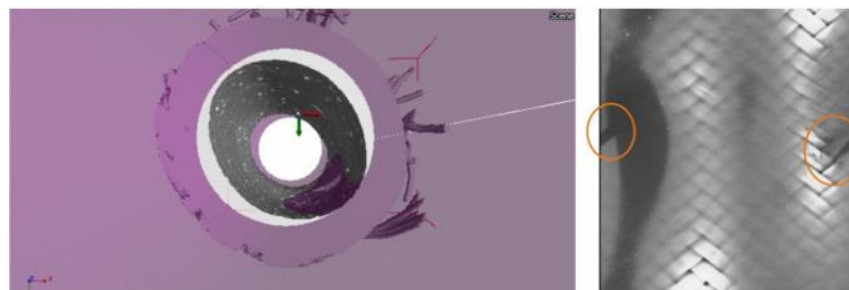
由于软管是椭圆形，要确定缺陷长度比较困难。用插入的圆柱体部分穿过缺陷处，被用来描绘出展开图。图 11 中，橙色代表缺陷（右），紫色代表圆柱体。

图 5 用来展开软管的圆柱体（左）和已展开的形状（右）
