TECHNICAL MEMORANDUM

Date: 1/23/2023	Study No: 0000029807
To: Larry Blackburn, P.E.	Tech Memo No: Techmemo 0000029807-1
From: Research Team	Revision No:
Subject: Evaluation of the Pavement Condition in FM 2094 in Houston

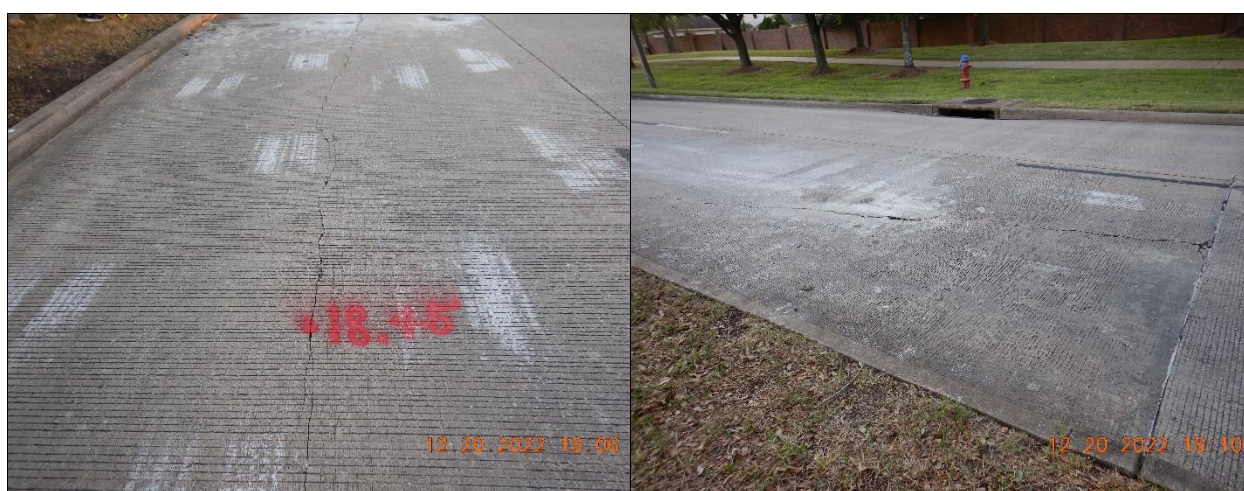
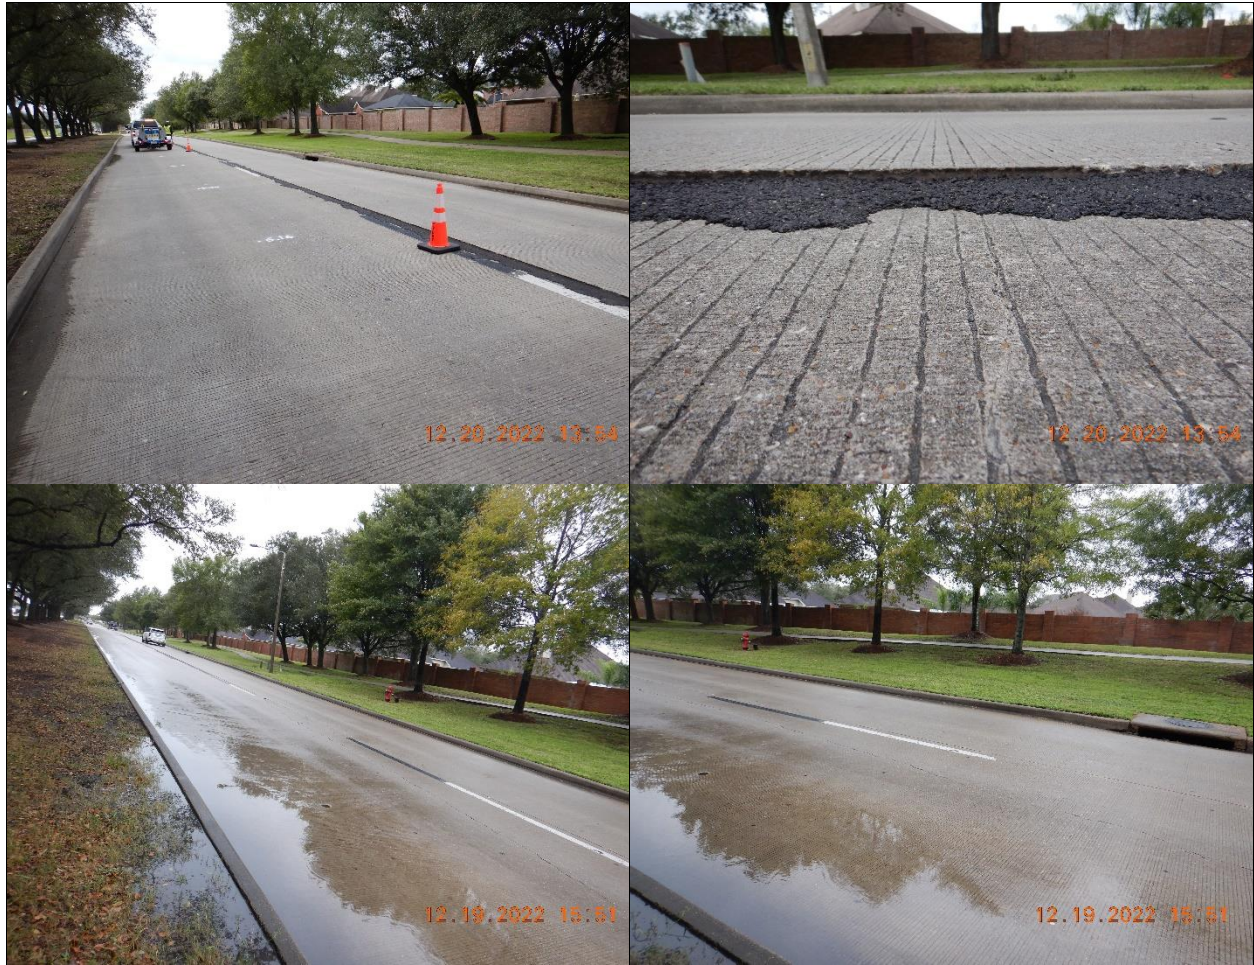
Figure 2 Distresses observed at the test section (Longitudinal cracking, faulting, and water ponding)

The condition of the subject section was evaluated at the project site, and undulations on the pavement surface, longitudinal cracking and faulting were the major distresses observed. Those distress types are not typical observed in CRCP in Texas. Undulations on concrete slab surface occur only when there are volume changes taking place in primarily subgrade soil. Volume changes in subgrade soil also cause longitudinal cracking in CRCP.

Figure 2 shows some of the sections with longitudinal cracking, faulting, undulations and resulting ponding of water. This has led to further deterioration of ride quality and pavement condition. **Figures 3 to 8** show the coring, DCP and soil extraction activities conducted in the field. Based on all the information gathered, a recommended optimum rehabilitation strategy was developed.

Considering the nature of the distresses and traffic characteristics in the subject project, it is recommended that the undulations or faulting are repaired by expandable polyurethane resin. How long this repair will stay effective will depend on the continued soil volume changes in the project site. However, it is considered that the performance of this repair might be comparable to full-depth repairs with Item 361, with a lower cost, since this material costs about \$5 per pound.

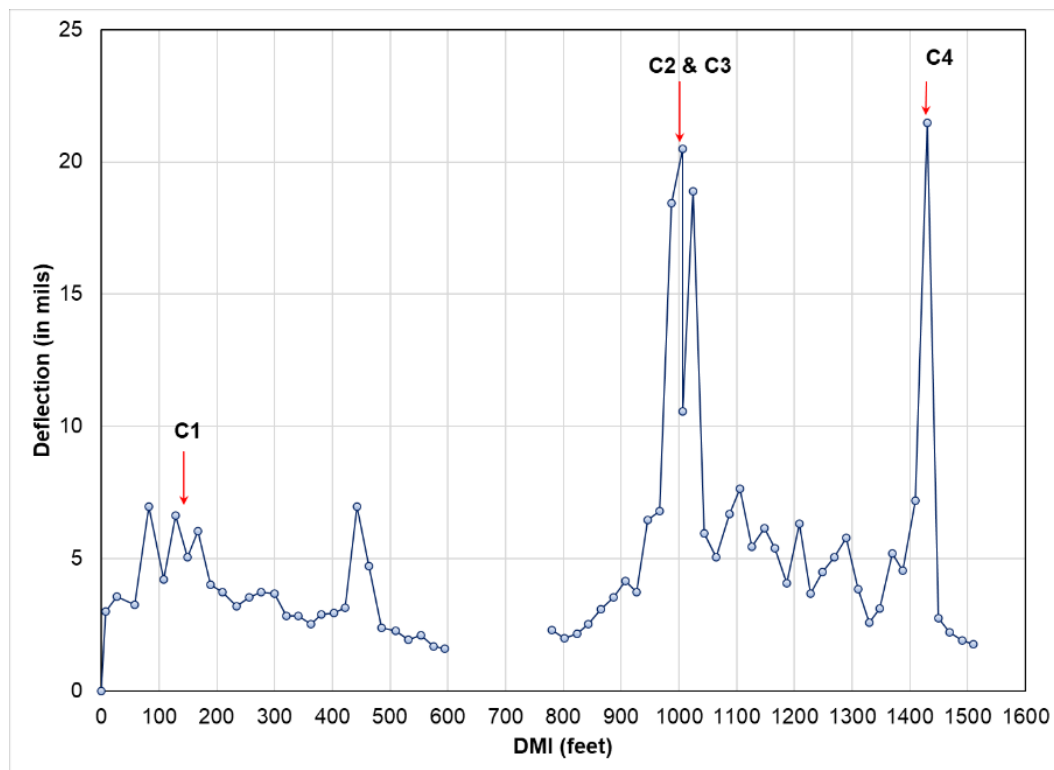
Deflections on the CRCP slab were evaluated at the inside lane at every 20-ft. **Figure 9** presents the deflections at 9,000-lb loading evaluated along the inside lane covering a total length of 1520-ft. It can be observed that the deflections were generally lower than 5 mils except for the specific DMI between 80–170 and 940–1460. The state-wide average of 10-in CRCP is about 2.5 mils, and it is observed that, even though the deflections obtained are comparable to the state-wide average value in some areas, in other areas, deflections are much larger, implying that voids exist in those areas, where longitudinal cracks were observed. Based on this deflection data, 4 locations were selected for further investigation with coring/DCP/soil extraction. The deflection in Core #1 was 6.04 mils whereas in Cores 2 and 3, at the same DMI, was 20.49 mils. Lastly, in Core 4, the deflection was 21.49 mils.

Figure 9 FWD deflections at the inside lane of the test section

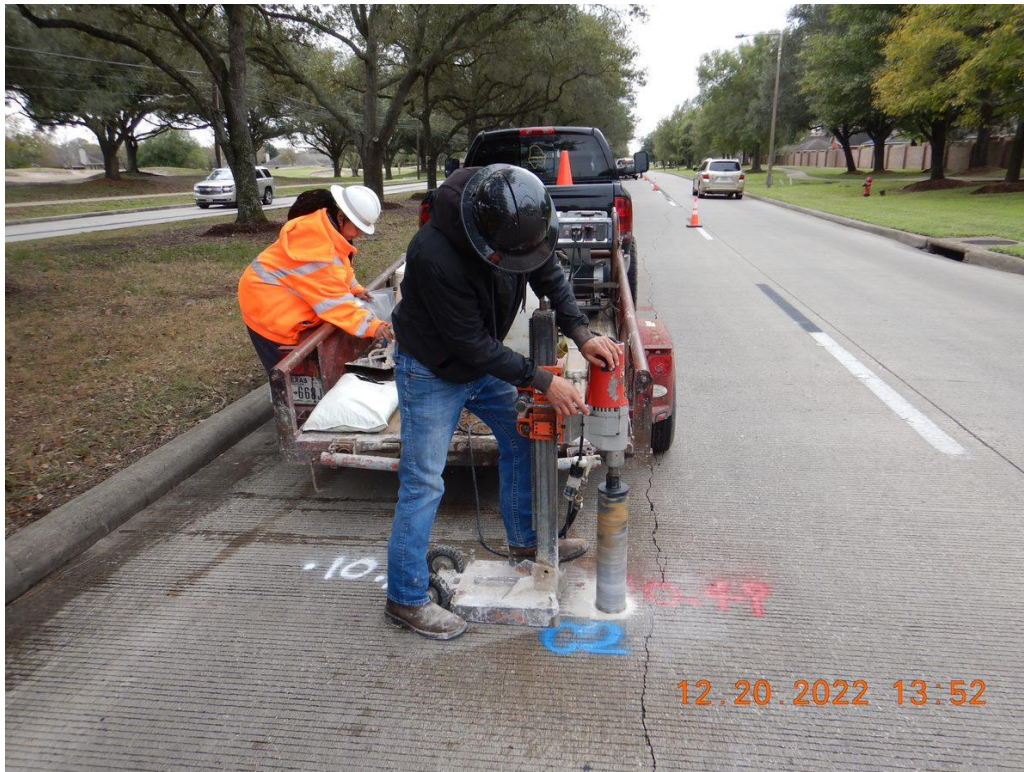
The visual distress survey has identified a longitudinal crack within the investigated section at the inside lane, as shown in **Figure 10**. **Figure 11** shows the distress map of the investigated section. The DMI of longest longitudinal crack was observed between 860 and 1090.

Figure 10 Longitudinal crack observed between 940 and 1460 feet (DMI) in the inside lane

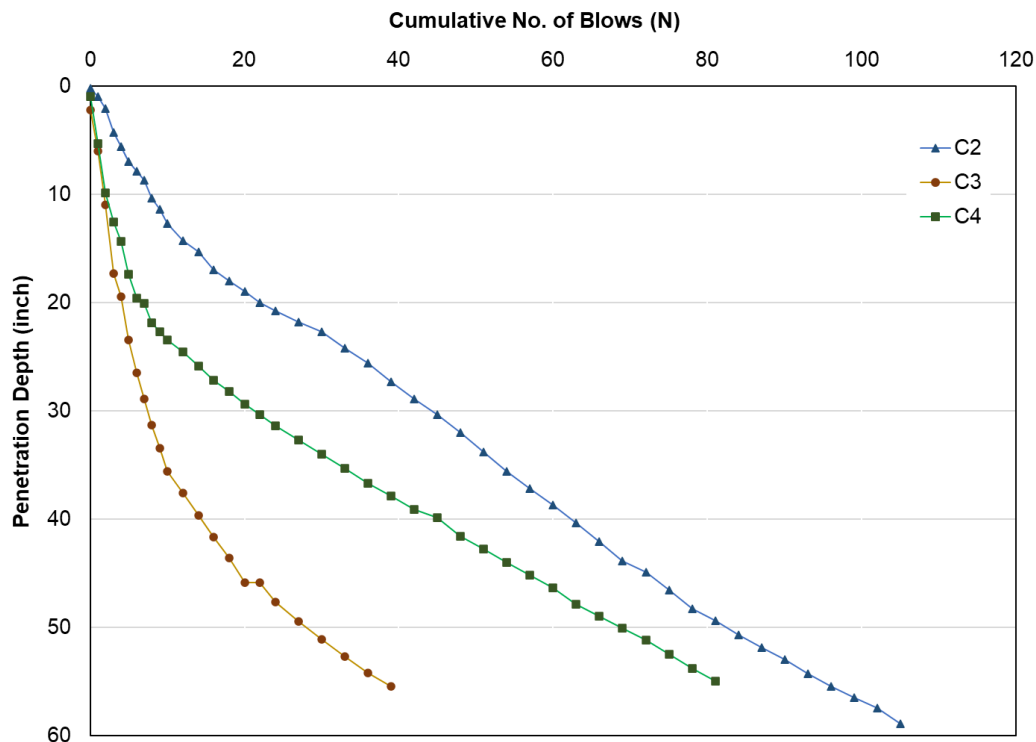
Figure 12 shows the DCP data on the other 3 locations. The slope of the DCP curves indicates the penetration rate per one blow, and the steeper slope indicates a larger penetration rate or lower modulus of soil. It can be observed that, at C3 and C4, the upper layer (up to 20-inches from the top of the subgrade layer) is less stiff compared to C2. In fact, the softer layer at C3 has continued until 35-inch depth. Figure 13 shows the modulus profile with respect to the depth at the three (3) locations. While C3 is at the same DMI as C2, C3 is located closer to the longitudinal joint as shown in Figure 14. Despite its proximity, the modulus profile is not similar and C2 is relatively stiffer. In addition, it was also observed that a large void (about 1.5-in) existed at C2 between the bottom of the concrete slab and asphalt bond breaker, as shown in Figure 15. This large void must have been developed due to differential volume changes. It is to be noted that uniform volume changes in the subgrade usually result in settlement of the slabs without large voids as observed here. Also, the large deflection at C2 (20.5 mils) must be due to this large void.

Figure 12 DCP data in the coring locations of the test section

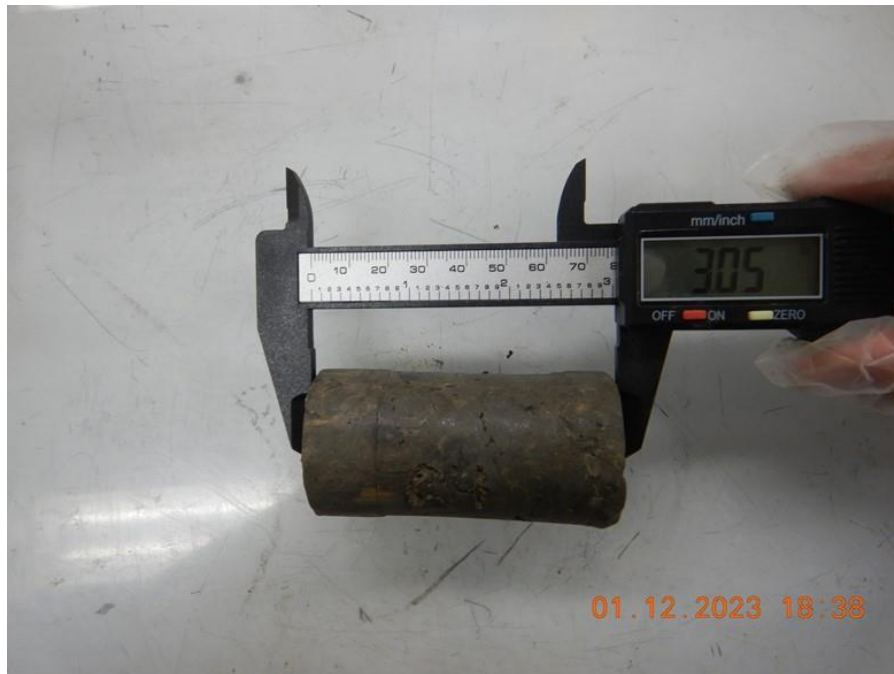
Shrinkage Test: A shrinkage core of up to 2 inches in diameter and a length of 1.5-2 times the diameter as prepared from the collected soil sample. **Figure 17** shows a shrinkage core specimen. The core specimen is prepared such that it is free of any defects or loose material. Initial dimensions and mass are recorded. Small pins are added to each end as reference points to facilitate consistent measurements of sample length as drying proceeds. The shrinkage core is first air-dried. Measurements of length and mass are recorded until shrinkage ceases. The core is then oven-dried to a constant mass of 221-230 °F and final length and mass are recorded. The data recorded facilitates the calculation of the initial and final water contents and the axial strain.

Figure 17 Shrinkage core specimen

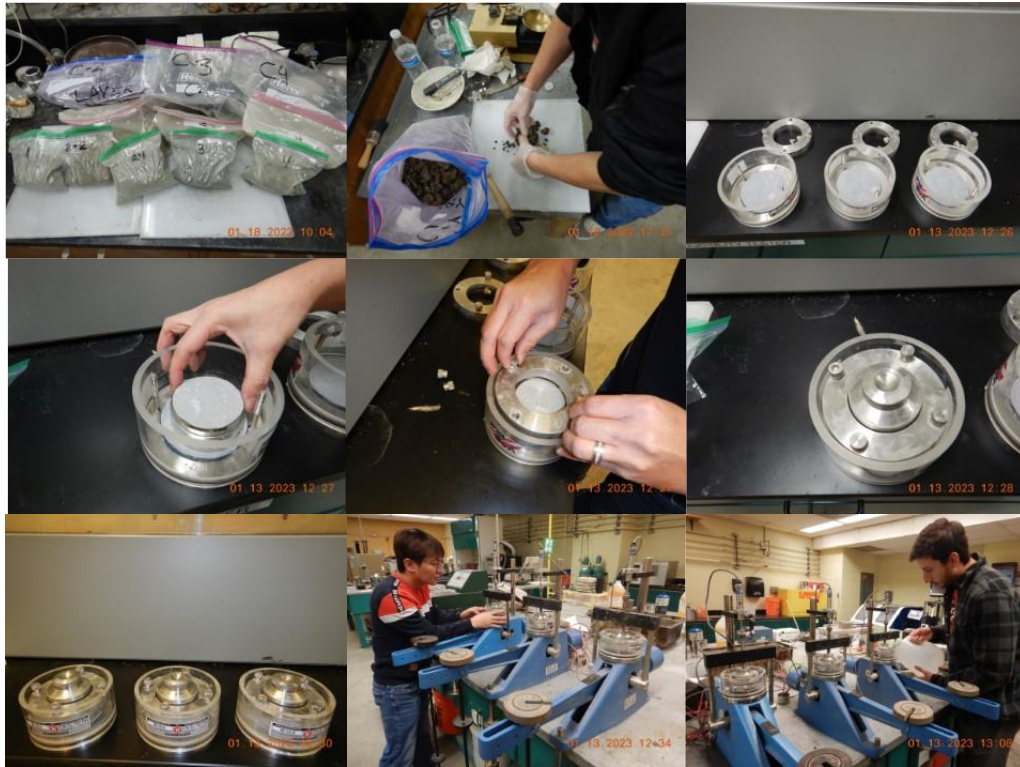
Swelling Test: This involves a simplified oedometer test in which the sample is installed in a steel ring (usually around 2.5 inches in diameter and 1 inch high) and placed in a consolidation apparatus. An LVDT sensor is installed to monitor the sample height. A load of 3.6 psi (25 KPa) is then applied for 30 minutes to record any initial settlement or seating adjustment. This displacement is used to correct the initial sample height for the determination of the swelling strain. After re-zeroing the displacement gage, the sample is then inundated with distilled water and allowed to swell until the swelling increment is not more than 5% of the total recorded swell. The initial water content is determined from the sample trimmings and final water content is measured from the extracted soil sample at the end of the test. **Figure**

18 illustrates the sequence of the swell testing and Figure 19 shows the close-up view of the last phase of the swell testing.

Figure 18 Swell testing procedure

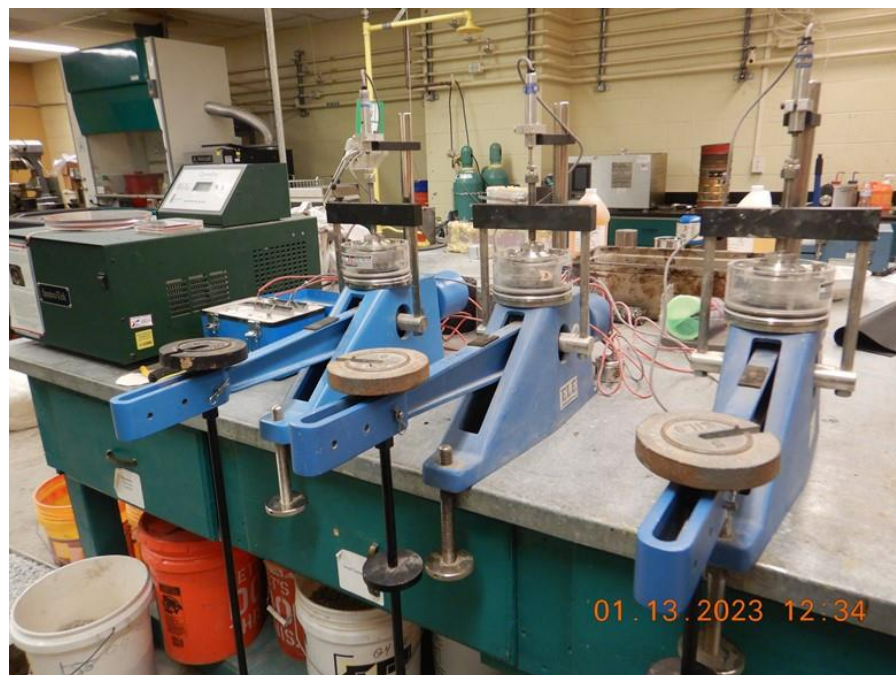
Figure 19 Last phase of swell testing

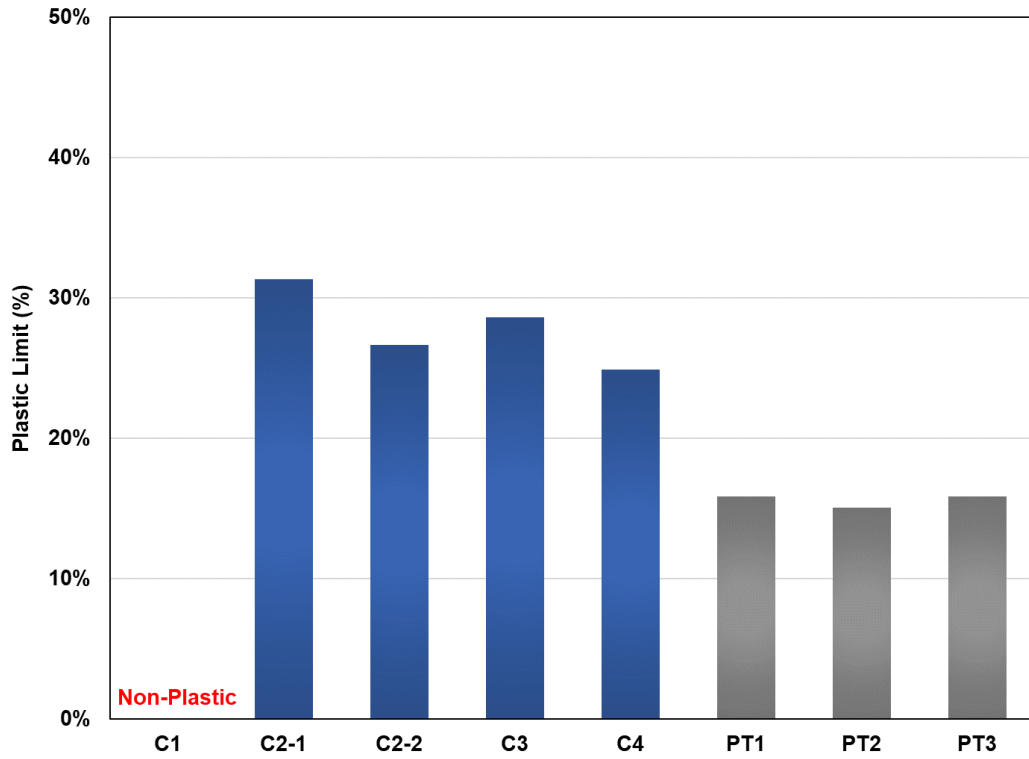
Figures 23 to 25 show the testing results of the Atterberg limits. Figure 26 shows that PI values are comparable to the Lubbock's soil samples. While PI values of the soil samples from Lubbock were slightly lower than those of the subject project's soil samples, the difference is not that significant.

Figure 23 Plastic limit of soil samples

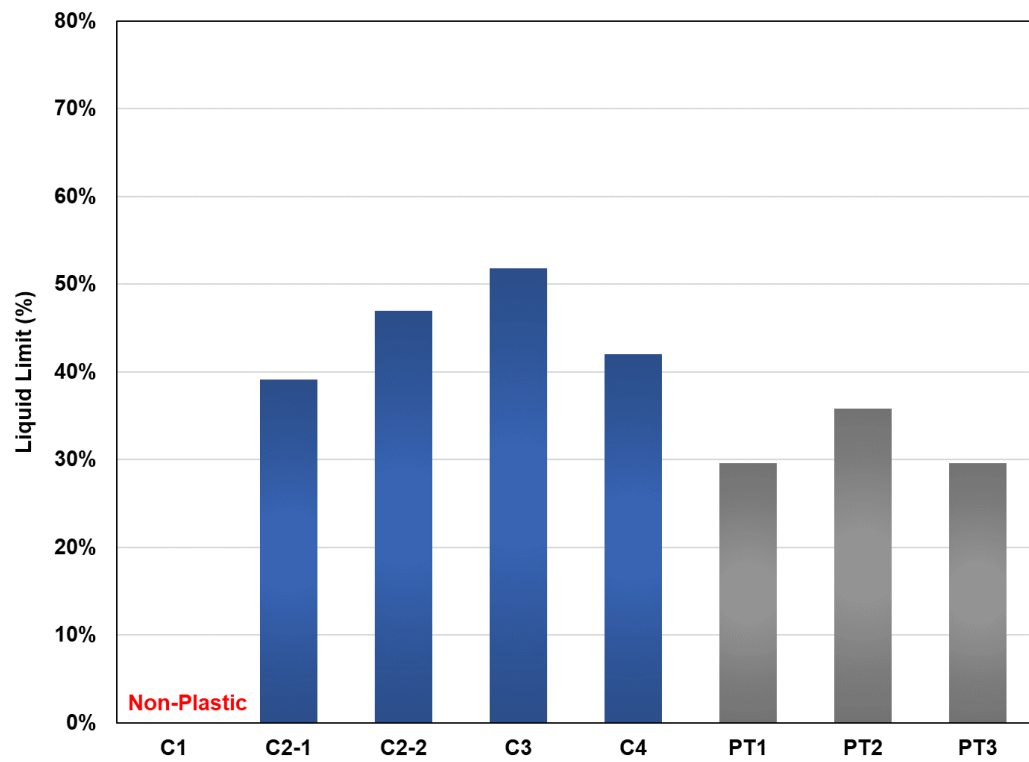
Figure 24 Liquid limit of soil samples

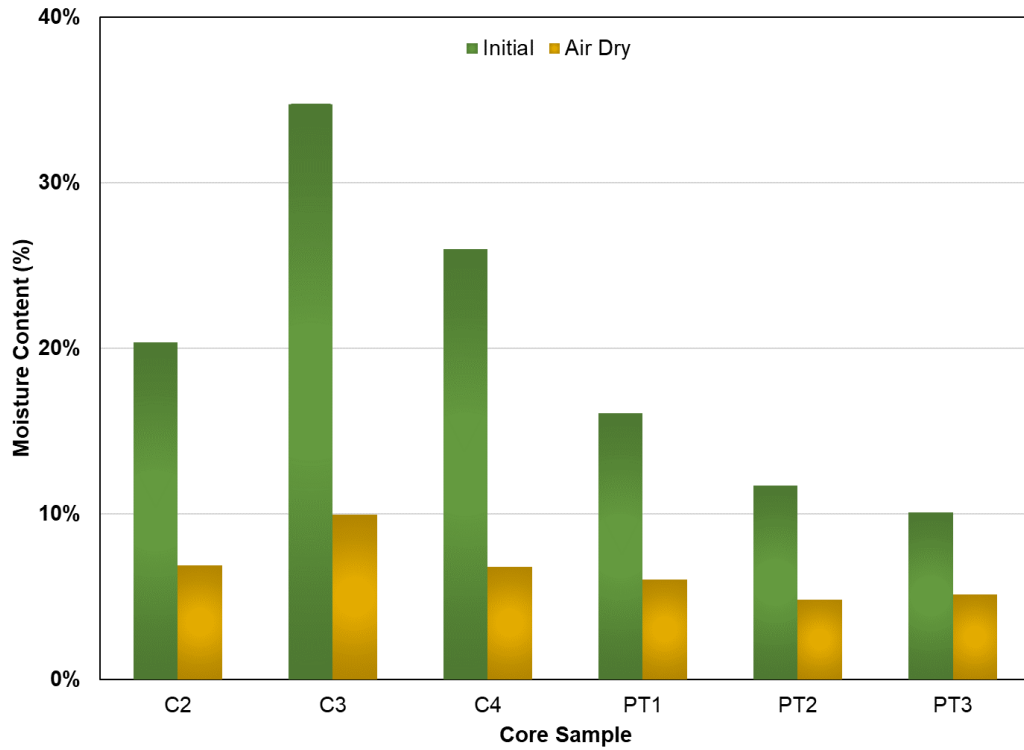
Shrinkage testing consisted of measuring moisture contents as well as lengths of the soil samples at in-situ, air-dry and over-dry conditions. **Figure 30** shows the moisture contents of soil samples at in-situ and air-dry conditions. The amount of moisture loss of the soils in the subject project is higher than the Lubbock's soil samples. However, the moisture loss in Lubbock soil samples were not translated into shrinkage, unlike the subject project's soil samples as shown in **Figure 31**. The shrinkage potential of the soils at the subject project is larger than that of the Lubbock's soil samples. This large shrinkage potential exacerbates the potential problems in the subject project. It could be concluded that the large shrinkage and swelling potential of the subgrade soil in the subject project is responsible for the pavement distresses observed.

Figure 30 Shrinkage specimens' moisture content
