# Diagnosing a misbehaving power slide door

## Fixing the power slide door lock assembly

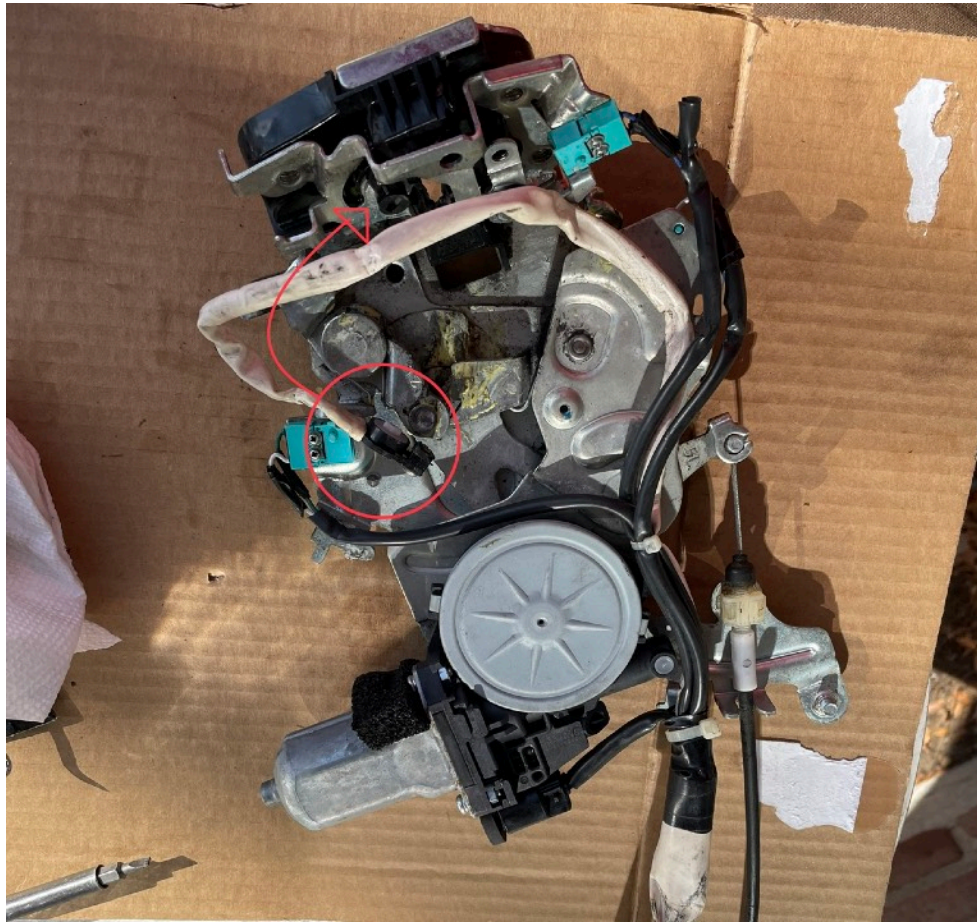
So, once I pulled the assembly, I was able to see what my problem was!

There is a position sensor that was completely broken off of the assembly. It let's the door CPU know the position of the latch pawl, effectively telling it whether or not the door is open or closed. Apparently my sensor was in the closed position and since it broke off, it would never change the value. That's why the door would only ever try to open.

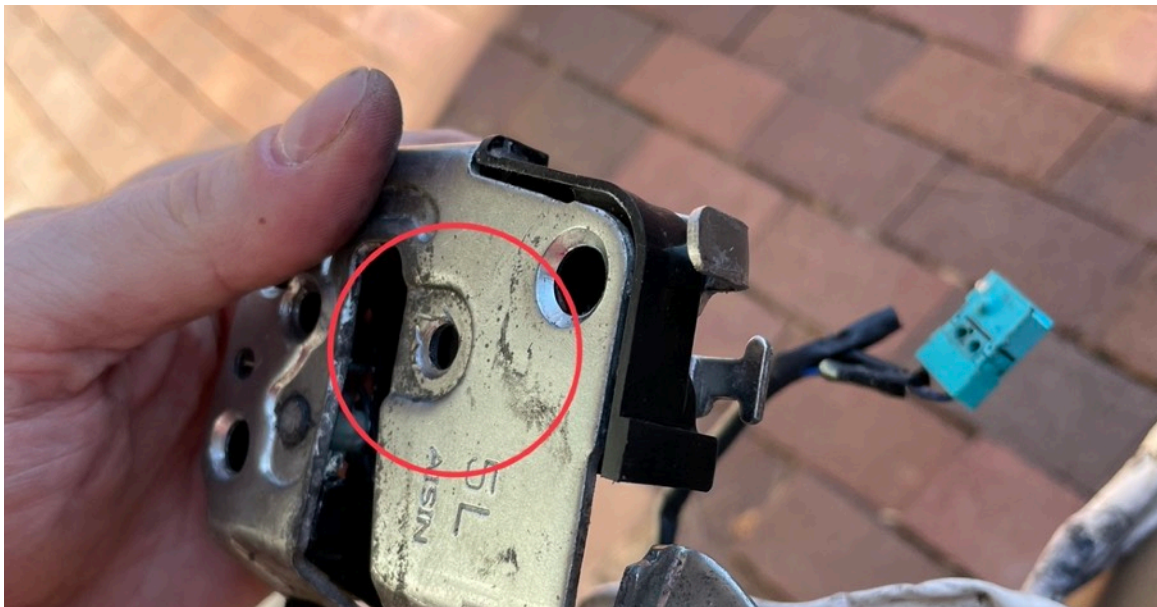
This picture shows the location, though. I drilled it by hand with a cordless drill and then used a narrow punch to remove the pin. The other end of the pin is unique in shape and so the pin needed to be kept around.

For starters I drilled out the spot on the pressed pin where the end was smashed to hold it in place. Unfortunately, I didn't think to take a picture of it first.

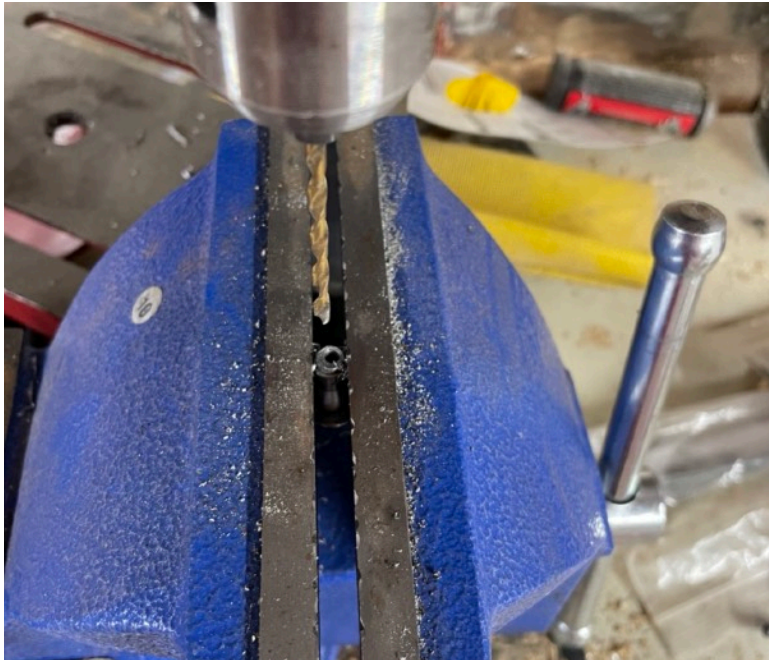
Notes at this point:

1. The other end of the pin looks a little beat up. That's because it is. I admittedly started working at removing the wrong end of the pin when I first set about removing the pi. You can learn from my mistake.
2. The hole with the machine screw in it is the same that I drilled out earlier. I honestly don't remember the size. I think it's more about what you might have on hand and what you can get to be flush with the raised part of the stamped metal. (Where 5L is stamped)

I then drilled and tapped a hole in the end of the pin that I had just ground out in order to be able to put a machine screw in it to hold it in place. I clamped it in a vice and drilled it with a drill press. I don't think I would have been able to get a good hole otherwise. Because I had drilled into it earlier and my original hole was a little offset from the center of the pin, my new hole was off center as well. Since the pin doesn't need to move, this turned out to not be a problem at all.

A test fitting showed that the pin would stay in place and so I started to work on replacing the broken plastic housing.

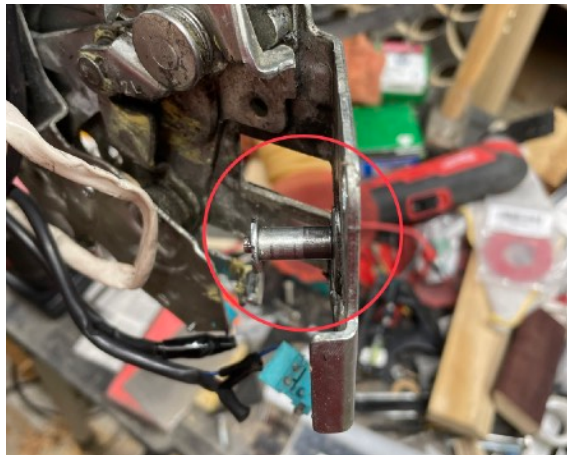
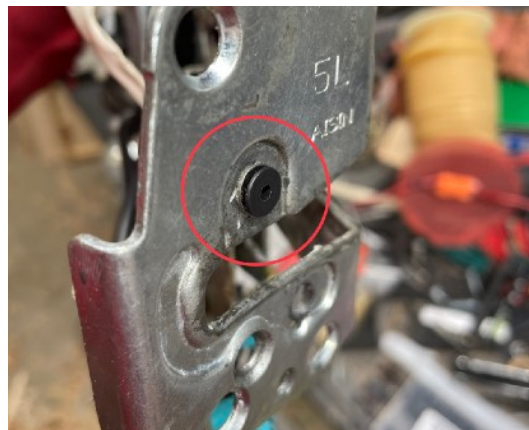
With the pin removed, the area I was working off came off into a smaller sub assembly consisting of one piece of stamped sheet metal, the broken housing, and various parts contained in the housing. The stamped metal was still attached to the housing in a way that I couldn't easily remove it. There is a pivoting piece, also attached via a pressed pin, that runs through the plastic assemble. I had zero confidence that I could remove it and put it back in a way that it still worked, so instead, I cut out part of the plastic around where the pin came through. As I did this, I realized that the plastic housing didn't really serve a structural purpose. That was huge, because it allowed me to modify the replacement part for easier assembly. The rotating pin is held securely between the two pieces of stamped metal when the assembly is all together.

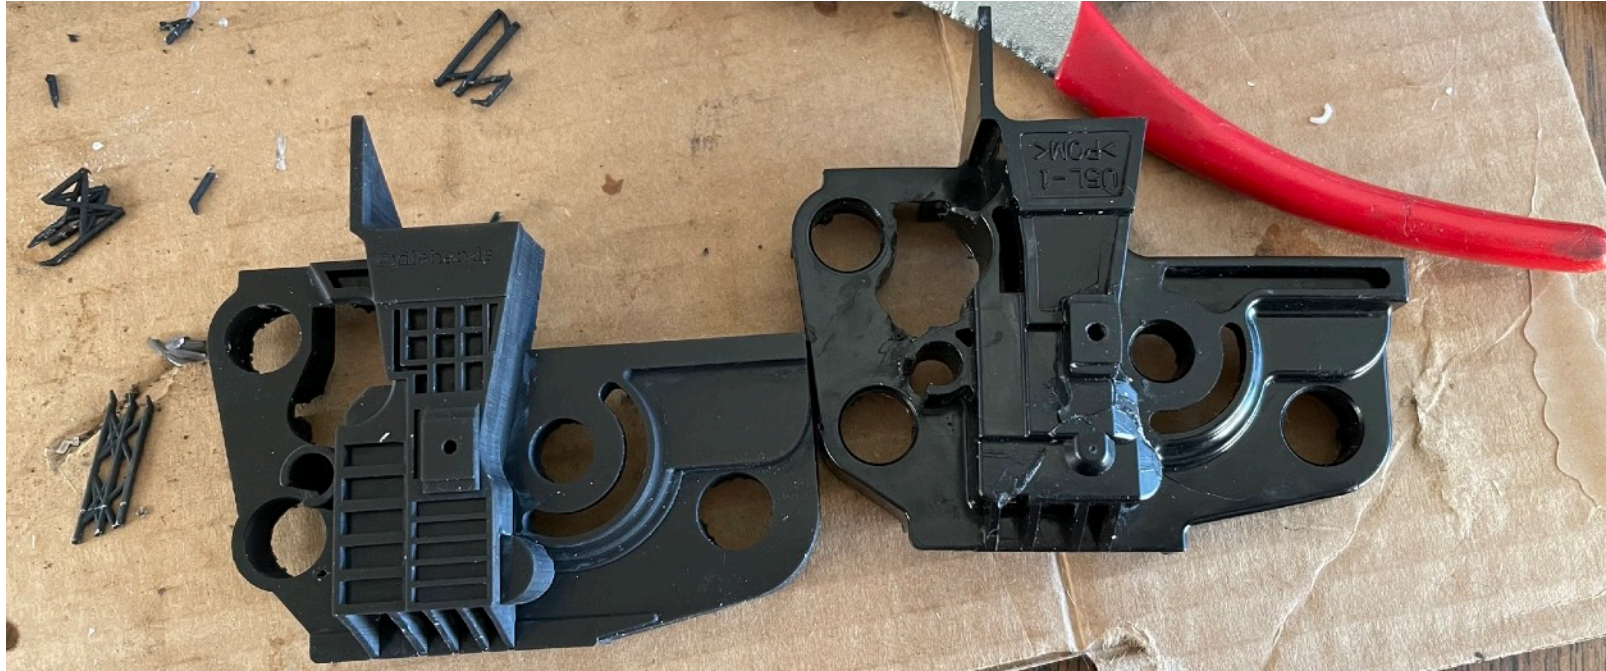
That's what the ribbing is on the top of the piece on the left (mine) vs the original on the right (Toyota's). I'm not kidding myself. I don't think that my piece will hold up for the 15 years the original did, but honestly, I don't need it to. I can either replace it again if needed. But it's a low stress piece and I think there is a good chance that it will hold up.

As I mentioned, it took 6 iterations. After the 5 iteration, I had a part that fit and everything worked. I made a follow up pass adding more material in places that wouldn't interfere with the function and fit but would help make the part stronger.
