CLEARANCE WARNING BUZZER NO.2

REPLACEMENT

6714I-01

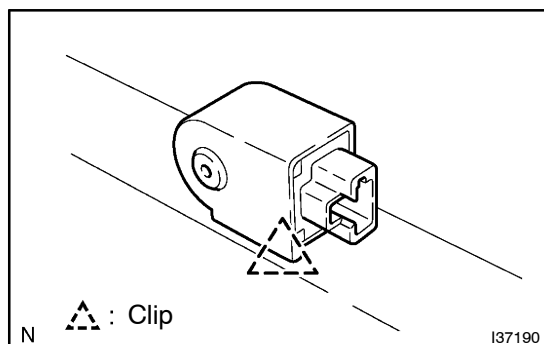
16. REMOVE CLEARANCE WARNING BUZZER NO.2

- (a) Disconnect the connector.
- (b) Disengage the clip and remove the clearance warning buzzer No.2.
