## AVC-LAN CIRCUIT (NAVIGATION ECU - STEREO COMPONENT TUNER)

### CIRCUIT DESCRIPTION

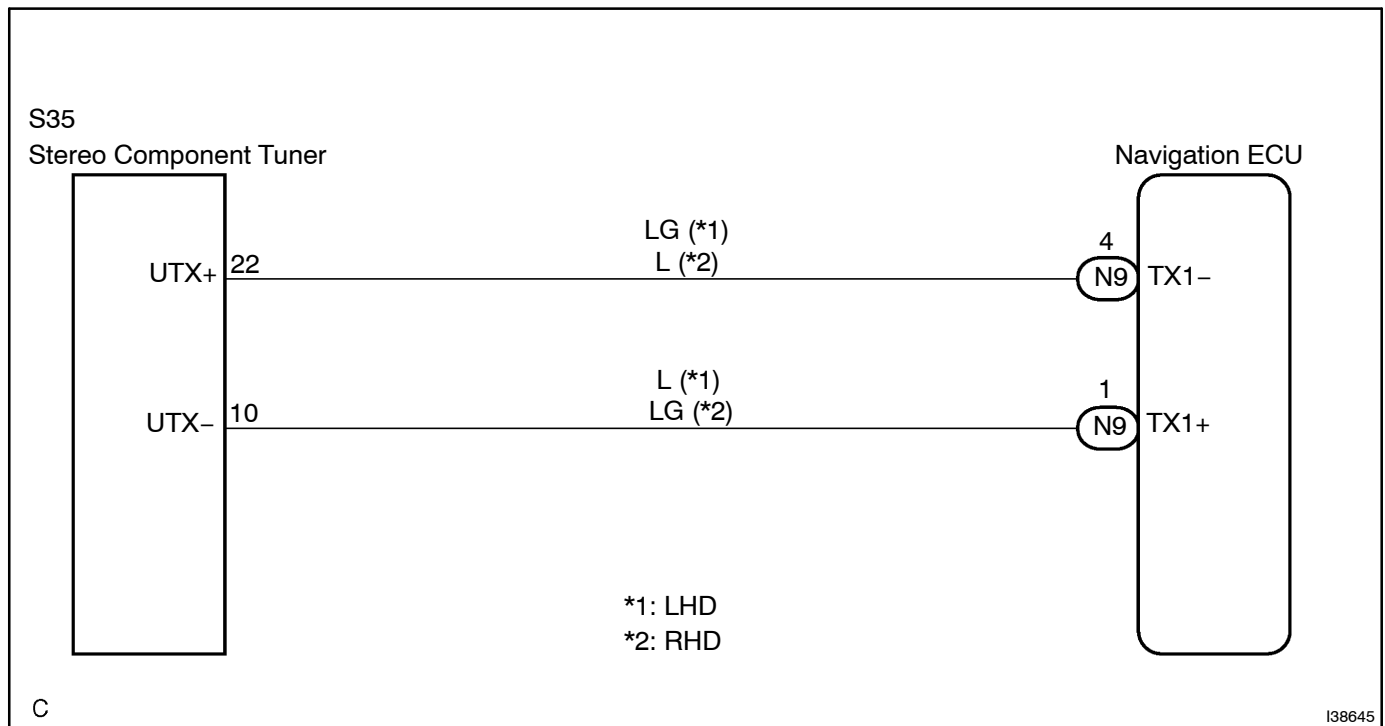
### WIRING DIAGRAM

Each unit of the navigation system connected to AVC-LAN (communication bus) communicates by transferring the signals from each switch.

In AVC-LAN, multi-display becomes the communication master, and the radio receiver assy has enough resistance necessary for transmitting the communication.

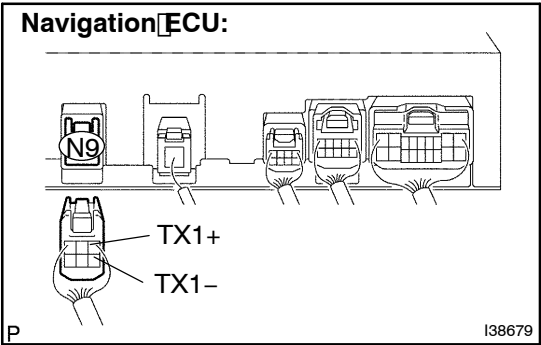
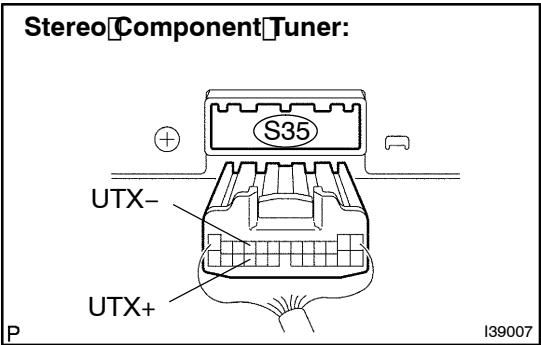
1 CHECK HARNESS AND CONNECTOR (NAVIGATION ECU - STEREO COMPONENT TUNER)

- (a) Disconnect the connector from the navigation ECU N9 and stereo component tuner S35.
- (b) Measure the resistance according to the value(s) in the table below.

Tester connection	Condition	Specified condition
TX1+ - UTX+	Always	Below 1 $\Omega$
TX1- - UTX-	Always	Below 1 $\Omega$
TX1+ - Body ground	Always	10 k $\Omega$ or higher
TX1- - Body ground	Always	10 k $\Omega$ or higher

NG REPAIR OR REPLACE HARNESS OR CONNECTOR
