DTC	B2234	FRONT RIGHT CENTER SENSOR MALFUNCTION
------------	--------------	--

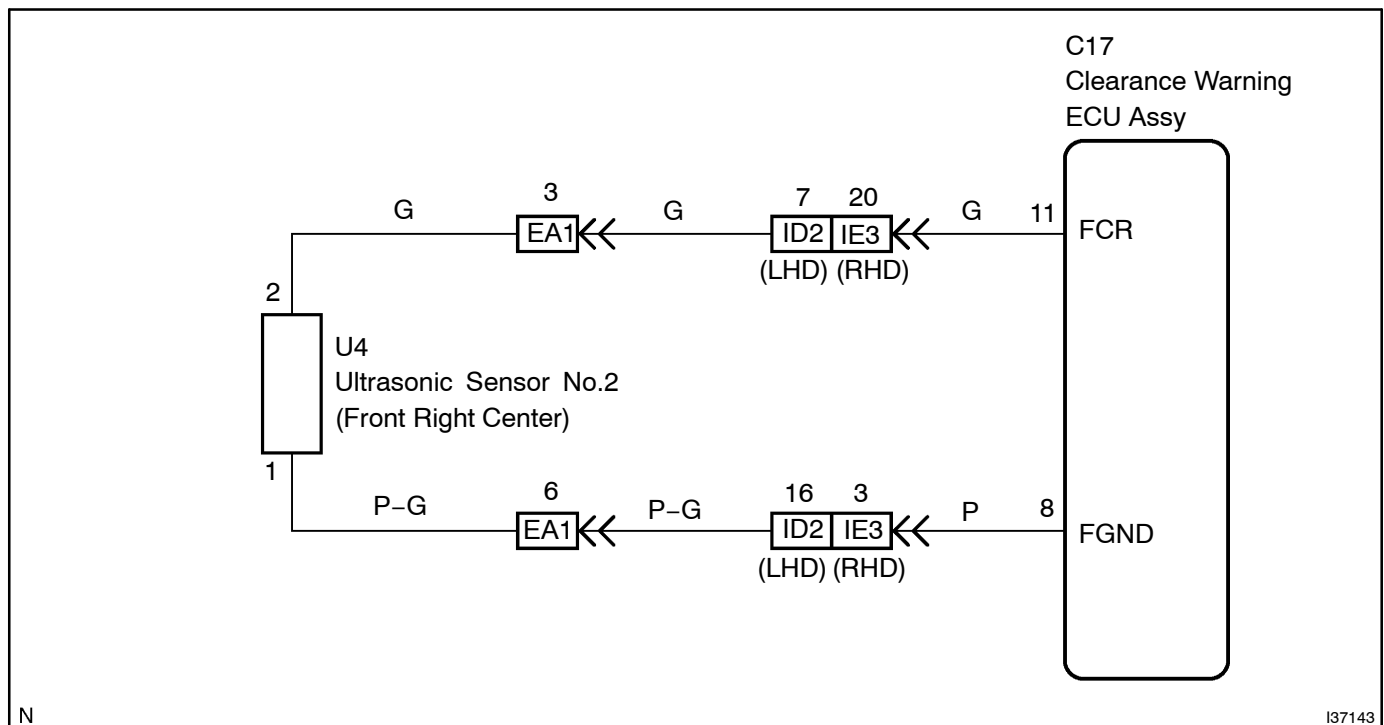
WIRING DIAGRAM

Ultrasonic sensor consists of a sensor portion that transmits and receives ultrasonic waves and a pre-amplifier that amplifies them. The ultrasonic sensor outputs the ultrasonic transmission and reception signals to the clearance warning ECU Assy.

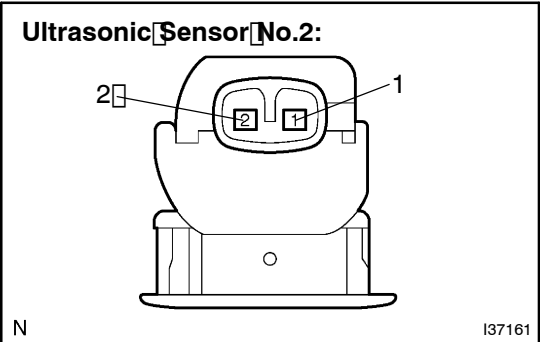
1 INSPECT ULTRASONIC SENSOR NO.2

- (a) Remove Ultrasonic Sensor No.2.
(b) Measure the resistance according to the value(s) in the table below.

Tester Connection	Condition	Specified Condition
1 - 2	Always	10 ± 2 kΩ

NG **REPLACE ULTRASONIC SENSOR NO.2 (SEE PAGE 67-27)**

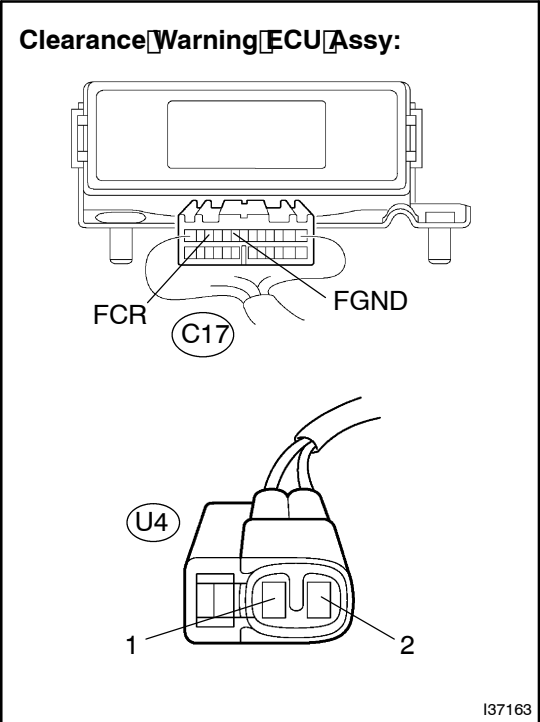
2 CHECK HARNESS AND CONNECTOR (CLEARANCE WARNING ECU ASSY - ULTRASONIC SENSOR NO.2)

- (a) Disconnect the C17 connector from the Clearance Warning ECU Assy.
(b) Disconnect the U4 connector from Ultrasonic Sensor No.2.
(c) Measure the resistance according to the value(s) in the table below.

Tester Connection (Symbols)	Condition	Specified Value
C17-11 (FCR) - U4-2	Always	Below 1 Ω
C17-8 (FGND) - U4-1	Always	Below 1 Ω
C17-11 (FCR) - Body Ground	Always	10 kΩ or higher
C17-8 (FGND) - Body Ground	Always	10 kΩ or higher

NG **REPAIR OR REPLACE HARNESS OR CONNECTOR**
