## AVC-LAN CIRCUIT (RADIO RECEIVER ASSY - MULTI-DISPLAY)

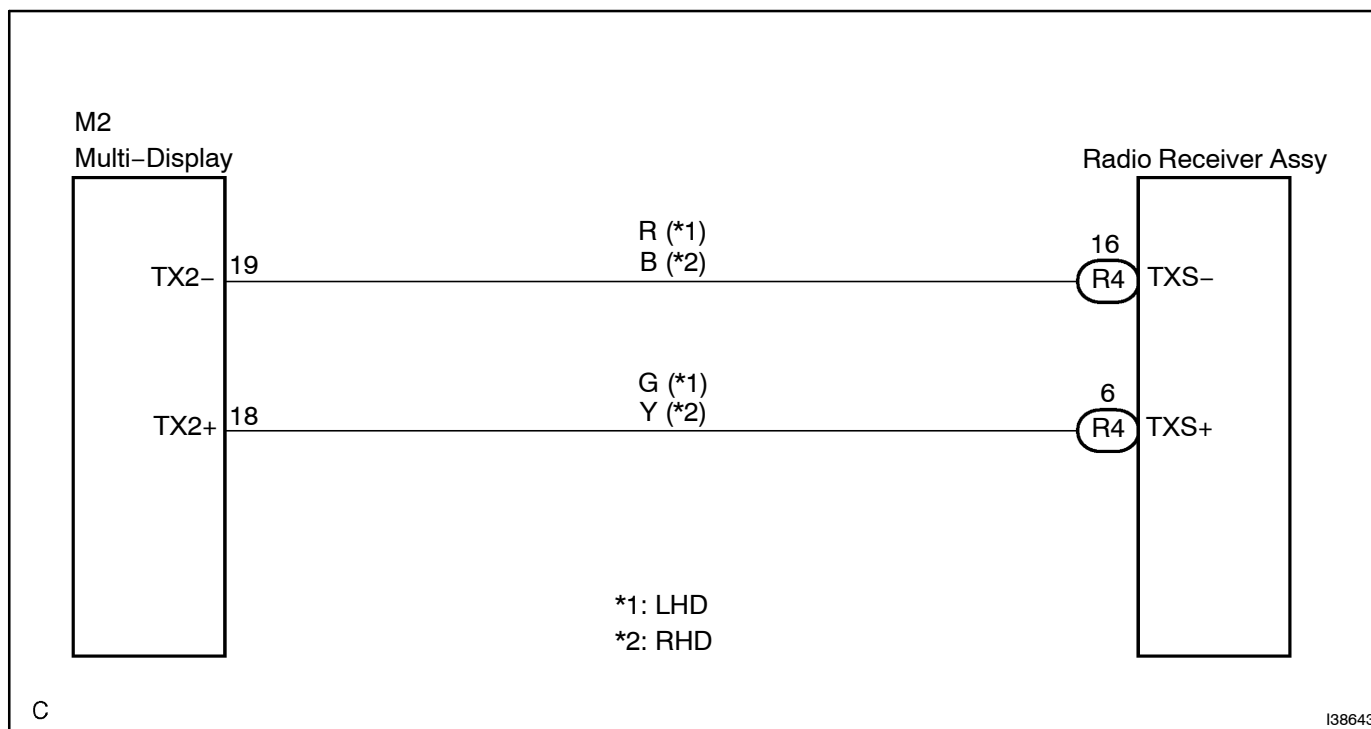
### WIRING DIAGRAM

Each unit of the navigation system connected to AVC-LAN (communication bus) communicates by transferring the signals from each switch.

When +B short and GND short occur in this AVC-LAN, navigation system will not function normally as communication is discontinued.

In AVC-LAN, multi-display becomes the communication master, and the radio receiver assy has enough resistance necessary for transmitting the communication.

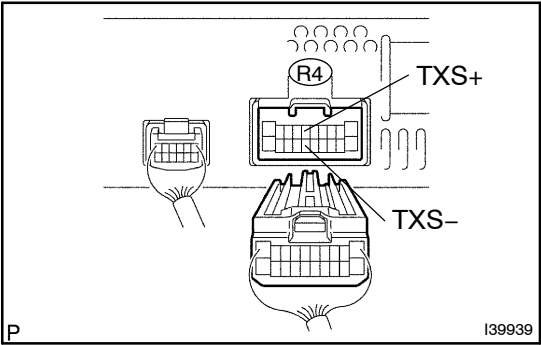
1 INSPECT RADIO RECEIVER ASSY

(a) Measure the resistance according to the value(s) in the table below.

Tester Connection	Condition	Specified Condition
TXS+ - TXS-	Always	60 to 80 $\Omega$

NG REPLACE RADIO RECEIVER ASSY (SEE PAGE 67-5)

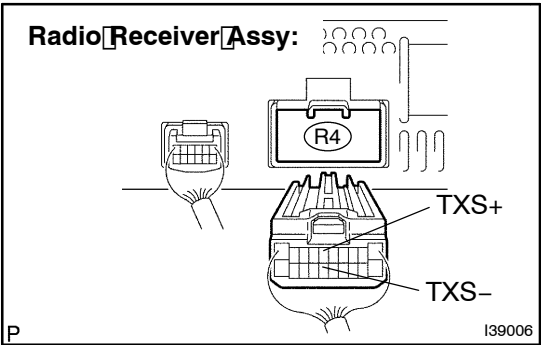
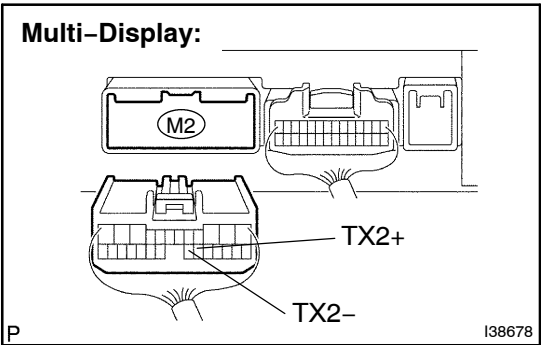
2 CHECK HARNESS AND CONNECTOR (RADIO RECEIVER ASSY - MULTI-DISPLAY)

(a) Disconnect the connector from the radio receiver Assy R4 and multi-display M2.

(b) Measure the resistance according to the value(s) in the table below.

Tester Connection	Condition	Specified Condition
TXS+ - TX2+	Always	Below 1 $\Omega$
TXS- - TX2-	Always	Below 1 $\Omega$
TXS+ - Body Ground	Always	10 k $\Omega$ or higher
TXS- - Body Ground	Always	10 k $\Omega$ or higher

NG REPAIR OR REPLACE HARNESS OR CONNECTOR
