Codford's Military Landscape

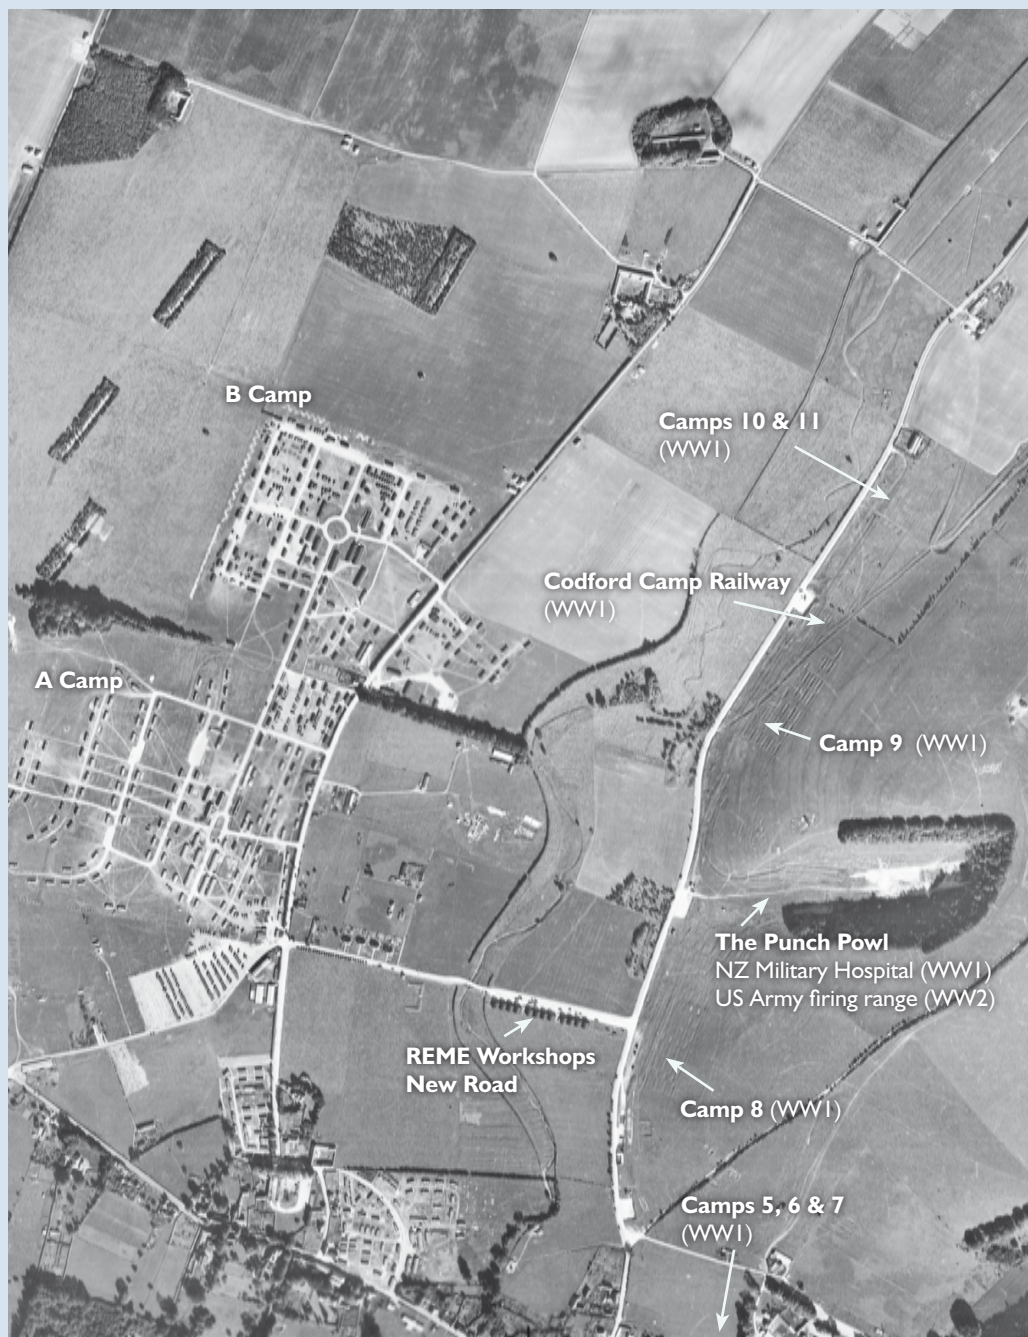
Figure A An aerial photograph of the landscape north of Codford High Street taken by the Royal Air Force in September 1945, showing the surviving Second World War army camps and evidence of those from the First World War.

This vertical photograph taken in 1945 shows the landscape to the north of Codford and south of Salisbury Plain, an area noted for military activity during both World Wars. It shows clearly a large number of ephemeral buildings and earthworks that relate to Codford's use as a military camp between 1916 and 1945. The buildings from the First World War were quickly removed following the cessation of hostilities but the surviving earthworks from that period allow various features and camps to be identified. The buildings from the Second World War are clearly visible.

There were no fewer than 15 different camps in the landscape around Codford, used principally to house Anzac troops before their deployment to France. Located around and to the north of St Mary's church, the remains of rows of temporary huts can be seen stretching along the eastern side

of the Chitterne Road. Also clearly visible are the earthworks associated with the Codford Camp railway that linked the civilian station with temporary halts at the camp sites.

The track running from the Chitterne Road into the Punch Bowl would have served the New Zealand Military Hospital that was established there in 1916.

Although little survives of the military structures today, in September 1945 the majority of the Second World War camp sites were still largely intact (see Figure A). The RAF photograph shows the buildings and Nissen huts of both A and B Camps in great detail. These camps housed American servicemen as did the Cherry Orchard Camp to the immediate north of the High Street. A substantial tank repair and vehicle depot site can be seen at Bury Mead at the junction of New Road and Green Lane and the former NZ Military Hospital site in the Punch Bowl was adapted for use as a firing range by the Americans.

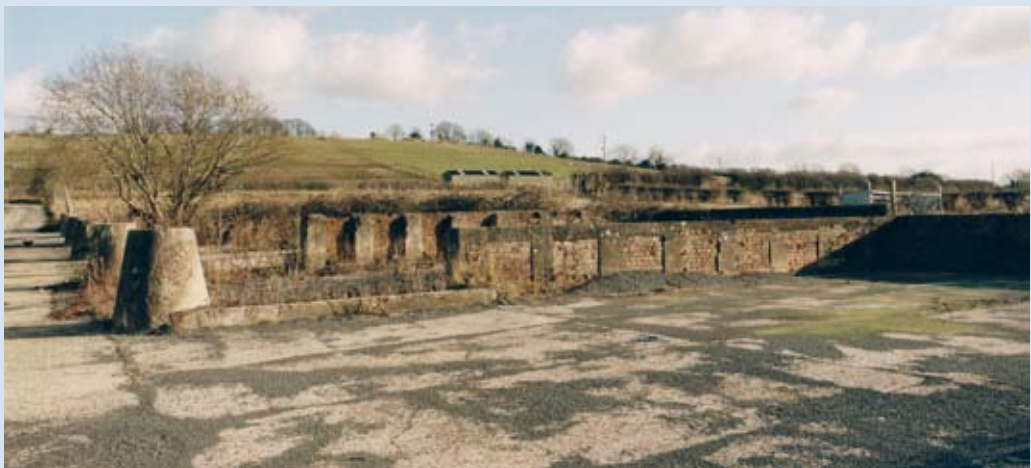
Figure B *Remains of REME workshops, New Road.*

The remains of a row of wheeled vehicle repair workshops operated by the Royal Electrical and Mechanical Engineers constitute one of the few structures from the Second World War to survive into the 21st century (see Figure B). Situated to the south of New Road, they are clearly visible in the aerial photograph.
