# A Case Study on Engineering Failure Analysis of Link Chain

**Objectives:** The objective of this study was to investigate the effect of chain installation condition on stress distribution that could eventually cause disastrous failure from sudden deformation and geometric rupture.

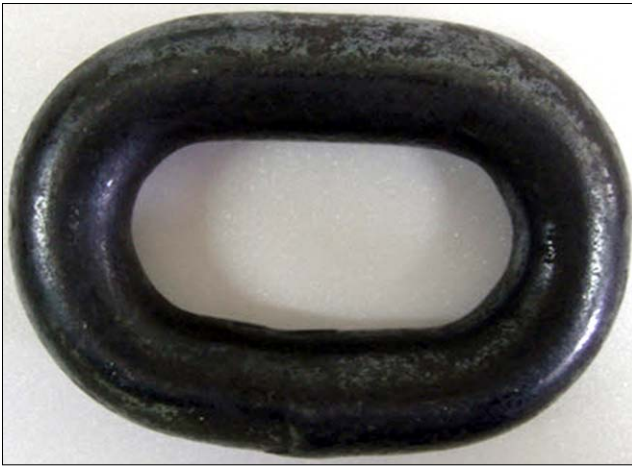
Fig. 1. Chain specimen of original crane chain.

In this study, 3D modeling and FE analysis were performed to identify the correct and incorrect installation procedures of link chain, and identify factors which could lead to disastrous failures from the incorrect installation. A chain (Fig. 1), consisting of consecutively connected metal rings, is usually used to crane heavy weight materials and hot parts in industry, due to its rigidity and strong resistance to heat and corrosion [3]. The results show that a method to reduce the rate of disasters could be identified by quantifying the effect of the worker's incorrect handling of the chain link procedure.

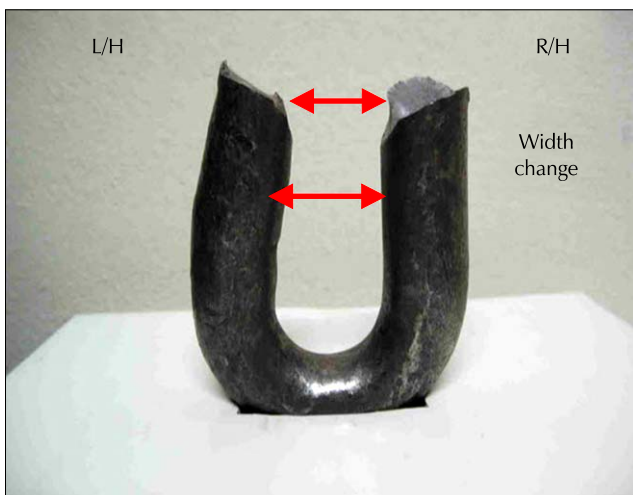
Fig. 2. Failed crane chain.

chain was sent to a metallurgical laboratory to identify the failure mechanism and its root cause. As shown in Fig. 2, the width of the ruptured chain ring was shrunk by deformation when the chain failed, without retaining its original shape. The fracture surface which was formed at an angle of 30-45° to the primary load direction, clearly shows the shear fracture. In a macroscopic view, both fracture surfaces of the crane chain show a shear fracture (Fig. 3 L/H) and the cup and cone shape (Fig. 3 R/H), of which phenomena are considered as evidence of catastrophic failure due to improper overload. Especially, Fig. 3 L/H shows a shear fracture with crushed damage formed by the compressive load on the side of the chain. To analyze the fracture surfaces, each part was viewed with a scanning electron microscope. As shown in Fig. 4, the fracture surface having the shape of cup and cone as an enlarged area of Fig. 3 R/H shows the equiaxed dimples in the flat surface and the elongated dimples in the inclined region. Elongated or equiaxed dimples are observed inside the fracture surface. Fig. 4B and 5C show the step-like topographies indicating the fracture due to bending moment rather than uniaxial tension. Also, as shown in Fig. 4D, cleavage fracture surface is usually formed under high strain rate loading condition. Therefore, it is considered that the fracture of the crane chain was occurred under high strain rate bending moment rather than uniaxial tension instantaneously.

- 1) The fractographic analysis of the failed part reveals that the crane chain was fractured catastrophically by the bending forces.
- 2) The results of finite element analysis show that the state of stress is strongly affected by the condition of the chain installed in the hook, due to the fact that the stress magnitude caused by bending forces is 2.5 times greater than that of the plain tensile load.
- 3) FEA results are in accordance with the fractographic analysis, in that the change of load condition from tension to bending severely affects the failure of parts.
