Safety and Health at Work

Original Article

Analysis of Thermal Characteristics and Insulation Resistance Based on the Installation Year and Accelerated Test by Electrical Socket Outlets

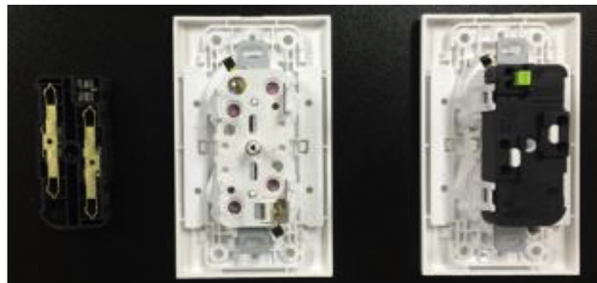
Fig. 3. Color and structural change of the collected installation year–specific electrical socket outlets. (A) 0 year. (B) 10 years. (C) 20 years and (D) 30 years.

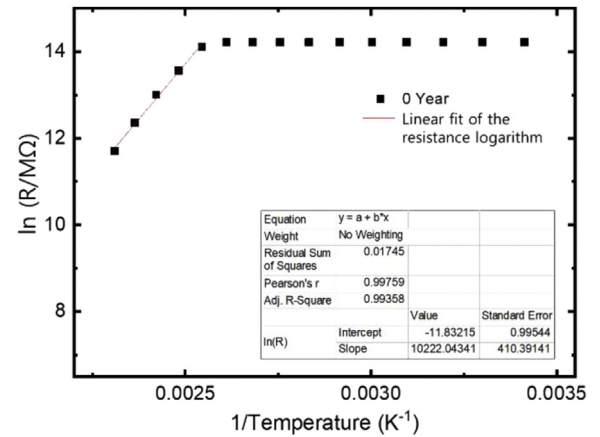
**Fig. 4.** Inclination based on electrical socket outlet temperature and insulation resistance.**Table 2**

As mentioned earlier, electrical socket outlets show temperature increases depending upon current values, and if the temperature rises, the insulation resistance becomes weaker.

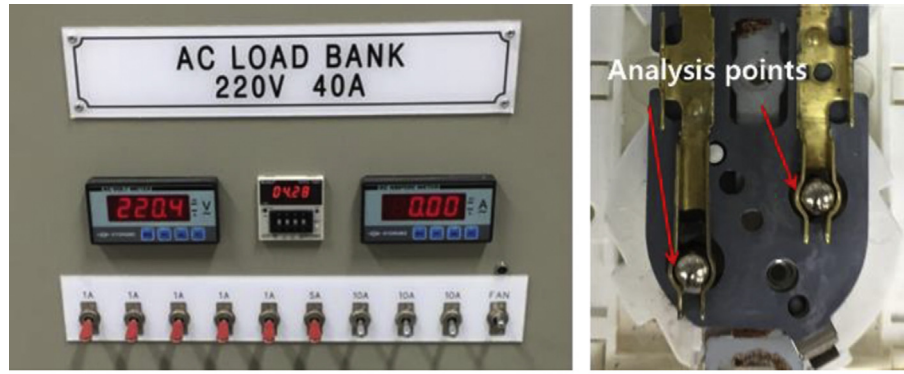
Fig. 5. Experimental process for the thermal characteristics of electrical socket outlets. (A) Experimental device for current application and analysis points of thermal characteristic of electrical socket outlet. (B) Measurement using thermal imaging camera.

without change after rising). Average data were obtained by measuring three times for 12 min for each current level. As shown in Fig. 5, in the experimental procedure, two thermal imaging cameras were used to observe temperature change. The main measurement was done using Fluke Ti25. The testo 872 was used for data correction. Thermal imaging cameras are examined and calibrated each year by a specialized agency, contributing to higher reliability of measurements. For the purposes of this study, an alternating current generator (0–40 A) was used. It is adjustable at intervals of 1 A. However, error of ± 0.4 A occurred with the current increase; therefore, the application range of 10.12–10.25 A was given for 10 A. Fig. 5A shows the AC generator and electrical socket outlet temperature measurement point. Fig. 5B shows temperature measurement using the thermal imaging camera, Fluke Ti25. The thermal property experiment was implemented while the electrical socket outlets were plugged in.

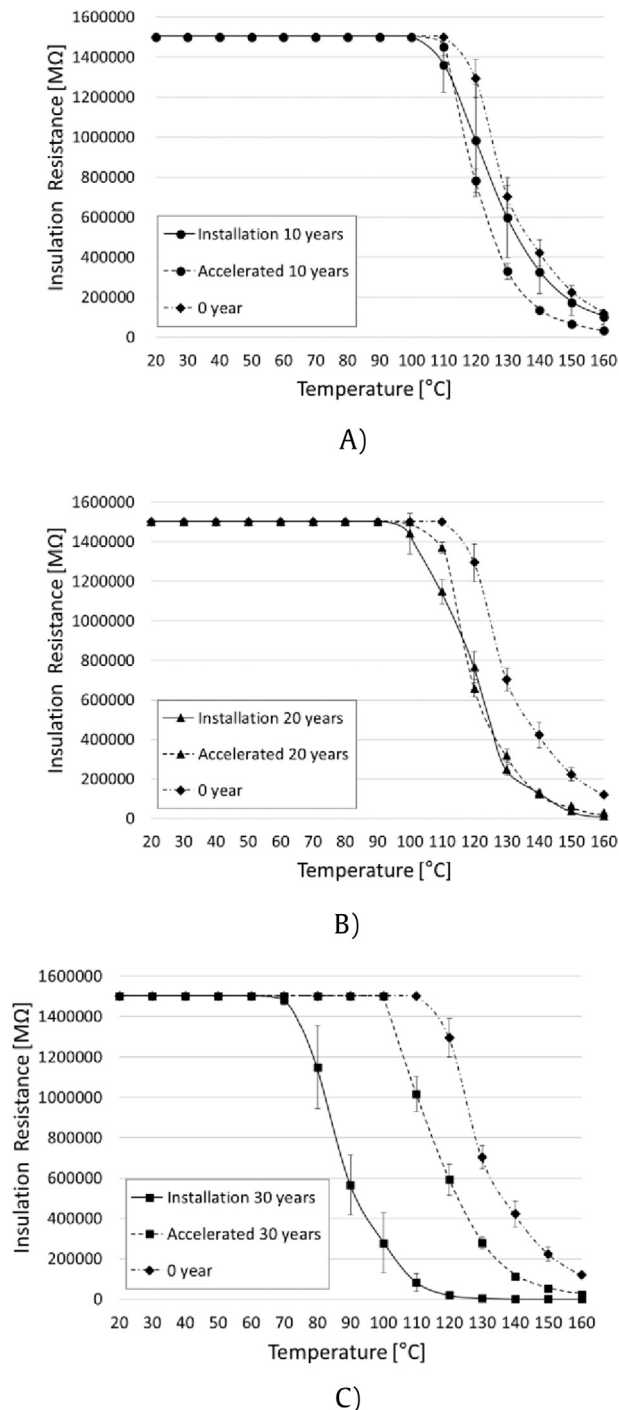
Fig. 10. Results of analysis of the insulation resistance characteristics of electrical socket outlets. (A) 10 years. (B) 20 years and (C) 30 years.

The average temperature of 0-year-old outlets where the accelerated-test insulation resistance began to fall was 120 °C; for all of the 10- /20- /30-year outlets, it was 110 °C. There was no case of rapid fall of insulation resistance. When the electrical socket outlets reached 160 °C, the average insulation resistance of the 0-year outlets was 119,669 MΩ; that of the 10-year outlets was 34,990 MΩ; that of the 20-year outlets was 29,732 MΩ; and that of the 30-year outlets was 23,995 MΩ.

The average temperature of the 0-year outlets where insulation resistance began to drop was 120 °C; that of the 10-year outlets was 110 °C; that of the 20-year outlets was 100 °C; and that of the 30-year outlets was 70 °C. For the 30-year-old electrical socket outlets, in particular, the temperature with rapid insulation resistance downturn plummeted. When the specific electrical socket outlets by installation year reached 160 °C, the average insulation resistance of the 0-year outlets was 119,669 MΩ; that of the 10-year outlets was 101,117 MΩ; that of the 20-year outlets was 11,886 MΩ; and that of the 30-year outlets was 1,599 MΩ.

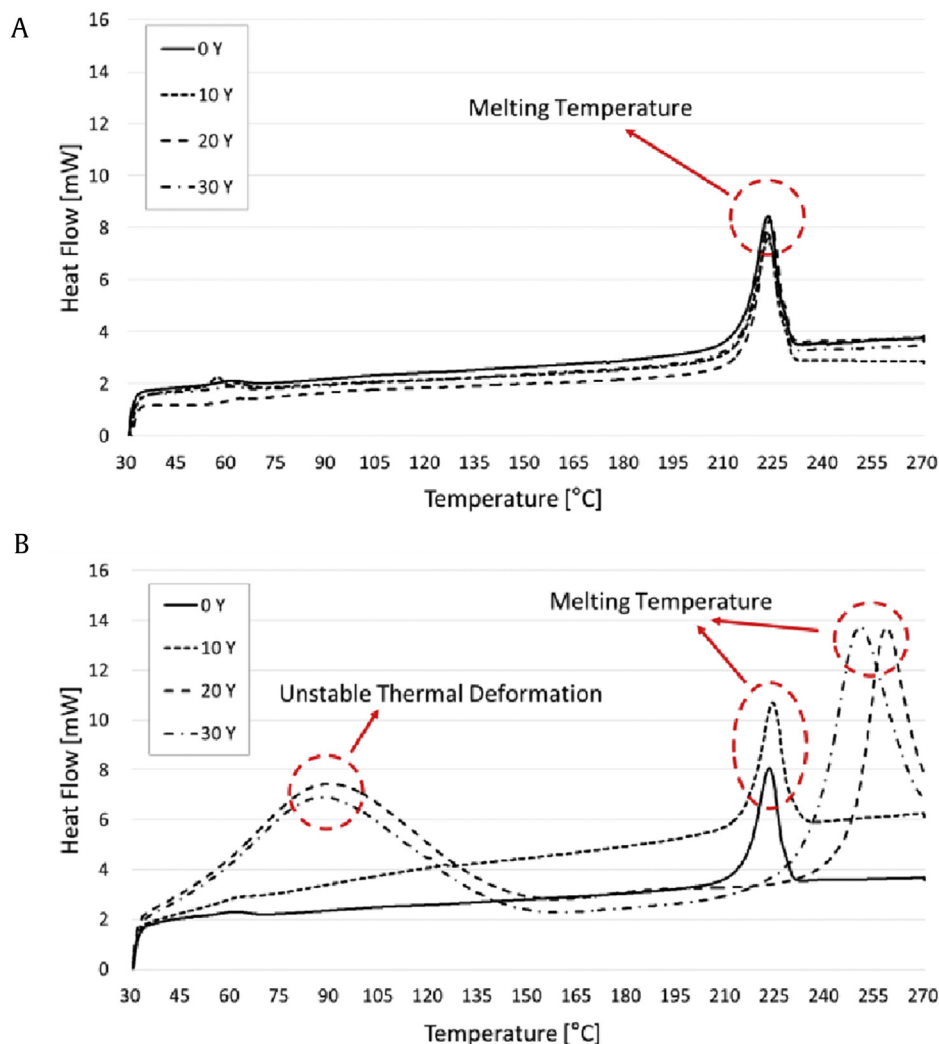
Fig. 14. Thermal deformation temperature results of electrical socket outlet insulators. (A) Thermal deformation temperature of accelerated test electrical socket outlets. (b) Thermal deformation temperature installation year-specific electrical socket outlets.

Fig. 14 exhibits the results of measuring thermal deformation temperature using DSC. As seen in Fig. 14A, the accelerated-test electrical socket outlets were measured to have similar thermal deformation temperatures, and the melting point of the insulator of 10-year outlets was 222.4 °C, that of the 20-year outlets was 223.4 °C, and that of the 30-year outlets was 222.2 °C, demonstrating no change. Fig. 14B also showed that insulators that had been installed for at least 20 years had unstable thermal deformation at 90 °C. The melting point of the installation year-specific insulator of the 0-year outlet was 222.5 °C, that of the 10-year outlets was 223.2 °C, that of the 20-year outlets was 257.6 °C, and that of the 30-year outlets was 248.6 °C, showing higher melting points for the 20-year-old or older outlets because of unstable thermal deformation.
