Post-Flight Performance Report

Roaring Lions

Normandale Community College

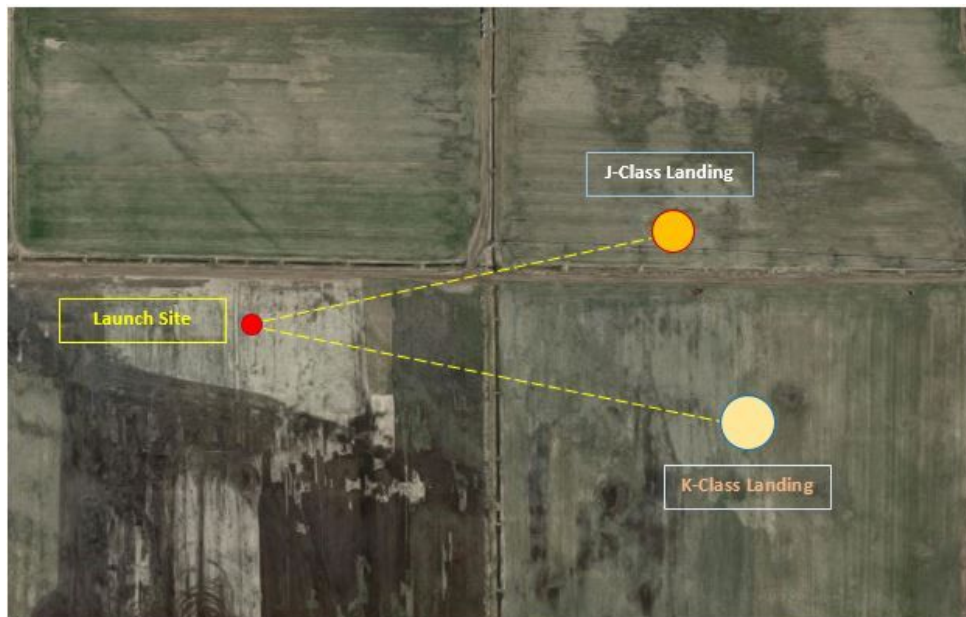
Our J825 propelled our rocket vertically and with little roll. After reviewing downward facing video, we can see the rocket rolled about 1.5 times and stayed almost straight up from the launch pad. After the drogue parachute deployed, the rocket began drifting east and once the main parachute deployed the rocket fell with little drift. Our next flight with the K185 took off vertically and began to slant <5 degrees south. Once the drogue parachute deployed the rocket began drifting to the east and once the main parachute opened the rocket drifted slightly further east.

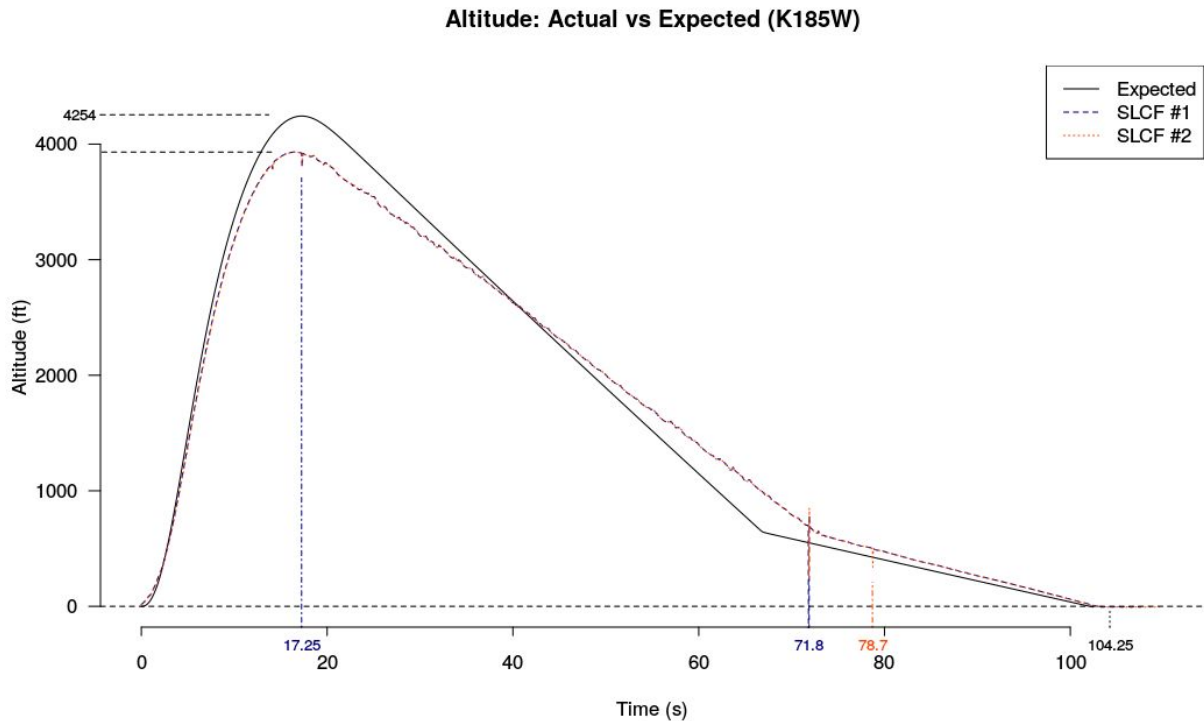
In our next graph of altitude of the K185W, we can see Norman again underperformed in altitude with our predicted apogee of 4254 ft, and our recorded altitude was 3931 ft. Here, we predicted our drogue chute to slow us to a speed of 71.8 ft/s, but our measured velocity was 60.4 ft/s.

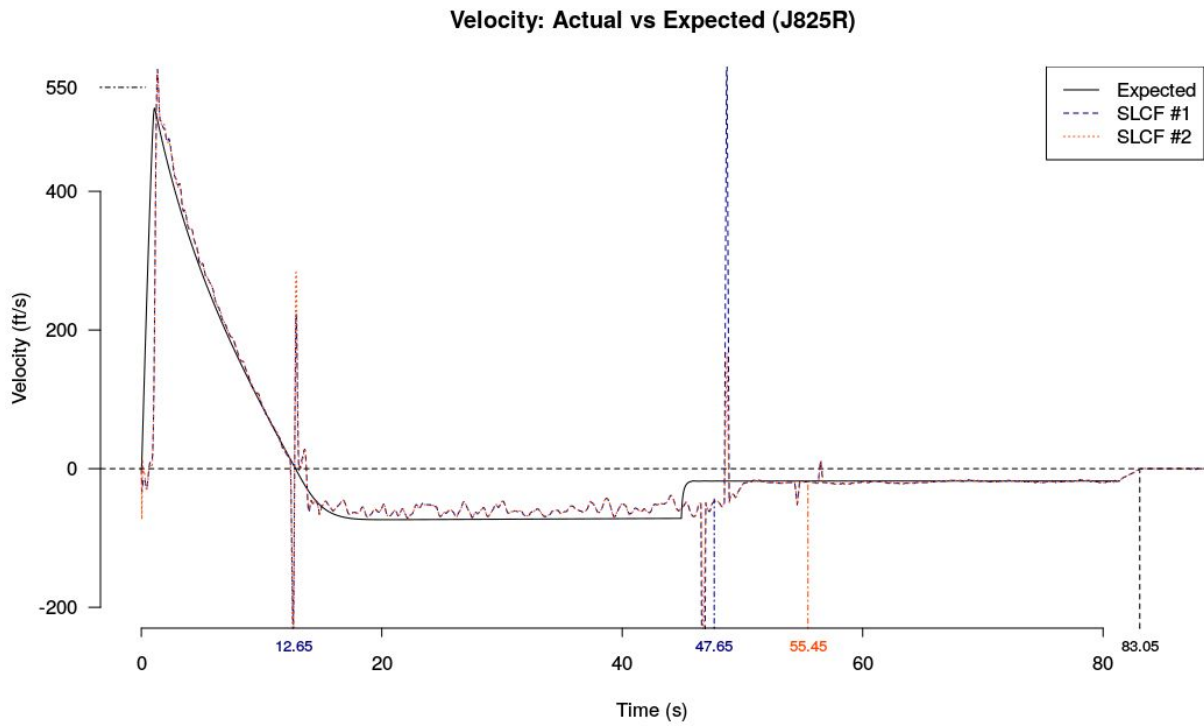
Our stratologgers (SLs) recorded data shows similar peak velocity and peak acceleration to our simulated data. The peak velocity with our J825R was 576 ft/s but our expected velocity was 520 ft/s. These values are within our margin of error considering our altimeter two recorded 515 ft/s on the same flight. The peak acceleration with our J825 was 18 Gs, 0.7 Gs less than our predicted value but this could be due to the 10% deviation between rocket motors. With our K185 motor our peak velocity was 461 ft/s where our predicted value was 474 ft/s though, this difference may be due to additional drag not included in our open rocket simulations. The K185 peak acceleration was 3.34 Gs much less than our predicted value. We believe the variance may be due to the additional drag induced by our external camera housings.

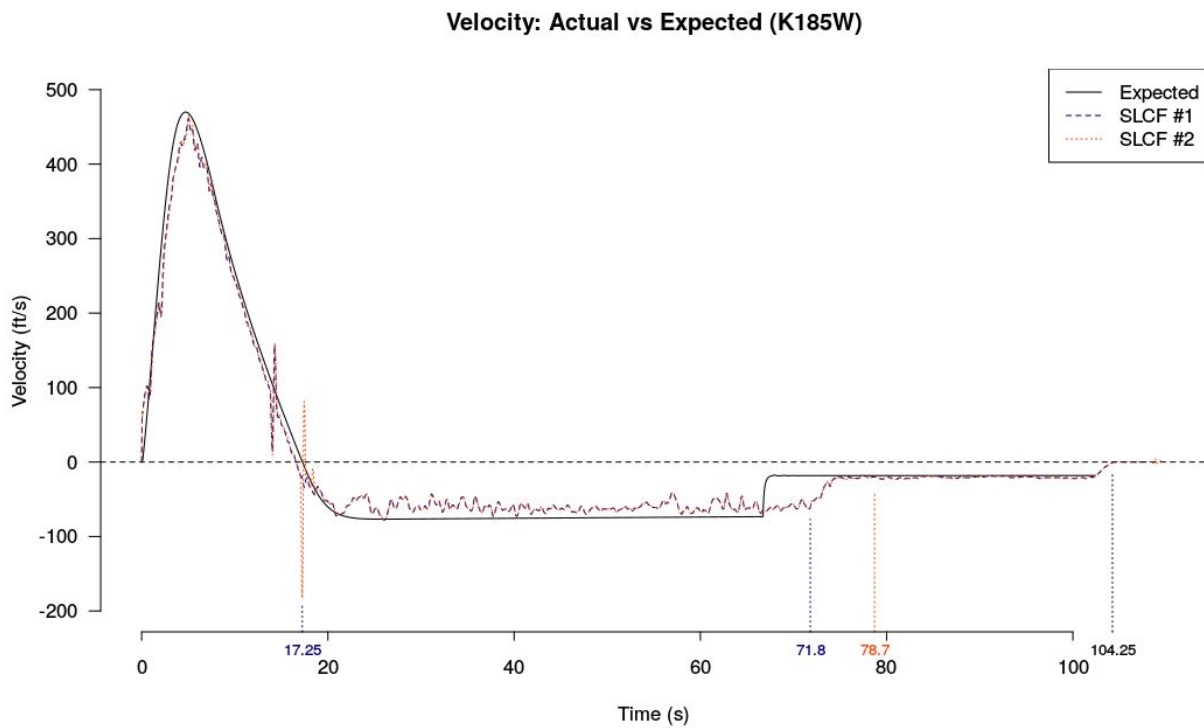
For the K185W flight, because of technical difficulties, we didn't deploy the braking mechanism. Then, using OpenRocket, we expected a max velocity of 474 ft/s and the SLs recorded 461 ft/s.
