The Ohio State University High Power Rocketry Team

I. Rocket Operation Assessment

a Flight Anomalies Analysis

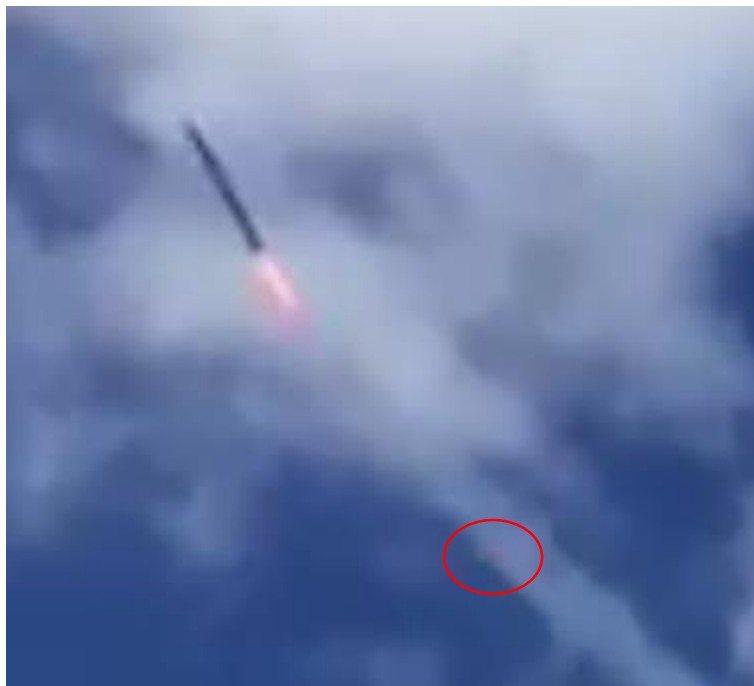
The rocket was set to fail since January and was completely unknown at the time. The retainer mount was attached using regular epoxy. The mount should have been attached using high temperature epoxy. During the second flight of the competition, the epoxy yielded to the high temperature of the motor during the boost stage. The rear enclosure fell off and the nozzle was ejected. The enclosure and nozzle were found 200 yards from the launch site, while the rocket continued to fly a half mile away. As the flight continued, stills from the video shows grains falling out of the motor tube. (Figure 1) The motor casing lodged itself up into the rocket when it crashed to the ground. The stratalogger ejection charge never fired due to cruising at such a low altitude. The motor ejection occurred after landing and destroyed the remaining parts of the rocket.

Figure 1: Still from video of Grain loss during second Flight

The designed drag system, due to structural failure of the motor retainer, was not successfully deployed during the second launch. This was a result of improper epoxy being used to secure the motor retainer. If it were the case that the drag system successfully activated then it was expected that the coefficient of drag would increase by about a factor of two. This can be attributed to the associated increase in drag force resultant of the near doubling in reference area exposed to the freestream. During the first launch, without the drag system deployed, the reference area was taken to be $S_{\text{(inactive drag system)}} = 0.0182414692 \text{ m}^2$ whereas the reference area for the deployed drag system was taken to be $S_{\text{(active drag system)}} = 0.0291898342 \text{ m}^2$. Supposing that coefficient of drag varies as an approximately linear function of the reference area leads to the expectation that the drag coefficient would nearly double for twice the reference area. This supposition is extremely limited and is based on intuition since no usable flight data was actually recovered.

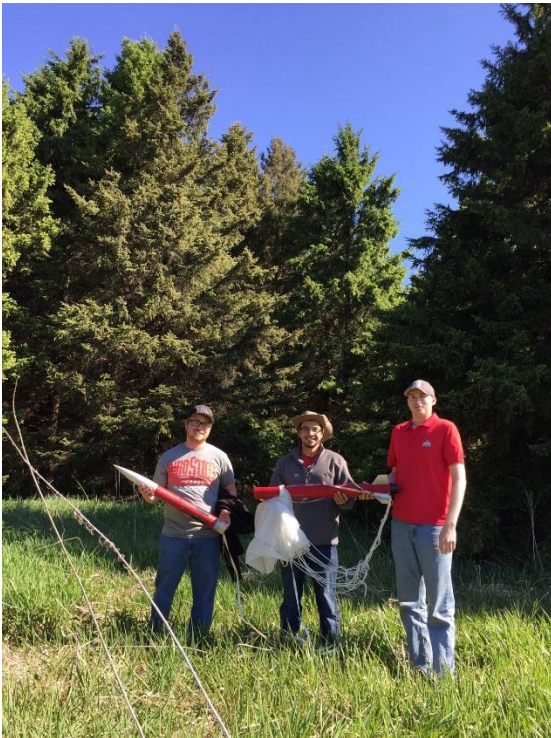
The first launch performed as predicted. The main chute deployed close to apogee and allowed for the rocket to coast a significant distance before landing in the top of a pine tree. (Figure 2) The rocket was successfully recovered by team member Sloane Le and brought to the launch site for data collection. The Altimeter Two, stratalogger, and Pi data was collected. Unfortunately, the stratalogger and Pi data was lost due to a Windows 10 upgrade. The

Figure 2: First Launch Recovery

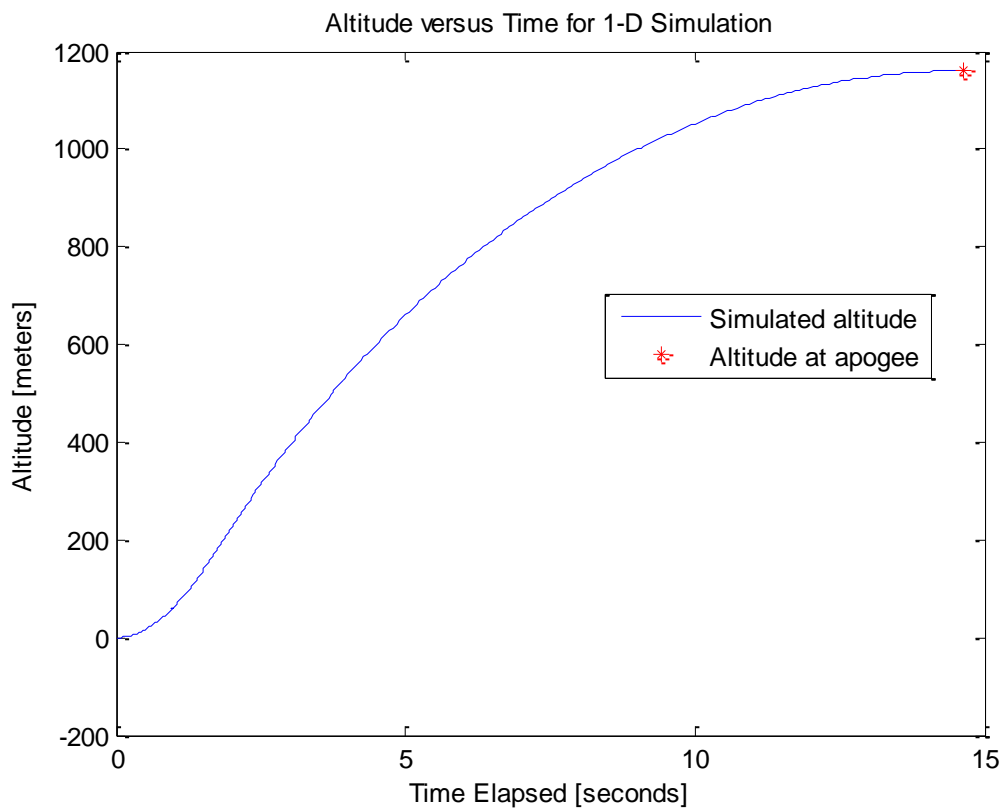
The peak altitude was found to be 1351.8 m which was over the expected 1160.5 m, (Figure 6) but under the 1581 m/s test flight altitude due to the added weight to the rocket. The true value for the 2nd Competition flight altitude was unknown due to the rocket having a catastrophic failure and crashing into the ground, damaging all flight electronics. The estimated altitude for the 2nd Competition flight was 27 m.

Figure 6: Peak Altitude Simulation

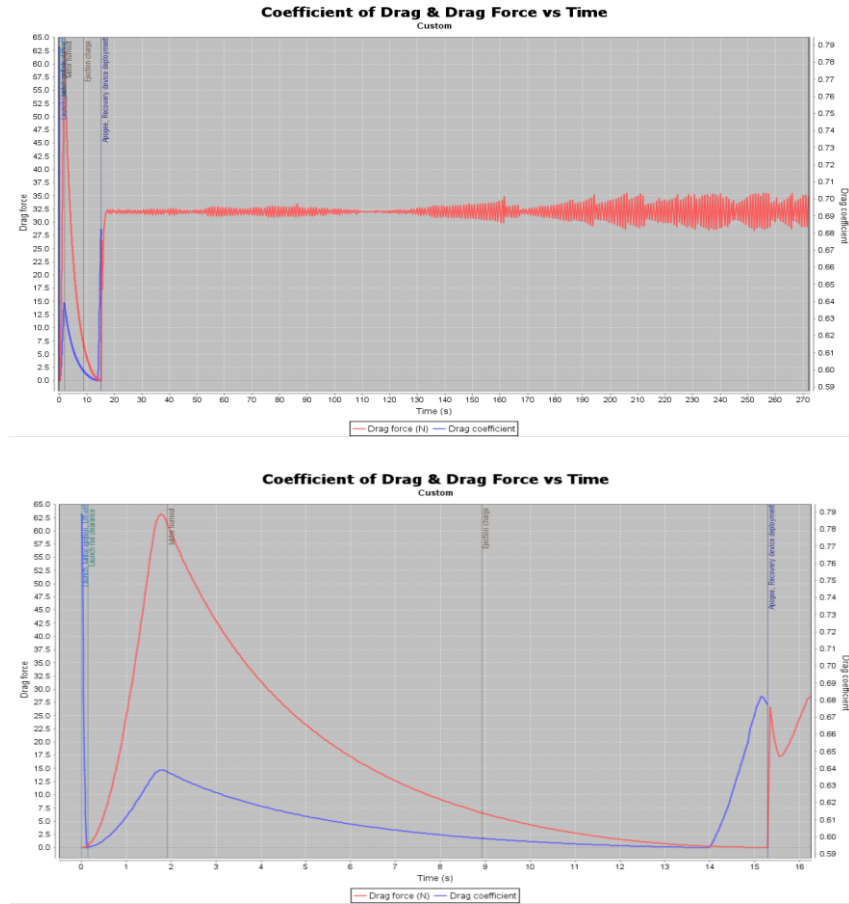
The rocket, with the drag system off, had the coefficient of drag of .61. The predicted coefficient of drag with the drag system on was 1.21. (Figure 7)

Figure 7: Coefficient of Drag Simulations

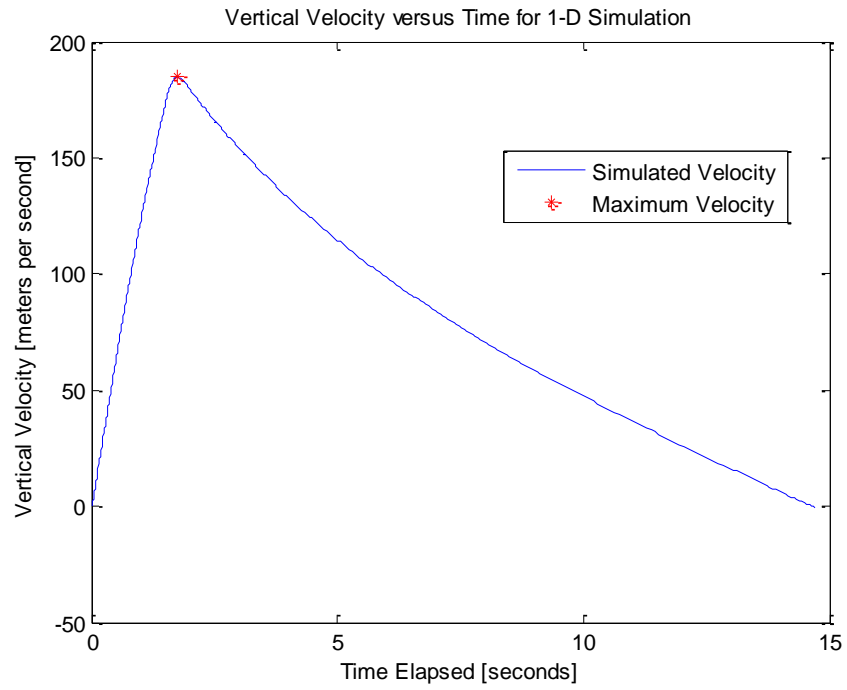
The Altimeter Two read a peak velocity of 193.6 m/s while our simulation gave a max velocity of 184.8 m/s. These two values are in near agreement. Thus supporting the approximate accuracy of our simulations. (Figure 8 & 9)

Figure 8: Peak Velocity Simulation

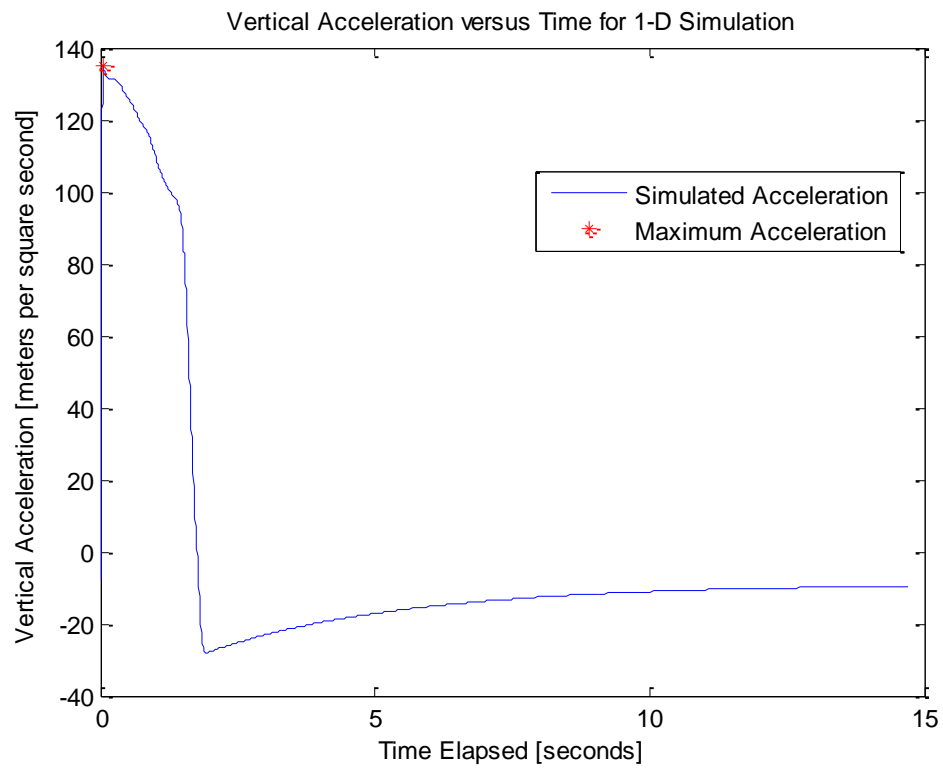
Figure 9: Peak Acceleration Simulation
