Post Flight Performance Report

NASA Space Grant Midwest High-Power Rocket Competition

The Ohio State University Rocket Team

29 May 2015

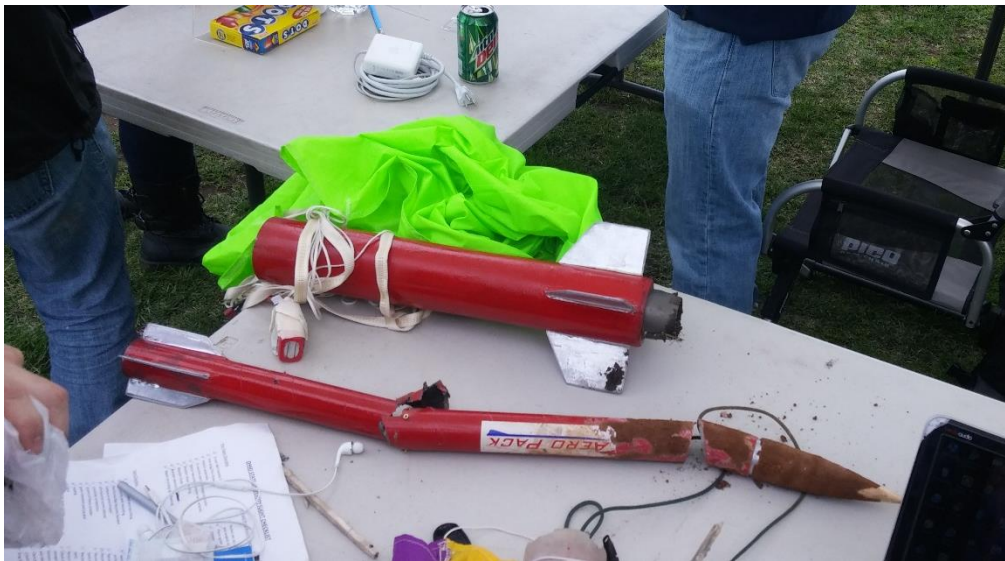
Figure 1: Recovery of Dart and Booster Data

During the final launch of the rocket, the dart parachute failed to deploy due to a malfunction in the igniter. It is impossible to tell for sure what failed in regards to the igniter as the impact of the dart with the ground destroyed the electronics on the dart. When the rocket was recovered, see Figure 1, the ejection charge was unburned. On-board video also failed to record due to the booster battery dying while on the launch pad. This happened because the rocket was recording data and video for over 15 minutes before the launch. The video recorder died about nine minutes after it was turned on. Thus all data from the booster section was not gathered as the battery died before launch. Both of these issues were beyond the control of the team.

The dart section, as mentioned previously, did not deploy its recovery system and thus fell to the ground ballistic ally. This did a considerable amount of damage to the dart section as shown in Figure 1. Due to the considerable amount of damage it is hard to determine the exact reason the parachute did not deploy. However, when the ignitor was recovered it appeared that it been broken but not burned. This indicates that the failure was in the commercial chip used to control the recovery system as multiple tests of the custom programming had shown it to be reliable in the deployment of the parachute.

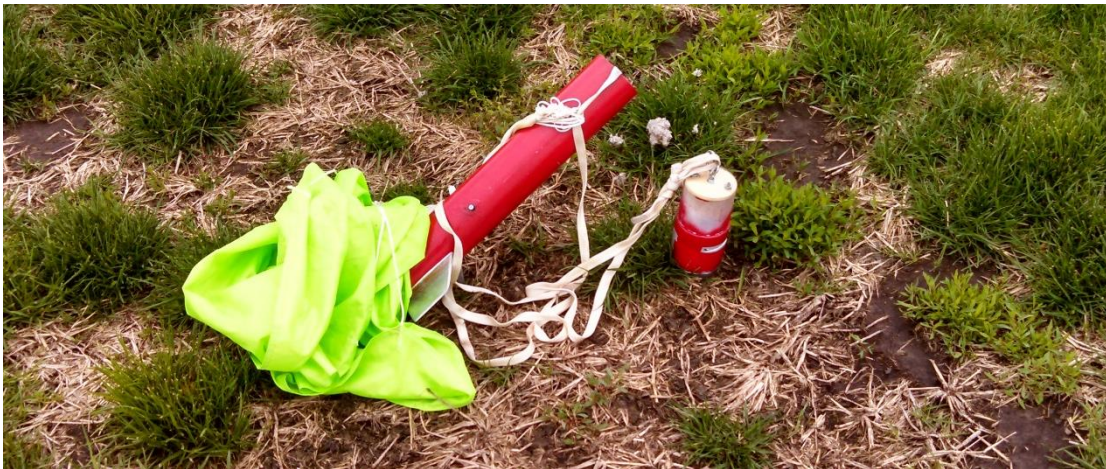
Figure 5: Tangled Lines of the Booster Section

The recovery system of the booster performed well during flight and allowed the booster section to land safely with only superficial damage. One point of interest is that the booster section did fall faster to the ground than expected. The most likely cause of this is that the parachute strings got tangled during deployment and caused the parachute to not fully deploy. This is reinforced by observations made when recovering the dart section that showed the strings tangled, as shown in Figure 5.

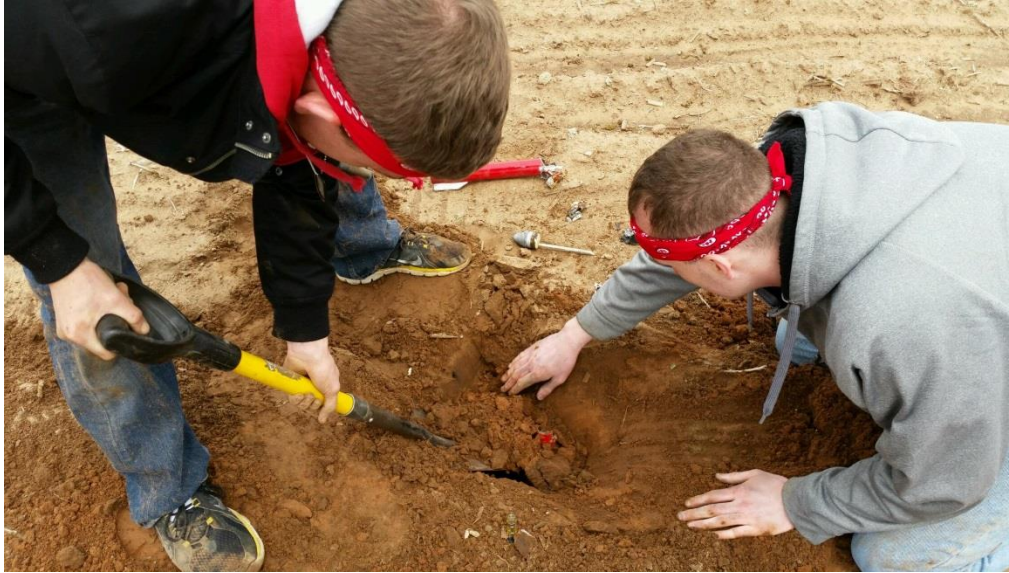
Figure 6: Digging out the Dart

The booster section landed close within 50 yards of the launch section and the electronics were recovered intact with the Altimeter 2 reporting an apogee of about 2400 feet. The dart landed about half a mile to the South Southwest of the launch site. It was buried about 30 inches into the ground and required a shovel to dig it out, as shown in Figure 6. The Altimeter 2 was completely destroyed but data recovered from the SD cards shows a max altitude of about 3536 feet.
