ISS Space Grant Team

“Don’t Bet on It” (Formerly Trappist-1)

**Illinois Space Society
University of Illinois at Urbana-Champaign**

May 31, 2017

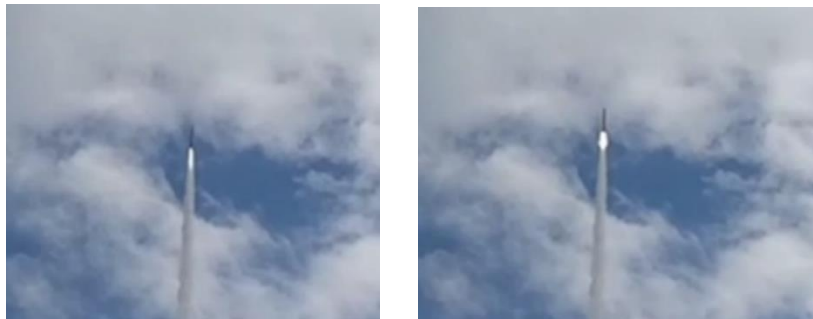
There was also a flare-up seen while reviewing footage from the K1103X launch. This flare up is likely parts of the motor liner falling into the gas jet. This did not affect the flight, but it was certainly interesting to note. This is shown in Figure 1.

Figure 1 - Flare-up as seen from the ground.

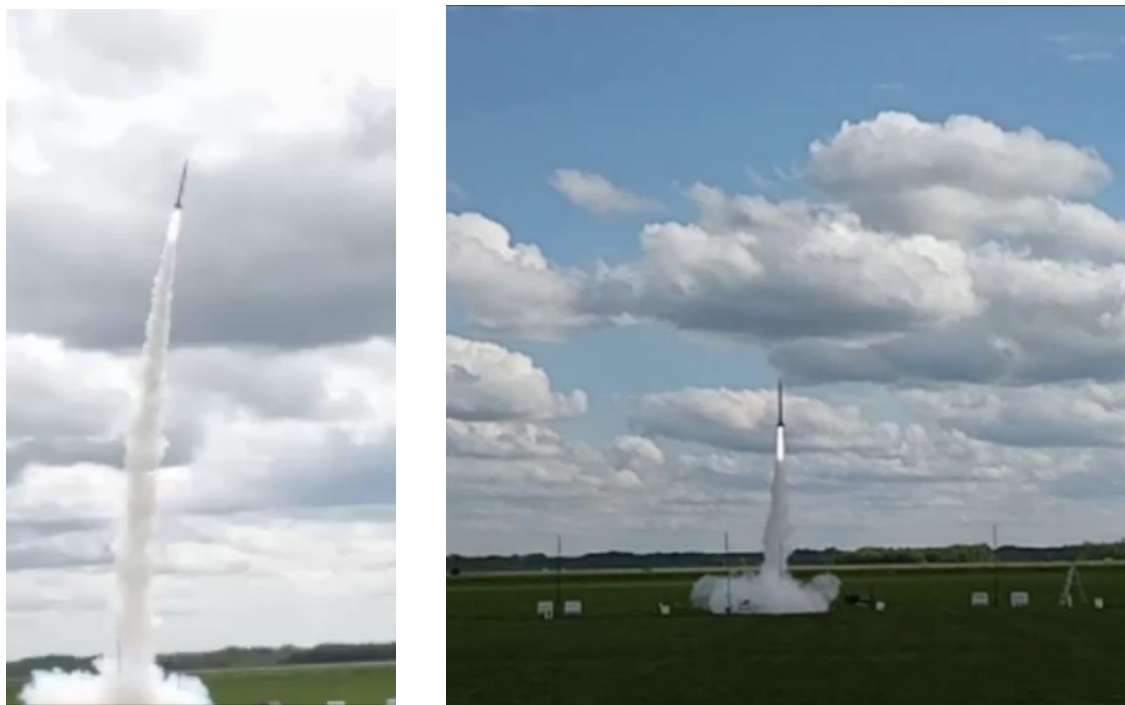
The rocket made two successful flights. On the first launch with the J415W motor, the rocket left the rail, and banked approximately 15 degrees clockwise as shown in Figure 2. This rotation off the rail has not been explained, yet it happened on the test flight which flew with the same motor. This could have cut into the apogee of the rocket, meaning that had it not happened, the rocket may have could achieve 3,000 ft. For the rest of the flight on the J415W motor, the rocket maintained a steady and straight path. This indicates that the flaps were stable throughout flight and the drag system did not impede the rocket.

Figure 2 - Liftoff with the J415W (left) and K1103X (right)

During the K1103X flight, the rocket flew one of the straightest flights of the day. It left the launch-pad much faster than on the J415W, and did not meet any problems leaving the launch rail. Throughout the entirety of the motor's burn, the rocket maintained its initial geometry. About a second after motor burnout, the drag system activated. It was not initially possible to tell, but the drag system slowed the rocket substantially. Even after the flaps rotated, the rocket maintained a very straight and low rotation flight. Prior to apogee, the flaps retracted to their initial positions, as evidenced by the straight flight post-deployment. Once at apogee, the rocket did not fire its electronic ejection charge. This led to the rocket slipping backwards for approximately 2 seconds, before the motor ejection charge activated. This is interesting. Instead of pitching over completely, it stopped when nearly parallel to the ground. This may have ensured that the drogue parachute could deploy before the rockets' speed was too great.

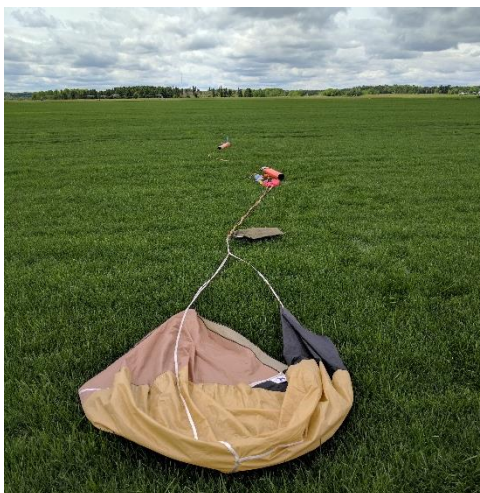
Recovery of the rocket was simple and seamless. After the J415W flight, the rocket drifted back relatively close to the launch-pad, making it easy to recover on foot. The landing site can be seen in Figure 3. The radio transmitter did not need to be utilized. After the K1103X flight, the rocket drifted slightly farther than on the first launch. It was still in walking distance, however, and the rocket was recovered as easily as the first time. On arrival at the landing site after the K1103X flight, however, it was found that two of the ejection charges did not activate. These were both disconnected from their terminals, shorted, and kept out of the way of teammates recovering the rocket. The altimeters were also confirmed to be off, ensuring no accidental ignition could occur.

Figure 3 - Landing site after the J415W flight.

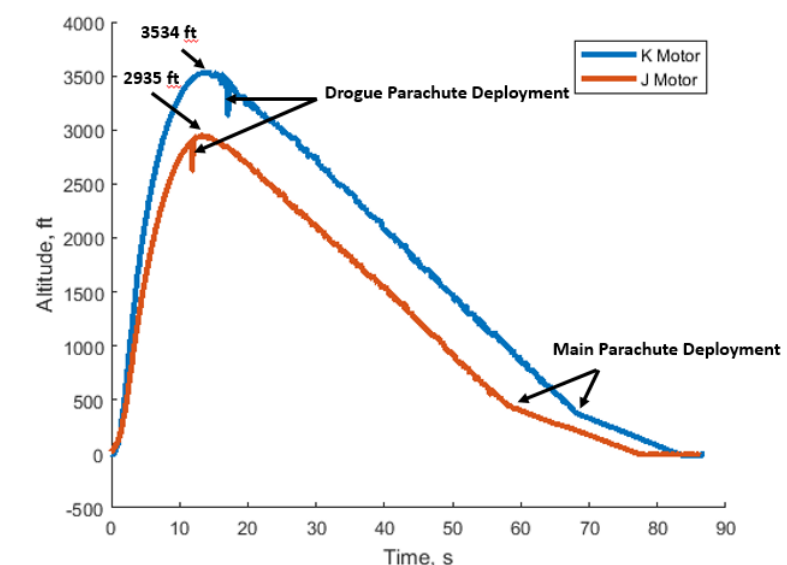
The peak altitudes achieved on the J415W and K1103X flight were 2935 ft. and 3534 ft., respectively. The J flight went lower than the 3300 ft. the OpenRocket predicted, most likely due to an increase in friction from the camera mounts, flaps, and pitot tube. Although the J apogee is below the 3000 ft. stated in the competition requirements, it came close and could reach 3000 ft. if the camera mounts and pitot tube were designed to reduce drag. The J and K flight altitude vs. time trajectory can be seen in Figure 4.

Figure 4 - J415W and K1103X Altitude vs. Time Graph

The K flight went significantly lower than OpenRocket's predicted apogee of 4544 ft., demonstrating the success of the active drag system. With a true apogee of 3534 ft., the apogee was approximately 1000 ft. lower than the prediction. The drag system was set on an altitude delay, so the flaps opened when the altitude reached 820 ft. (250 m) and closed when rocket reached 2789 ft. (850 m). The altitude at which the flaps closed was set conservatively to ensure the same geometry at launch and apogee, so they closed early and caused the K apogee to be higher.

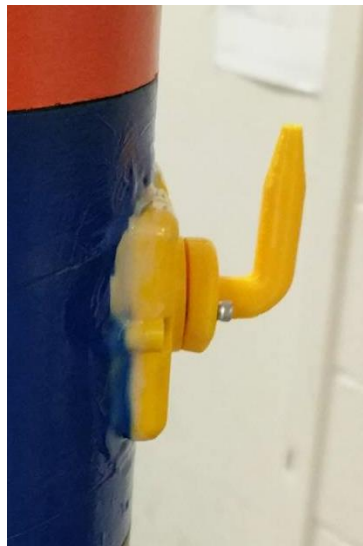
The team decided to 3D print a pitot tube to measure velocity to allow easy replacement in case one got damaged. On the J flight, the team's pitot tube successfully collected pressure data and used the isentropic flow equation to calculate velocity. The curve matched reasonable well with the StratoLogger data after being scaled. Unfortunately, the SD card was not completely in the slot for the K flight, so no data was recorded. The pitot tube used by the team can be seen in Figure 5.

Figure 5 - Close-up of the Pitot Tube

The team used the BMP280 Barometric Pressure Sensor to measure both static and dynamic pressure. One sensor was in the avionics bay, and various holes in the coupler allowed it to read the static atmospheric pressure during flight. The other sensor was in a chamber inside the pitot tube, and it measured dynamic pressure as air was directed in the chamber during flight. The two pressures were used to calculate velocity using the following isentropic flow equations:

The velocity was then measured against the StratoLogger altimeter velocity data. Because the chamber of the dynamic pressure sensor affected the pressure reading due to airflow, the velocity readings needed to be scaled to match the real velocity. The team expected this to be necessary as the 3D printed pitot tube chamber size did not account for different the dynamic pressure readings, so the curve would be the correct shape, but the values would be off. Additionally, the tube that directed air flow into the pressure chamber may not have been the optimal size. Earlier iterations of the design output inconsistent readings due to a large tube that caused turbulence. The team found that a small tube approximately .1 in. in diameter minimized turbulence and still allowed enough air to enter for an accurate reading.

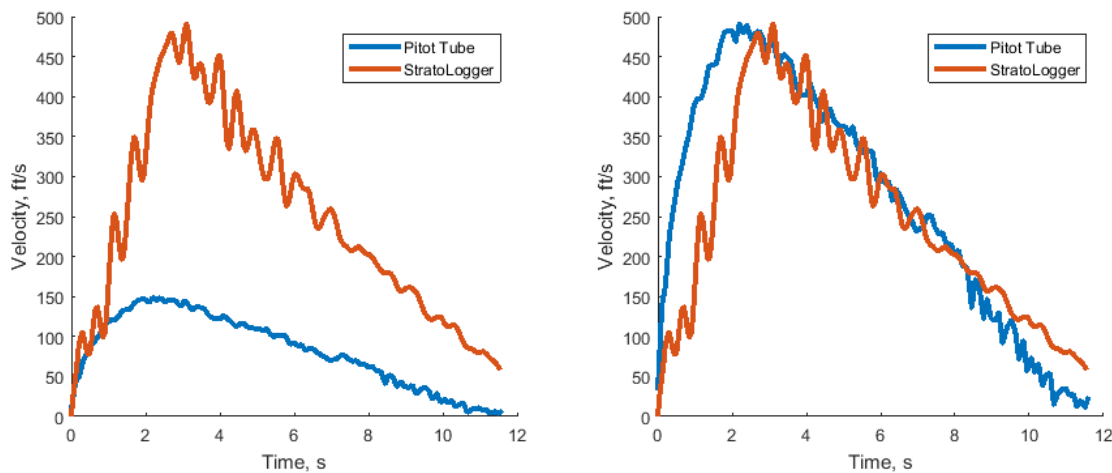
To scale the pitot tube data, the team took the max velocity measured by the StratoLogger and divided it by the max velocity measured by the pitot tube to get the scale factor. The max velocity measured by the StratoLogger was 491 ft./s. The pitot tube velocity was then multiplied by that scale factor to get the pitot tube velocity measurement. The scale factor was 3.3, and this number is expected to be similar on all flights utilizing this pitot tube. Plots of the unscaled and scaled pitot tube velocity measured against the StratoLogger can be seen in Figure 6. Unfortunately, the scale was not able to be tested on other flights due to a lack of data on the K flight.

Figure 6 - Unscaled Velocity Curve (left) and Scaled Velocity Curve (right)

Per the StratoLogger, the max acceleration was 515 ft./s². Interestingly, the pitot tube data was smoother than the StratoLogger data. This is likely because the StratoLogger calculates velocity

using the derivative of altitude with respect to time, and the pitot tube calculates velocity directly using measured quantities. The pitot tube detected a higher acceleration earlier into flight, but both velocity measurements matched closely after motor burnout, which was where the velocity measurements were maximized. The pitot tube received low readings toward the end where the actual velocity was low because the pitot tube design was built to read higher velocities and was not as accurate at lower speeds. Flight data after apogee is not shown because the pitot tube could not accurately measure dynamic pressure.

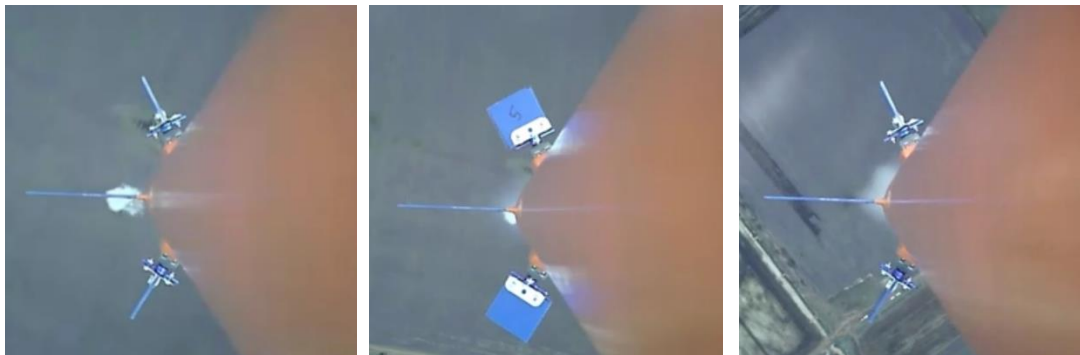
Throughout the motor burn, the rocket went straight up, with no obvious deviation from its trajectory. This, along with the video displaying two of the three flaps maintaining orientation is deemed reasonable evidence to support that the flaps were not activated whatsoever during burn, and that rocket geometry was maintained. The flaps can be seen in Figure 7.

Figure 7 - Flaps After Motor Burnout (left), Flaps Activated (middle), Flaps Retracted (right)

Approximately a second after motor burn concludes, the flaps activate. The flaps were set to activate 850 ft. above ground level. Per OpenRocket simulations, this was approximately 30 ft. above the predicted altitude at motor burnout. The simulation was slightly higher than actual, however, so the flaps activated later than expected. This slight change may have been crucial to the active drag. Right after motor burnout, maximum velocity is achieved. Higher velocity means more drag to lower the rocket's apogee. This critical period was missed, so the apogee is higher than expected. What was also noticeable from the video and flight itself was the minimal amount

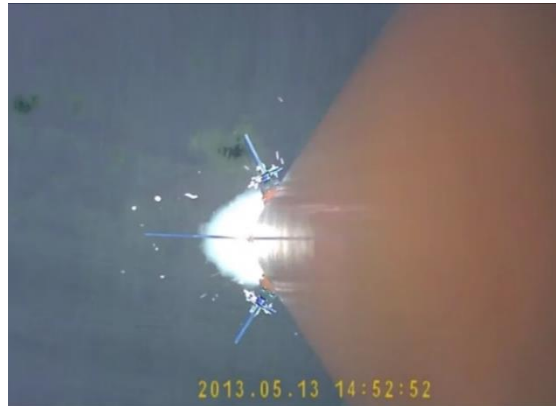
of deviation from trajectory and minimal rotation. Some rotation was predicted because of the way the flaps must rotate, which could induce a torque on the rocket. This torque appears to have been negligible since in the video, the rocket rotates only slightly. The same goes for at flap retraction. The process of deployment and retraction is shown in Figure 8.

Figure 8 - Downward View During Flight on the K1103X Motor

The only video the team obtained was a downward view from the launch on the K1103X motor. This video showed off many aspects of the rocket launch, including ignition, burnout, drag deployment and retraction, coasting, and parachute deployment.
