Northwestern University
2145 Sheridan Road
Evanston, IL, 60201

Flight Performance

Flight Trajectory Assessment

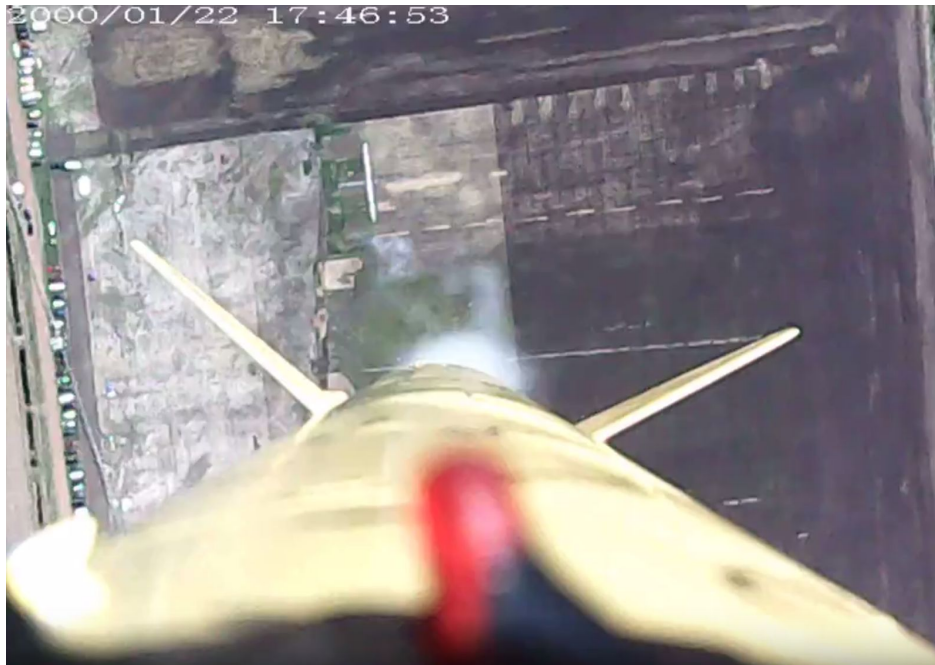
Figure 3

For flight 1, there was interrupted footage of the rocket's flight. The first video shows the rocket right as it is lifting off. The second video shows the last few seconds of flight before burnout. These few seconds are more descriptive of the rocket's movements. The rocket starts by holding its position and then it rotates approximately 15 degrees to the right (Figure 3). It then immediately rotates back to its original position (Figure 4). This shows that even though the wind caused the rocket to rotate during flight, the rocket was able to successfully autonomously self correct during the flight. Unfortunately, only the middle LED was captured during the first video. It seems to be off for most of the rotation and sort of turns back on when it stops.

However, the sun glare makes it difficult to determine if the light is on or off (Figure 3). Overall, flight 1 was consistent with its task of autonomously self correcting during the first flight.

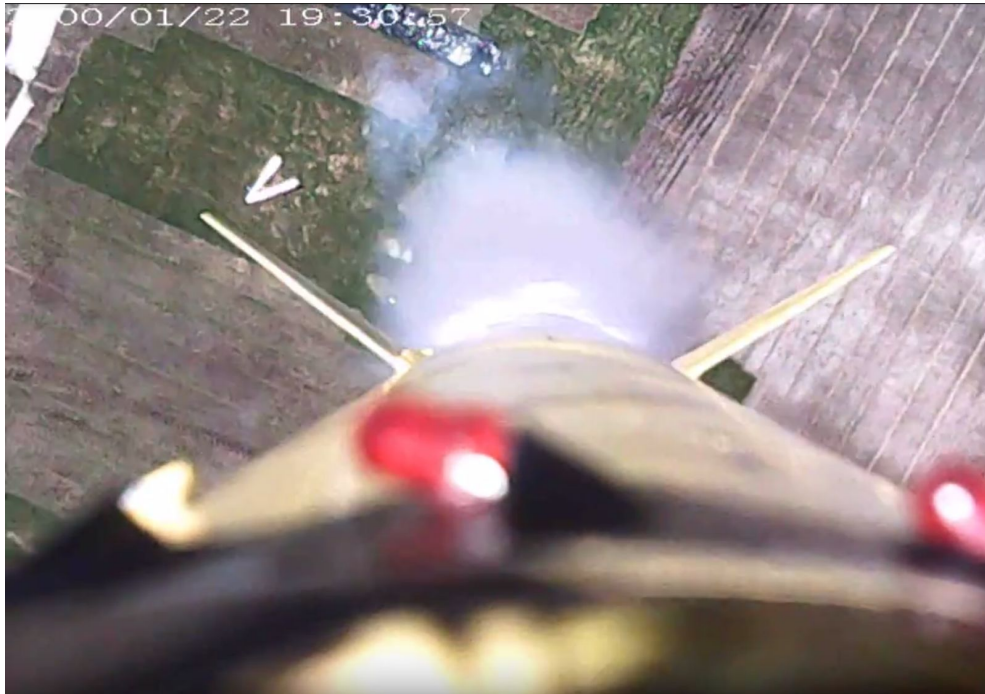
Figure 5

For the second flight, the flywheel system successfully held the first command for the entire flight. The middle light was on almost the entire time. The sunlight made it difficult to see what

color the LEDs were, however, in Figure 5, the shadow from the rocket shows that the middle LED light was on when the rocket was going straight up. The rocket was commanded to hold four different commands after the flight. However, the video shows that the rocket appears to have gotten stuck on the first command and not rotated at all during the flight (Figures 5 and 6). This is consistent with our LED light system because the middle LED was on and the rocket was not rotating. However, the rocket should have been rotating, therefore the video results and the given commands are not consistent.
