# Bulldog Rocketry

## Flight Readiness Report

2016-2017 NASA Space Grant Midwest  
High-Power Rocket Competition

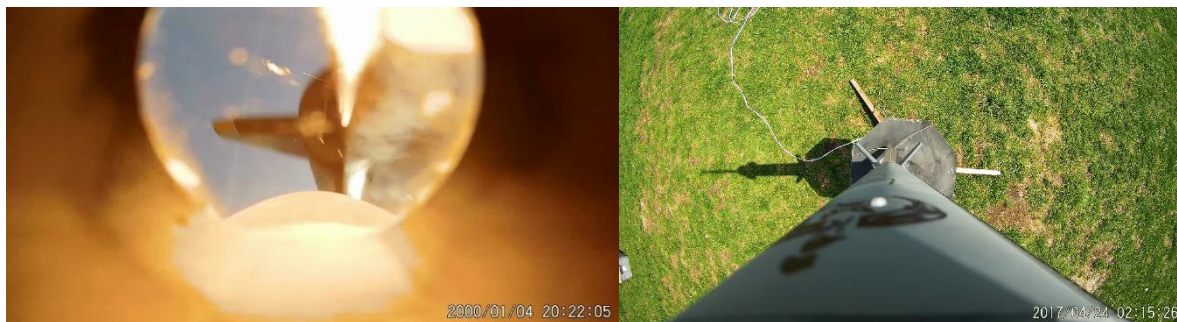
**Figure 11: Upward and downward facing camera views.**

The cameras role is to sense and log airframe separation and parachute extraction from the airframe for both drogue and main parachute deployments. The cameras also collect up and down video from outside the airframe to certify expected (i.e. primary, not backup) drogue and main parachute full deployment. In order to record quality reliable video, two 1080p cameras were selected, each with built in battery and enough memory to operate independent of the other electronics. The reason for using two cameras is to have redundant recording and to balance the rocket. Having no wires running to the camera allows the video to be taken from almost any location on the rocket. The view angle and distance were selected based on the camera's field of view and the aerodynamics team's choice of location. Figure 11 shows the upward and downward views. The picture on the left is when the bottom portion of the rocket passed over the nose cone (yes it's strange but the team will discuss it later) and the picture on the right is of the downward camera on the launch pad.

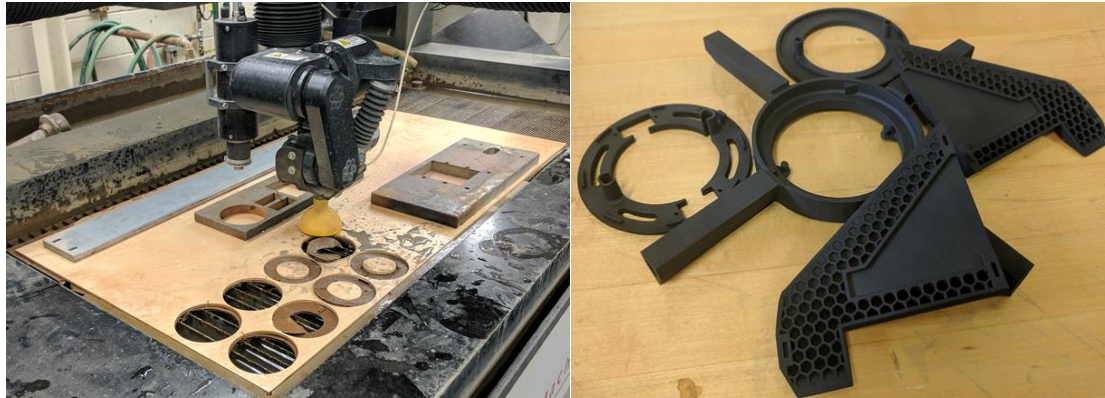
**Figure 12: Centering rings being waterjet cut from aircraft grade 3/16 inch birch wood. The 3D printed parts made from Carbon Fiber filled Nylon 11.**

The engine mount consisted of seven centering rings and two aluminum threaded rods. The team manufactured centering rings from 3/16 inch thick aircraft grade birch wood. The wood is very light and contained no imperfections which made it ideal for rocket construction. The centering rings were slid onto the threaded rods and secured in their proper location by aluminum nuts. Red Loctite was used to ensure that the nuts would never move. The fins were test fitted into the centering rings slots multiple times. The entire assembly was test fit into the body of the rocket multiple times before it was epoxied and inserted to ensure precise alignment. The entire exposed body tube of the rocket was filled with body filler and sanded multiple times to hide any of the spirals that come with blue tube.

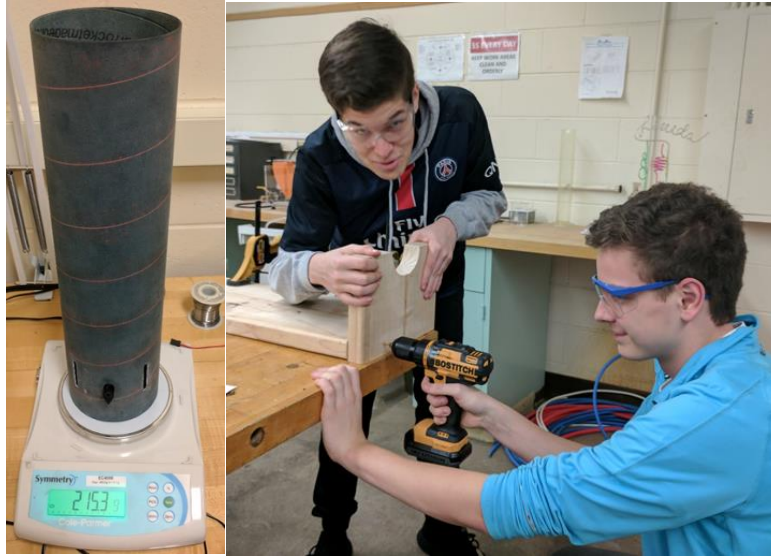
**Figure 14: The rocket body being weighed after the body filler has been applied and sanded. Nick and David assembling the rocket work stand.**

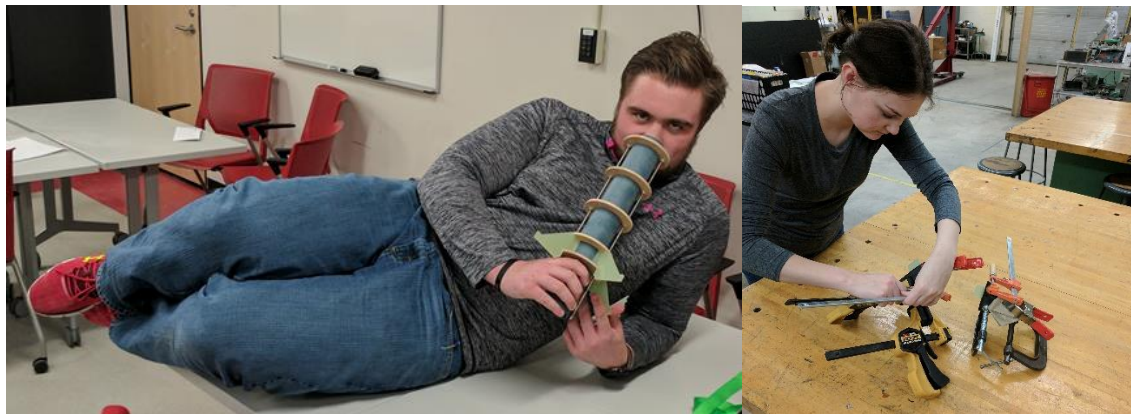
**Figure 15: Logan (future President) inspecting the alignment and spacing of the centering rings and fin tabs before inserting the engine mount into the body. Courtney clamping the fin prosthetics together after epoxying them.**

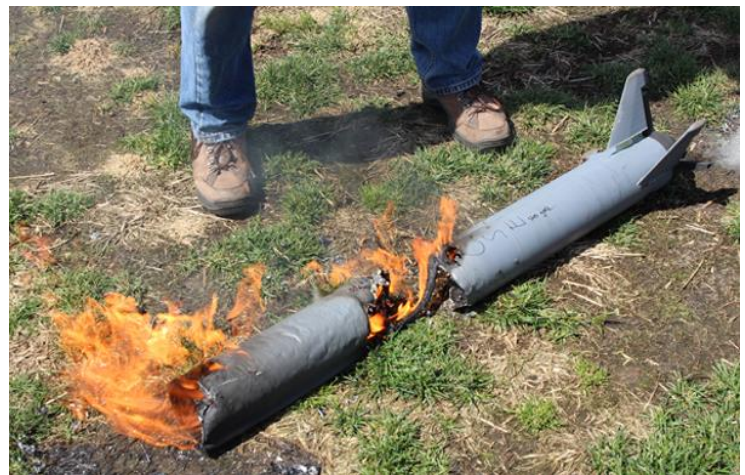
**Figure 17: Flaming rocket after test flight one.**

and cameras were not damaged due to the separation, the rest of the rocket was completely destroyed by hot fire. The hot fire can be seen destroying the airframe in Figure 17.

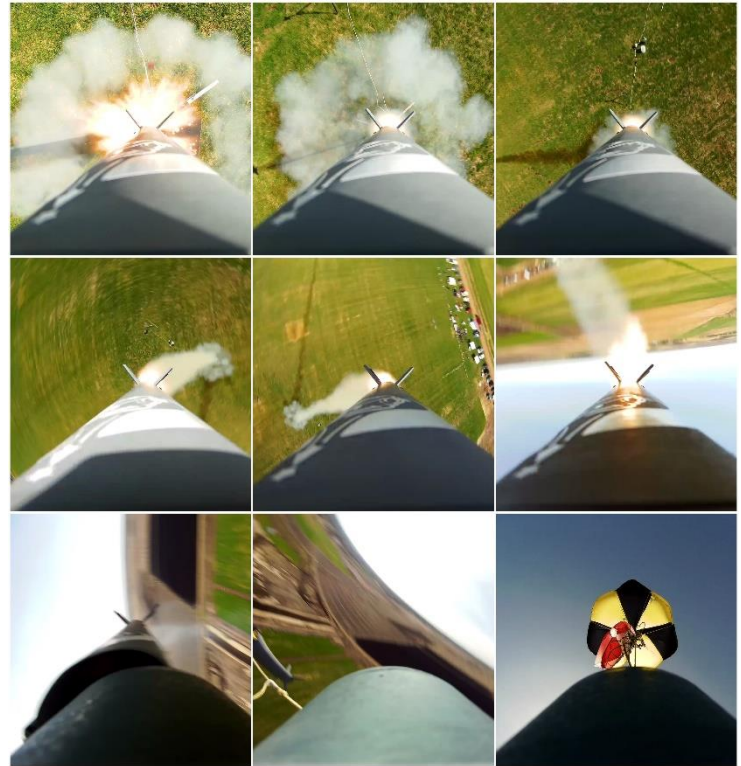
Figure 18: Flight two aerodynamic instability causes early deployment.

The team worked diligently to completely rebuild the rocket in 5 days so they could complete yet another test flight on April 29<sup>th</sup>, unfortunately the second flight didn't go much better. The second flight was with a Cesaroni K2045. The first half of the boost phase went well, but as you can see in Figure 18 the rocket began to pitch downwards due to aerodynamic instability caused by the doghouse. After the rocket was perpendicular to the ground the nose cone separated at 116 meters due to a pressure differential created by the massive change in direction during the boost phase. The shock cord passed by the nozzle and separated the upper and lower portion of the rocket but not before zippering the lower portion of the rocket. The lower portion of the rocket free fell back to earth and hit the ground causing the fins to separate from the airframe. The avionics bay deployed under a tangled main parachute but landed softly. The progression of the flight can be seen in Figure 18.

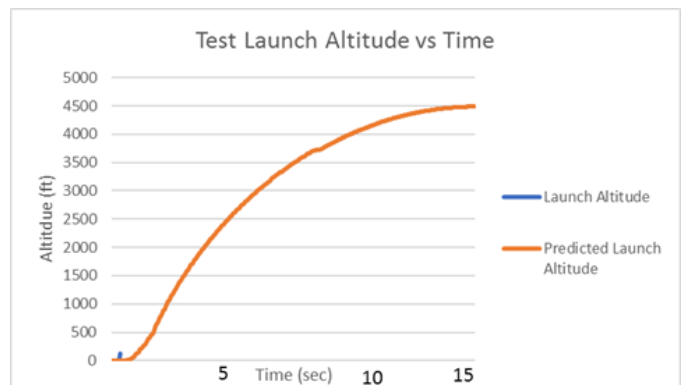
Figure 21: Test flight two altitude vs predicted altitude.

The second flight did not reach its predicted altitude. Subsequently, there is a massive amount of error in the graph. This is because there was an instability in the design of the rocket. Also, the amount of force caused the avionics package's mounting hardware and wire connections to fail. This caused the loss of power and subsequently the loss of data. Going forward with both issues being fixed the team plans to achieve the predicted altitude of 1311 meters.

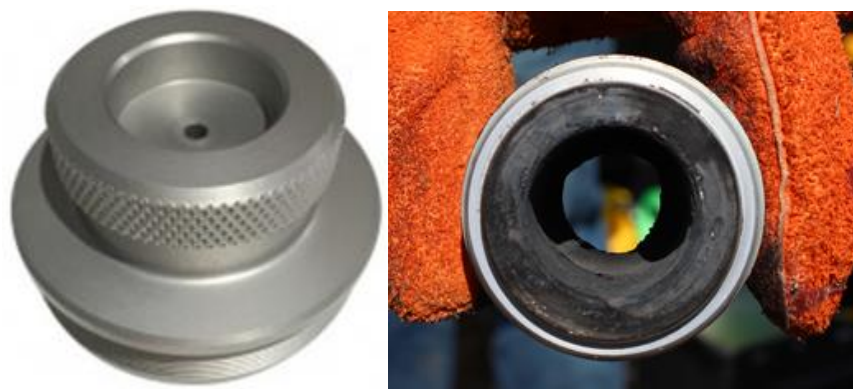
Figure 23: AeroTech Forward Closure (Left), AeroTech failed Forward Closure (Right).

On 4/23 the UMD rocketry team performed a test flight using an AeroTech J135W-14A as the first of two potential test flights. Immediately upon ignition on the launch pad an engine failure caused the rocket to separate and burn from both the top and bottom of the engine. The team believes this was due to a failure of the forward end closure of the AeroTech motor (23). This caused the engine to burn both downwards and upwards which forced the piston to eject the recovery system and avionics bay. The entire lower portion of the rocket needed to be rebuilt, including the entire engine assembly, the center brake ring of the air-brake, and the recovery system housing tube. The fins, avionics, top and bottom centering ring for the air-brake, the drogue parachute, and the main parachute were all salvageable. The team was able to rebuild the entire rocket in only 72 hours. This swift recovery time is attributed to the team's quick action to salvage parts and their foresight in planning material purchases for this possibility. Twice the amount of necessary building materials was purchased ahead of time in the event that something disastrous like this were to occur.

After considerate flight analysis it was determined the failure was due to a defect in the forward closure of the AeroTech motor itself and not to any failures in the teams design. For this reason, no additional changes were made to the original design when the rebuild was done.
