ROCKETDOGS

## POST FLIGHT PERFORMANCE REPORT

University of Minnesota Duluth

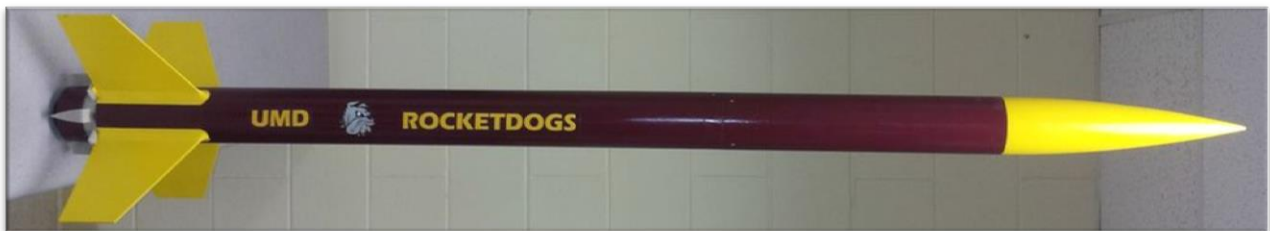
The final design of the rocket is a 3 in outer diameter, 65.63 in length body with a one-time deployed air brake built weighing 6 lbs. The rocket was constructed using components purchased from reputable high powered rocketry suppliers. An Arduino microprocessor uses in-flight data sampled during flight to electronically deploy the air brake based on a developed flight model. The final assembled rocket is shown below in Fig. 1.

Figure 1: Assembled Rocket

The air brake, made using a selective laser sintering process from glass impregnated nylon, is designed as a tear drop shape located behind the rear fins when in the undeployed position. When activated, solenoids release a spring loaded section which separates the teardrop into two parts and exposes flat surfaces normal to the rocket's flight path in order to increase drag. The recovery system consisted of a single 60 in. rip-stop nylon chute deployed by black powder canisters deployed electronically at apogee, and was designed to employ a delayed motor backup ejection, if required.

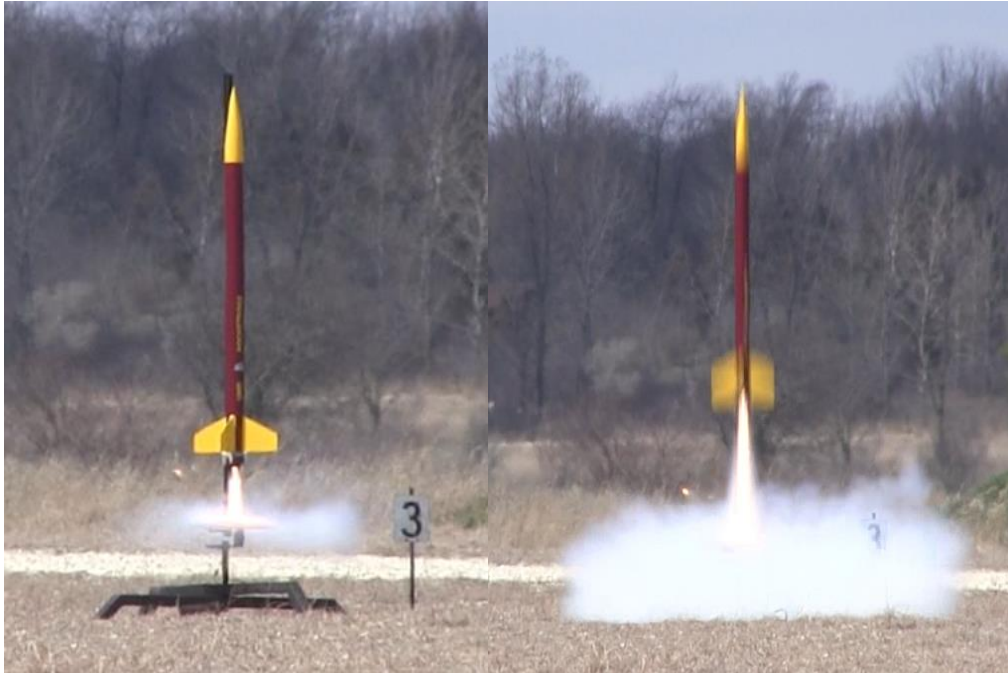
The RocketDogs team launched twice at the competition. The launches were within 125 ft and 115 ft of the desired apogee and recovered in flyable condition. The launches themselves will be discussed in detail in their own sections. Figure 2 shows the rocket leaving the launch rail during the first launch.

Figure 2: RocketDogs Rocket Leaving the Launch Rail

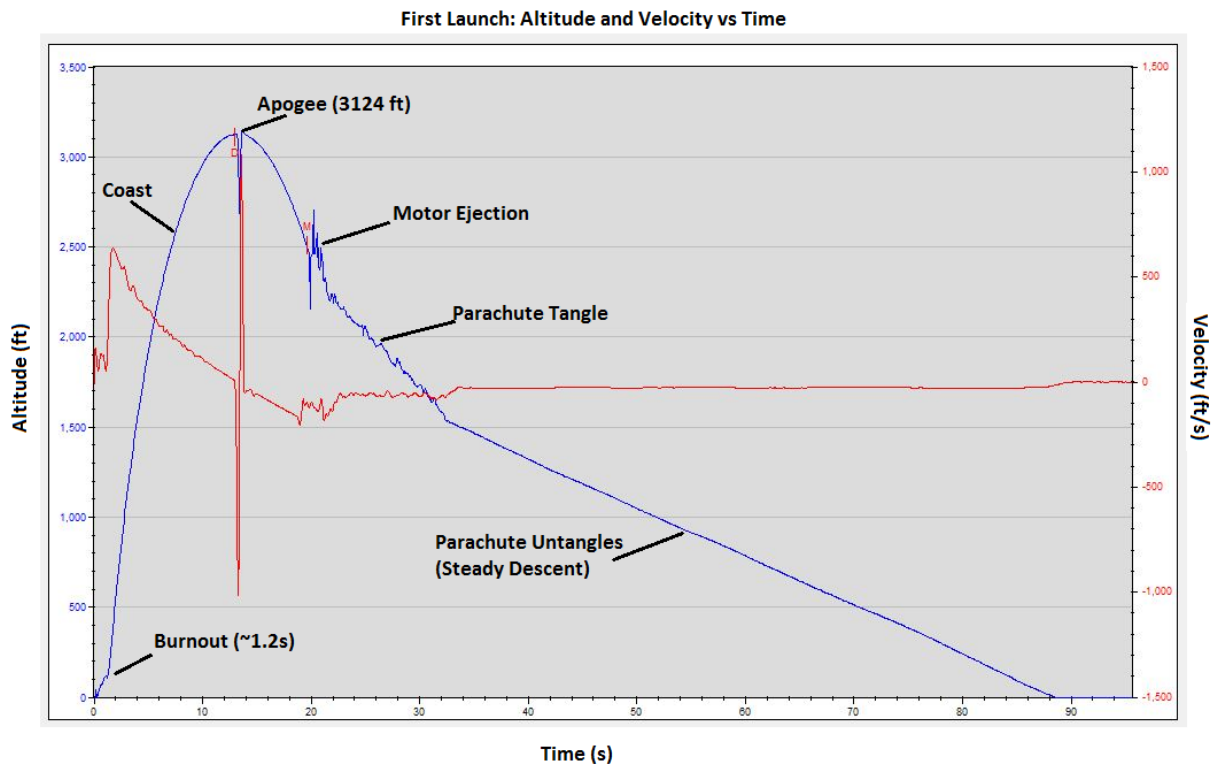
The first launch used an I540 motor and the target was to reach an apogee of 3000ft. Shown in Fig. 3 is the graph of the data collected by the PerfectFlite SL100 StratoLogger altimeter during the flight. The graph displays the altitude above ground level (AGL) and the instantaneous velocity plotted against time through the flight, as well as when the altimeter deployed the parachute. Of note is the discontinuity of the data at the apogee of the flight. This discontinuity is caused by the altimeter firing ejection charges when the rocket reaches apogee, causing an increase in pressure to separate the rocket and release the parachute. Due to a failure to ignite both canisters of gunpowder, the rocket did not separate at apogee as intended. Instead, the parachute deployed under the pressure from the backup motor ejection 4 s later. The unstable descent of the rocket begins at approximately 20 s. The cause of this instability was the

parachute being deployed after apogee and then becoming tangled in its own chords. The parachute fully deployed at approximately 32 s, providing a smooth final descent.

Figure 3: Graph of first flight, StratoLogger data, altitude (blue) and velocity (red) vs. time.

Shown in Table 1 are the key parameters extracted from the first rocket flight, both simulated and measured. The apogee of the rocket was recorded by the Raven III altimeter at 3124 ft, or 124 ft away from the intended height. The primary reason for this error is due to the air brake never deploying in flight; it was discovered during post-flight inspection that a wire had seemingly become disconnected during the assembly process. The disconnected wire was supposed to be connected to the solenoid for deploying the air brake; therefore, the air brake could not deploy when needed. The calculations found an apogee of 3140 ft if the brake did not deploy and if there was no wind whatsoever. This is 16 ft above the recorded apogee for the first flight, with wind speeds of approximately 10 mph. Also of importance is the descent rate of the rocket being higher than predicted. This was the result of the parachute not completely open due to an entanglement issue with the shock chord.

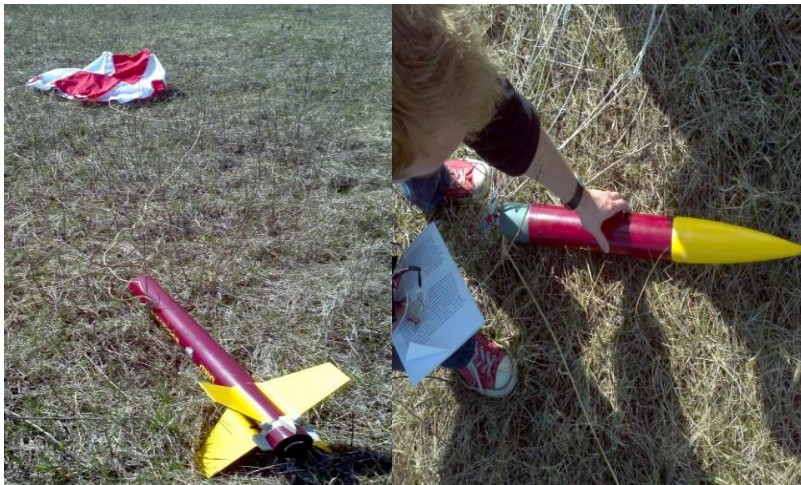
Figure 5 shows the recovery of the rocket in the field. The rocket is structurally sound with no parts critically damaged.

Figure 5: Field Recovery of the Rocket

The photographs show the lower half of the rocket in one piece and in good condition. The rocket also did not drift far from the launch pad. Figure 6 shows the approximate location where the rocket was recovered for each flight.
