UNIVERSITY OF NEBRASKA-LINCOLN
2017-2018 MIDWEST HIGH POWER ROCKETRY COMPETITION

Husker Rocketry Post Flight Performance Report

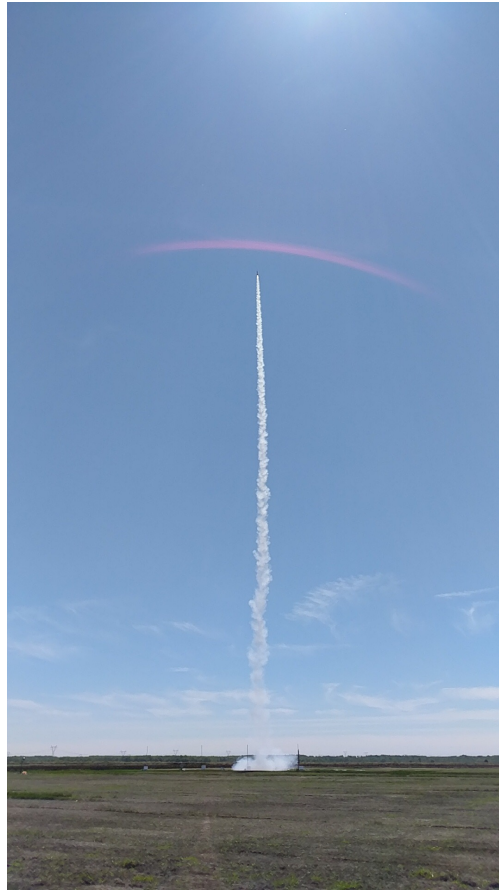
Figure 1: ACROBAT ascending during flight 2.

For the second launch, the wind had shifted to the south and had a lessened influence on our flight and recovery. The smoke trail was identical to the previous flight, with the trajectory being equally stable but more vertical.

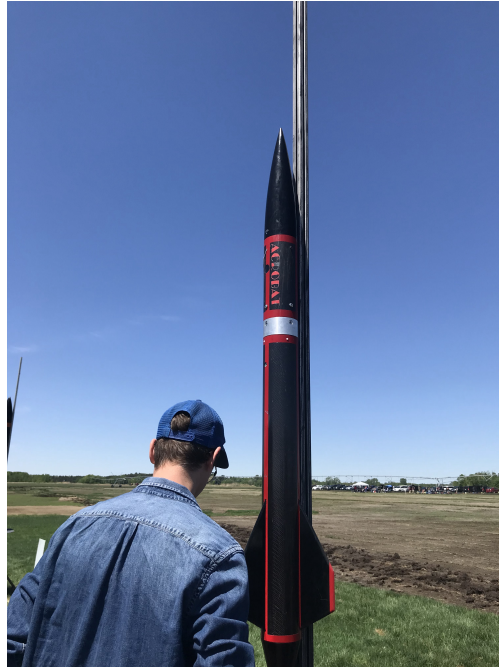
Figure 2: ACROBAT on the launch rail.

The pre-launch procedure was followed with only a few adjustments that needed to be made. A test rail was used to make sure the rocket would easily slide on the launch rail and clear the bolt heads. It was found that the upper button did not slide on the rail. A new button was installed which allowed the rocket to slide more easily on the test rail. The old button was probably overtightened which squeezed and deformed the plastic.

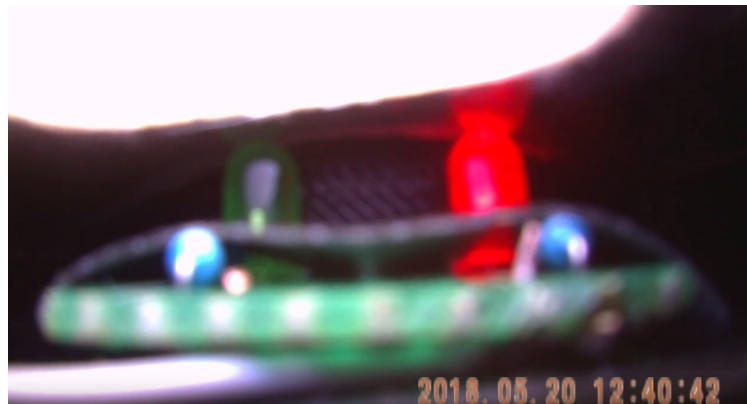
Figure 6: Camera View from flight 2

The camera used for collecting flight footage is mounted behind a curved polycarbonate window within the AV bay. Due to this mounting system, the camera focus can be severely affected, having a dramatic effect on video quality. The video from the second flight shows that the sunlight being refracted through the window is bright enough to severely limit what can be seen in the camera footage. However, the roll maneuver LEDs can be seen in the footage regardless of the sunlight through the window, suggesting that this placement and intensity are effective to show the roll of the rocket. Cross-referencing the camera footage with the onboard data shows that the respective LEDs are being lit during roll and heading hold maneuvers.

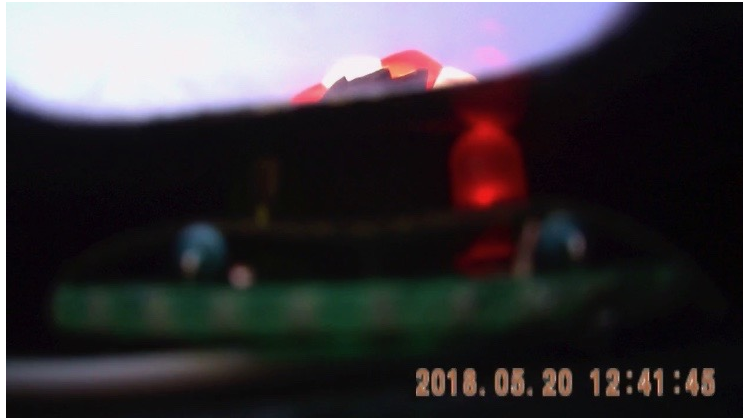
Figure 7: Camera View from flight 2 with parachute
