Flight Readiness Report

Wichita State University

Team RISE

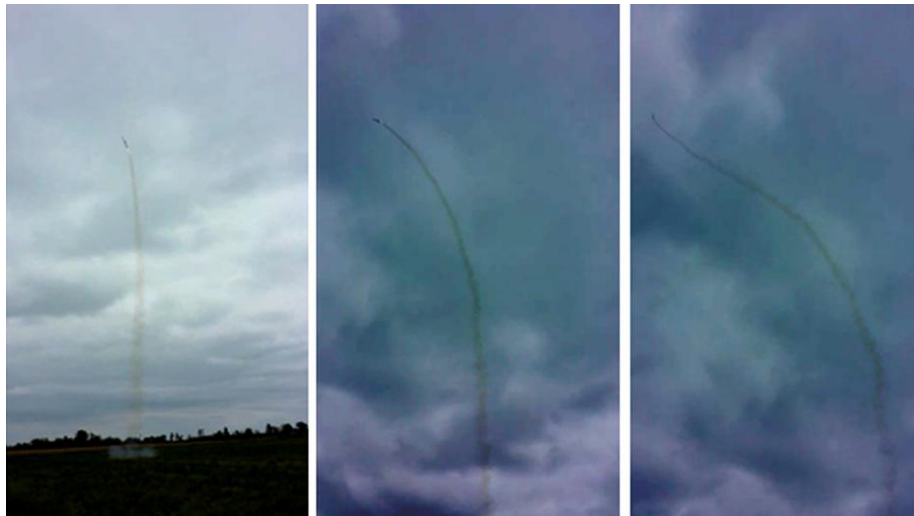
Figure 5. S-curve as seen in Flight 4.

Actual center of gravity and center of pressure locations matched our predicted values as a whole for each rocket configuration. Evidence of proper stability could be seen in all of our launches. In all flights (even in Flights 1 and 2 prior to premature separation) the rocket could be seen properly correcting itself as well as having appropriate reaction to any wind gusts. However, specifically in Flight 4, we saw that the rocket as a whole was very susceptible to wind. It was found that due to the lack of surface contact between the dart and booster sections the dart was allowed to move more freely than expected causing the nose of the rocket to change overall angle of attack resulting in a large S-curved flight path during propelled flight as seen in Figure 4. After burn out, both the booster and the dart continued in straight-line flight further showing that the cause of this disturbed flight path was not a lack of section stability, but a poor connection between sections. We were able to improve our flight path performance by improving this contact point prior to Flight 5; though there was a motor failure, this flight showed that no s-curve motion occurred during ascent.

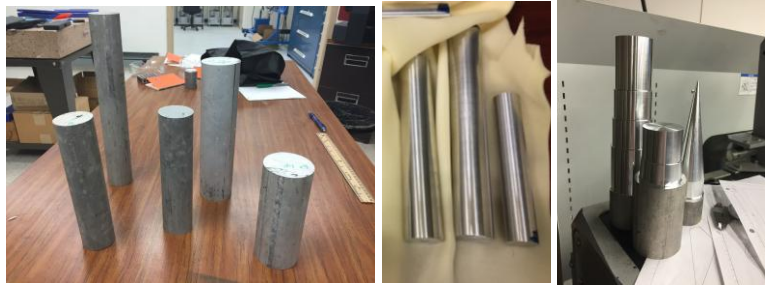
Figure 5. Solid T6061 Aluminum bars before (left) and after being lathed with a manual lathe (center) and CNC machine (right)

The mandrels for these parts were manufactured from solid T6061 Aluminum bars. Cylindrical mandrels for pieces like body tubes, pistons, couplers, etc. were machined on a manual lathe. Appropriate spindle speed was found to acquire a suitable surface speed of the material as well as a good feed rate for the cutting tool. Mandrels for complex shapes such as the nosecone, boattail, lip, drag chute petals, etc., were machined on a CNC lathe.

The code was written using the correct vernacular in Notepad where the tool was programmed to do an initial stair-step pattern followed by a straight tapered line for cones or a series of tapered lines for curves. Lathing efforts can be seen in Figures 5 and 6.

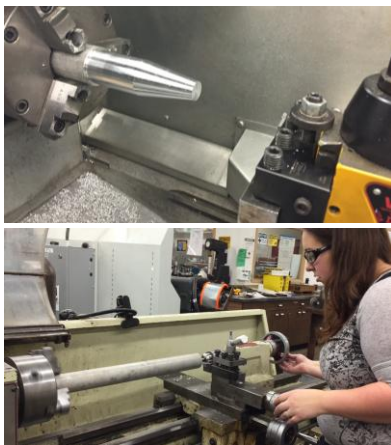
Figure 6. CNC machine (top) for transition and manual lathe (bottom) for body tubes.

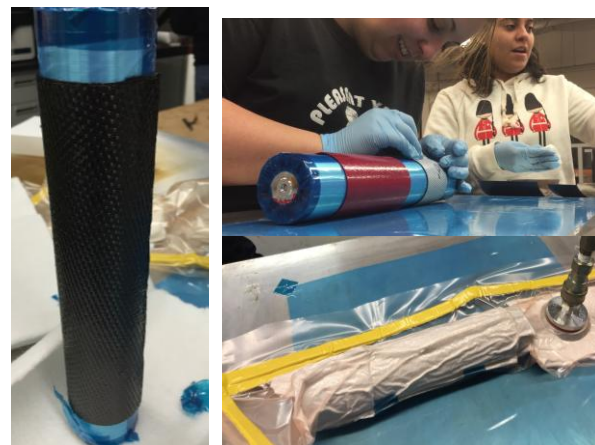
Figure 7. Body tube wrapped in carbon fiber (left), film adhesive (top) and vacuum-bagged (bottom).

Patterns for all the parts were cut from prepreg 53201-1 carbon fiber plies and FM-300 film adhesive. After covering mandrels with release agent and a release film layer, the two carbon fiber plies were laid-up on the mandrels and covered with the film adhesive. Each piece was covered with aluminum foil, breather material, vacuum-bagged and placed in the oven at $250 \pm 10^\circ\text{F}$ for approximately five hours. Finally, all pieces were sanded down to have a smooth finish and to ensure a perfect fit. Figure 7 shows the lay-up process.

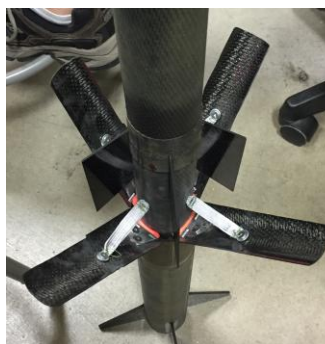
Figure 10. Drag chute assembly.

The fuselage pieces, couplers, pistons, motor tube, and bulkheads were assembled using epoxy. To construct the drag chute system, the cup structure was installed within the booster using centering rings and the hinges were attached with screws extruding from the outside of the fuselage into the cup structure. Earplugs were placed in between the hinges and body tubes to secure them in place since limited space prevented the use of nuts. Finally, elastic strips were installed first within the cup and then onto each petal securing it with washers, screws, and nuts as seen in Figure 10.

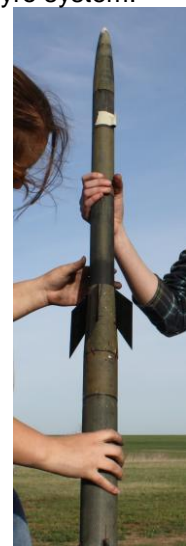
Figure 11. Dart-booster alignment.

booster, the payload bed and parachutes can be inserted. For complete rocket assembly, the dart is aligned and placed within the booster as seen in Figure 11.

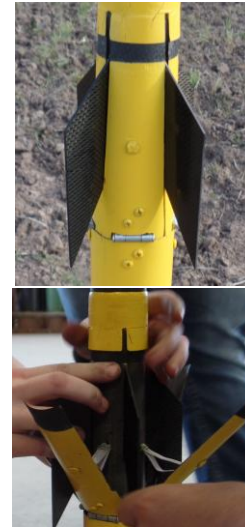
Figure 14. Drag chute
closed and deployed for
fifth launch.

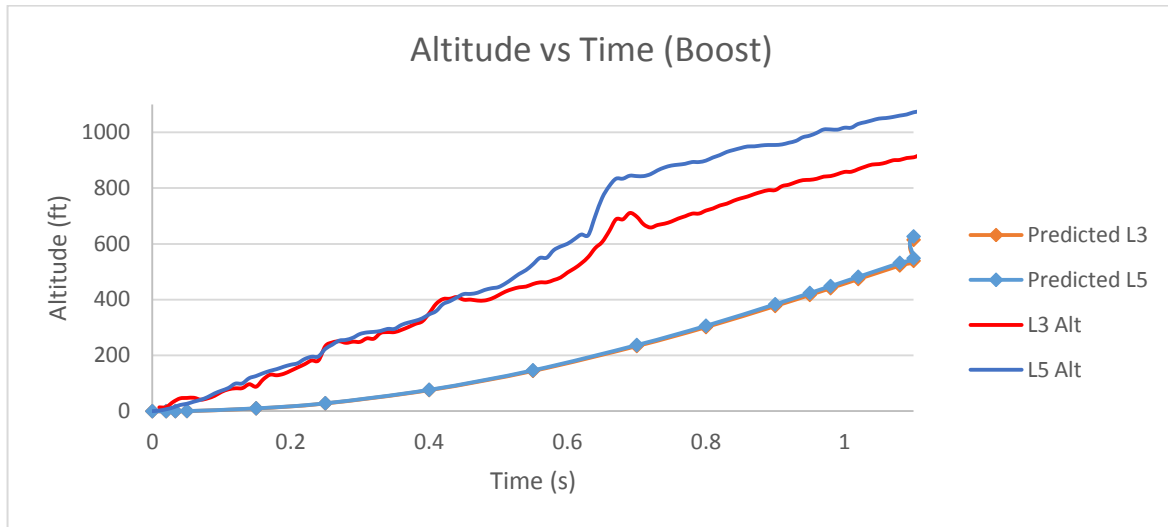
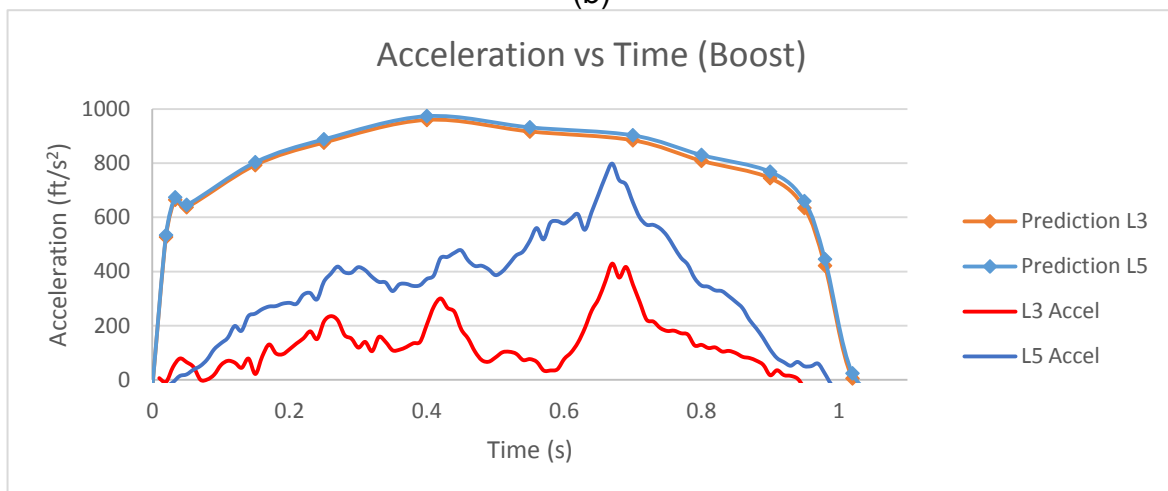
Figure 12. Boosted performance: (a) Altitude, (b) Velocity, (c) Acceleration.

During the third launch, the boost performance of the dart matched the predicted performance in many aspects. The maximum acceleration during boost was 827 ft/s².

The maximum velocity during boost was 621 mph or Mach 0.8. Separation occurred at an altitude of 911 ft. The boost performance is shown on the graphs below in Figure 12.

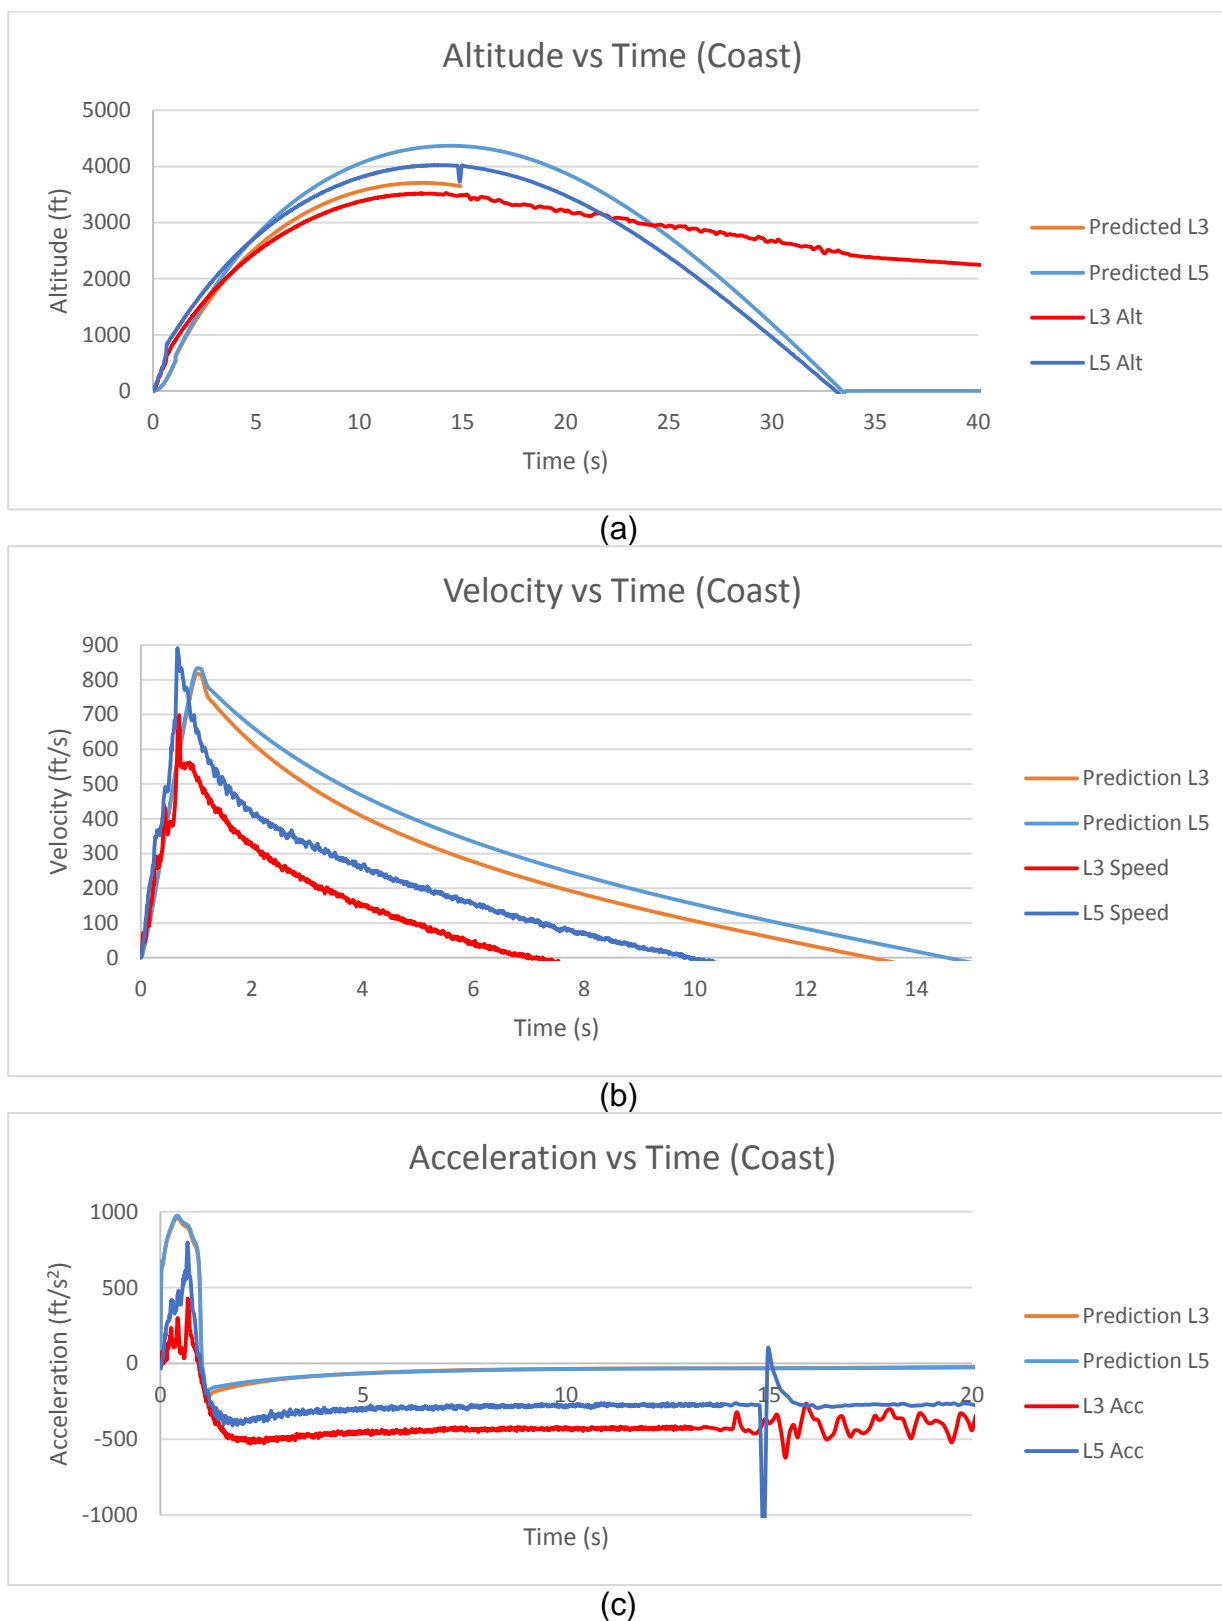
Figure 13. Dart performance: (a) Altitude, (b) Velocity, (c) Acceleration.

For Flight 3 during coast, the dart performed as predicted. The maximum altitude of the dart was 3726 feet and the maximum altitude of the booster was approximately 1900 feet. The total time of dart flight was 127.7 seconds. Coast performance is shown in Figure 13.

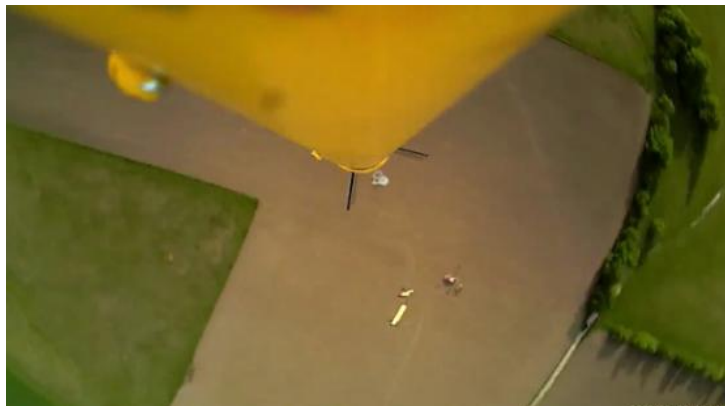
Figure 14. View from onboard camera.

On-board video was recorded with a direct downward view using the 808 Keychain Camera with a lens mounted externally to the dart using an extender ribbon cable. This camera records HD footage at 30 frames per second. The launch pad is visible during the entire ascent. Separation and dart parachute ejection could also be easily viewed in the footage. During a majority of the flights, the booster parachute ejection or other key events can also be seen as shown in Figure 14.
