Wisconsin Space Grant Consortium Regional Rocket Competition

Post Flight Performance Report

University of Cincinnati, Cincinnati, Ohio

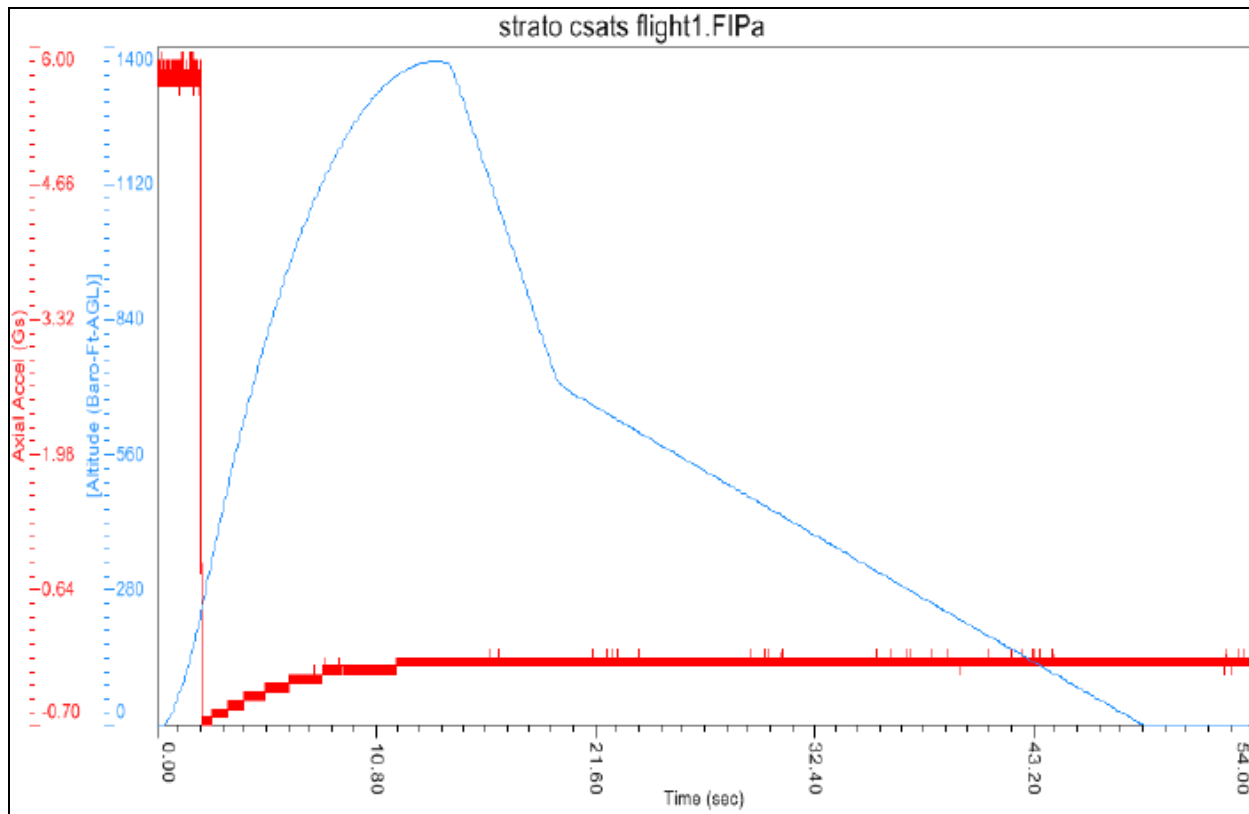
Figure 1: Raven Competition Flight Recorder Data, Altitude and Acceleration

The competition results presented are from two sources. The first source is the Raven altimeter supplied by the competition and shown in Figure 1. The second source is the SL100 Stratologger altimeter used as a backup as well as for ejection charges in recovery, shown in Figure 2.

Looking at both sets of data, it is evident the rocket did not reach a maximum altitude of 3000 feet. The max altitude from the Raven was 1372 feet, and was 1590 feet from the Stratologger. The rocket was expected to reach within the competition window of 2500-3500 feet, but did not reach more than halfway to the goal apogee due to unexpected issues during flight.

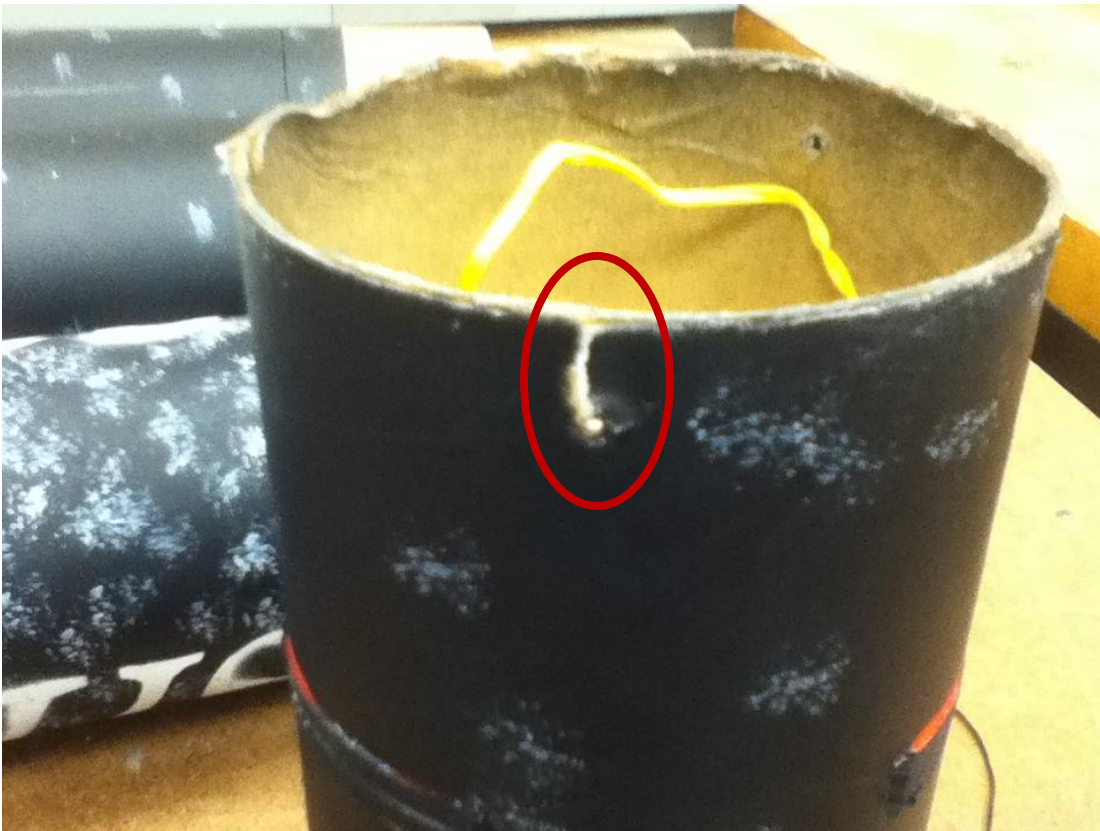
Appendix B

After burnout, disaster hit and ended the flight prematurely. The rocket separated in half above the air brake section; the rocket was modular so it was already a separate section, held together by a steel screw (See Appendix A and B). After the rocket split, the upper portion of the rocket and the lower portion tumbled about until the drogue parachute deployed at 650 feet, since the Stratologger calculated it was past what could be considered apogee, slowing and steadying the descent of the lower portion. The upper portion continued to descend in a wild manner until the main parachute deployed at 500 feet as programmed in the other Stratologger altimeter. Since both parachutes deployed, both sections were recoverable in order to assess the damage and deduce what happened. In addition to the rocket splitting in half, a fin was knocked off of the lower body tube during the tumble and ejection of the drogue parachute, and as the drogue parachute ejected, the force ripped the 3D printed mount for the air brake electronics in half, dumping them overboard (See Appendix C and D).

Reviewing the damaged rocket, it is obvious that one screw was not enough to secure the upper portion of the rocket to the air brake module. The screw ripped through the body, causing the upper portion of the rocket to separate from the lower. Looking at the Stratologger data in Figure 2 and recalling the events from the launch, the conclusion was made that the air brakes deployed after the 2 second delay for burnout, as was expected. As nothing else could have caused this separation at that time during the flight, it was concluded that the deployment of the air brakes had a stronger force than anticipated and ripped the modules apart. In the end, two or three more screws to secure the modules could have prevented this disaster by helping transfer the load, but ultimately, the strength of the material of the rocket body was to blame.

Picture of Damage to Airbrake module: Location of Failure.

modules consisting of thin cardboard held together by one screw at the location of the majority of load transfer during air brake deployment was an engineering oversight and the cause of disaster for the rocket flight. As a result, the rocket was recovered, but was damaged enough to the extent where repairs in the short amount of time left in the competition were not possible to try for a second flight. In the end, the rocket did not reach the expected 3000 feet, but fell short by under half of the goal apogee. Lessons learned include verifying that if the design is modular, important load paths need to be reinforced, and the load will be distributed evenly instead of in a concentrated area.

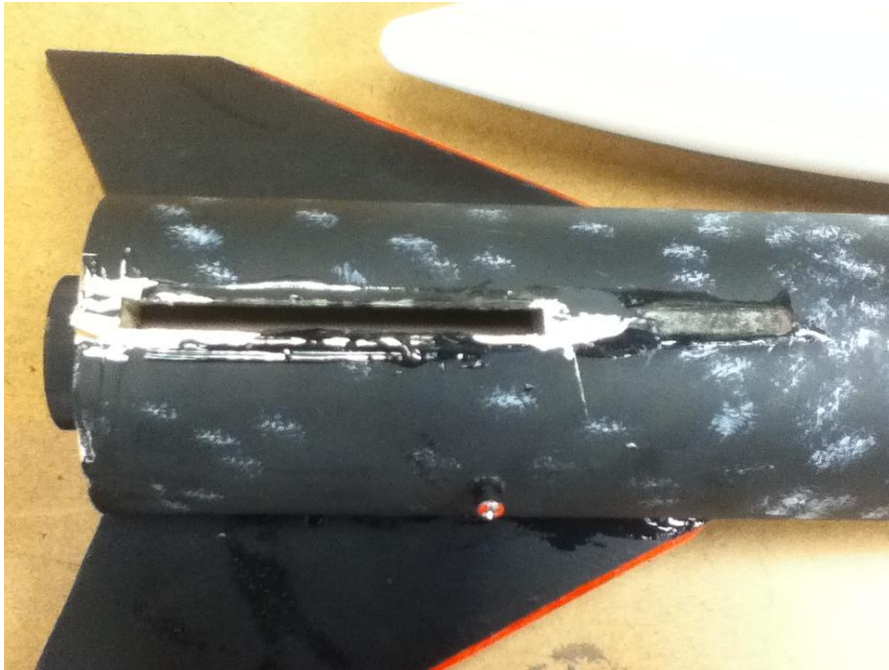
Appendix C

Picture of Damage to Lower Body Tube: Fin Damage.

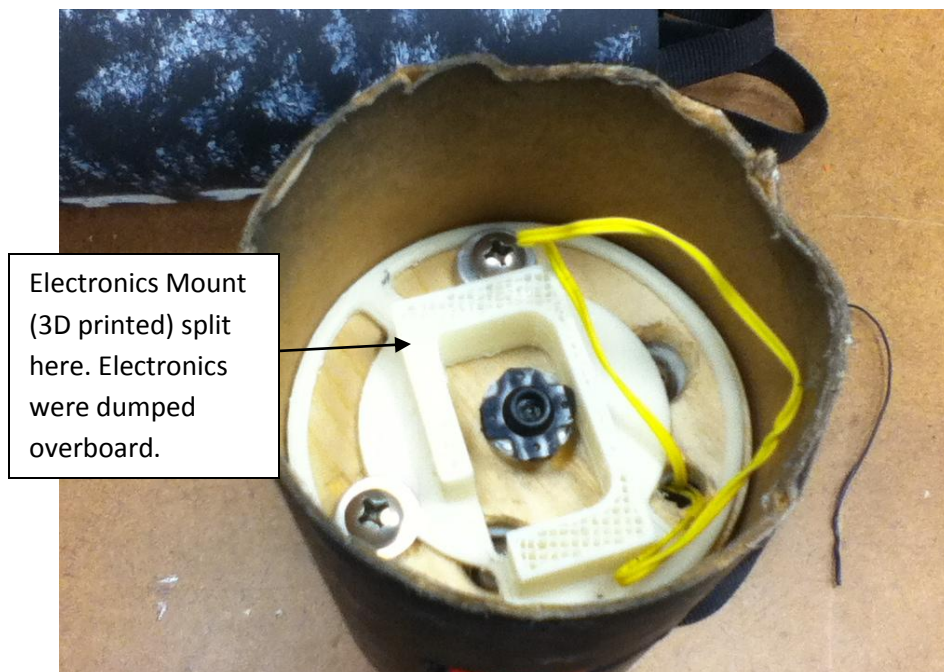
Appendix D

Picture of Damage to Airbrake module: Electronics Mount Damage.
