Space Hardware Club
University of Alabama in Huntsville

Team Air Mail

Post Flight Report

2014-2015 Space Grant Midwest High-Power Rocket Competition

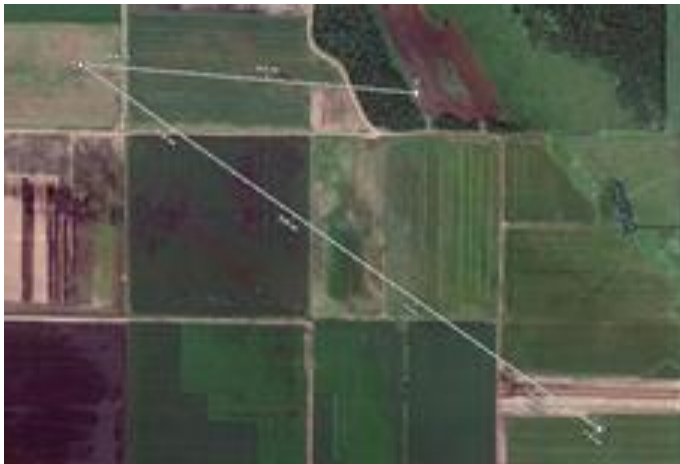
Figure 2: Flight Distances Overhead view of the launch sites and landing sites of the booster and dart using Google Maps

The booster was found just on the other side of a group of trees due east of the launch pad. Using Google Maps, the booster's distance from the launch pad has been determined to be 0.45 miles. The dart landed past the booster in a southeast direction. It landed 0.85 miles from the launch pad. Both stages of the rocket were intact and easily recoverable.

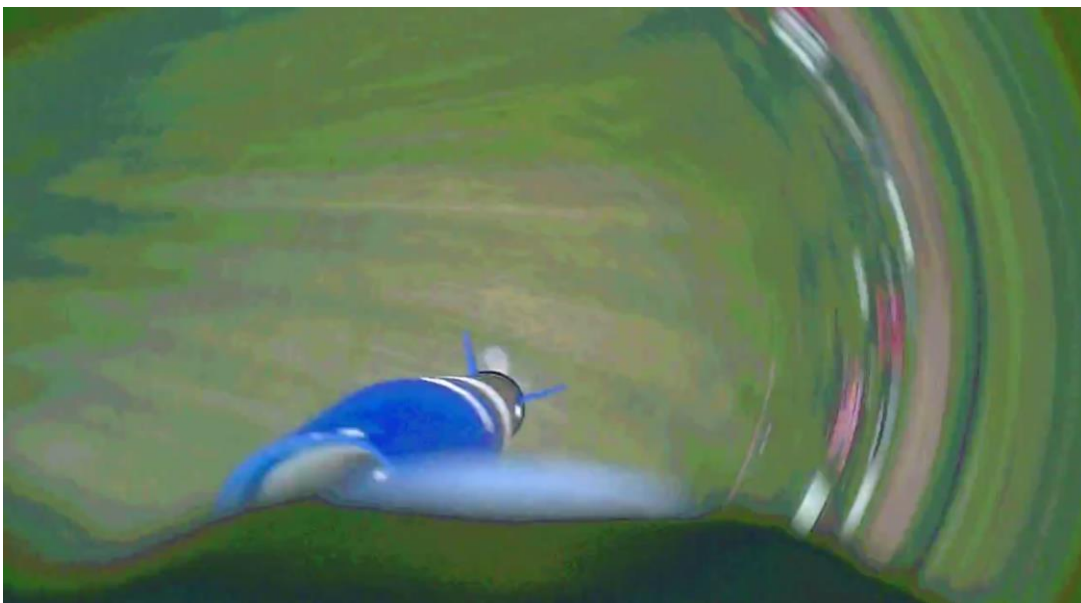
Figure 6. Separation. *A still from the recovered video from just after the booster and dart separate.*
