Post-Flight Performance Report

Roaring Lions

Normandale Community College

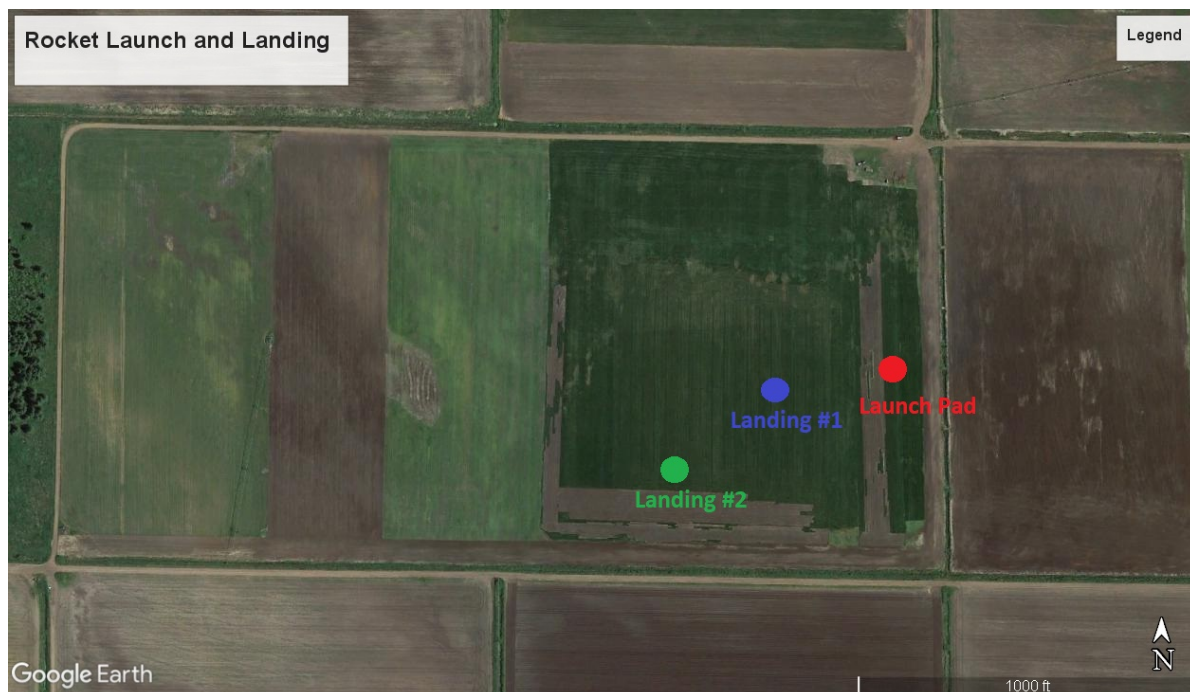
Figure 2 - Rocket launch and landing locations

Both launches had similar characteristics and propelled the rocket at a slight angle in the northeastward direction. The rocket continued to coast in this direction after the motor completed its burn phase. In the video from the second launch, the rocket rolls about seven times before reaching apogee. Once at apogee the drogue parachute deployed and the rocket began drifting southwest. The rocket continued to drift in the same direction after the main parachute was deployed. In both launches, the rocket eventually landed in the field in front of the spectating area just west of the launch pad.

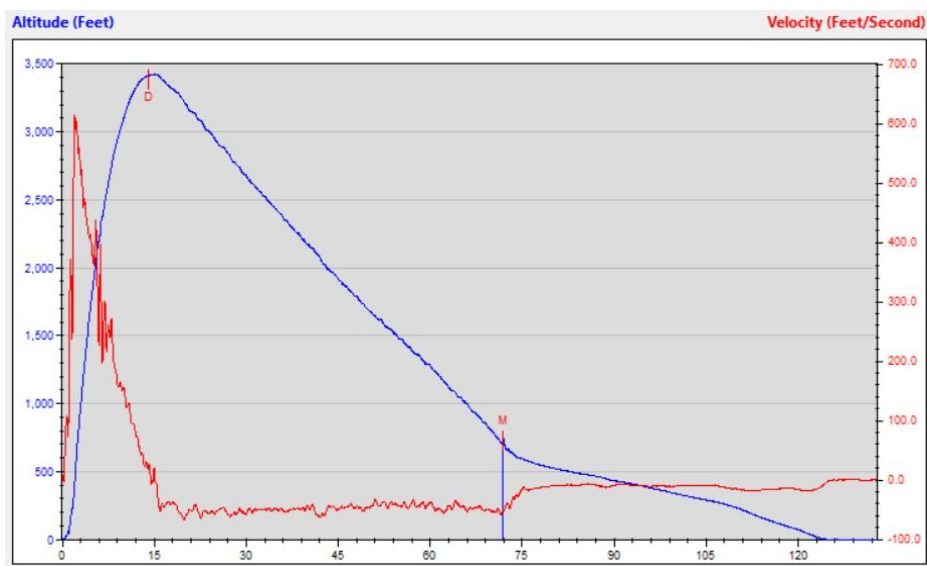
Figure 4 - Stratologger data plot of launch #1

Both of our flights were nearly identical in performance and recorded a peak velocity of approximately 645 ft/s 1.75 seconds after liftoff. Our coast period lasted 11.85 seconds and our two flights achieved an apogee of 3420 ft and 3406 ft. The drogue chute was deployed and the rocket descended at an average 48 ft/s to 700 ft where the main chute was deployed. Following main chute deployment, average descent speed decreased to 12 ft/s until landing shortly thereafter.

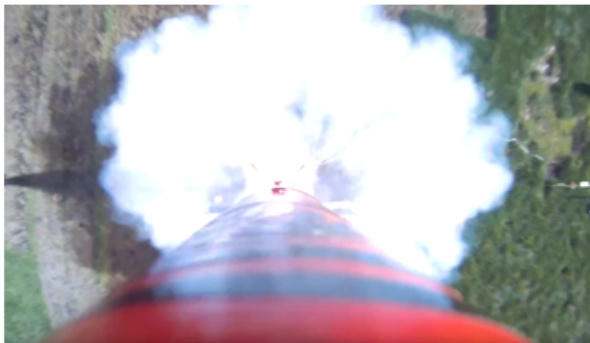
Launch

The rocket was fitted with one FireFly Q60 video camera which was housed in a 3D printed unit attached to the main parachute bay. The camera was oriented to face downward so the roll system and drogue deployment could be easily monitored. On the first launch, the camera was set to take pictures instead of recording video. One picture was taken of the rocket sitting on the launch pad. This mistake was corrected before the second launch and changes to the procedure were implemented. During the second launch the camera was monitoring the three LED lights mounted below the avionics bay. In the video the lights were difficult to see and no real data could be collected from them. Images taken from the second launch are posted below.
