# **Illinois Space Society Space Jam**

**University of Illinois at Urbana-Champaign**

**NASA Space Grant Midwest High-Power Rocket Competition 2014-2015**

**Final Design Report**

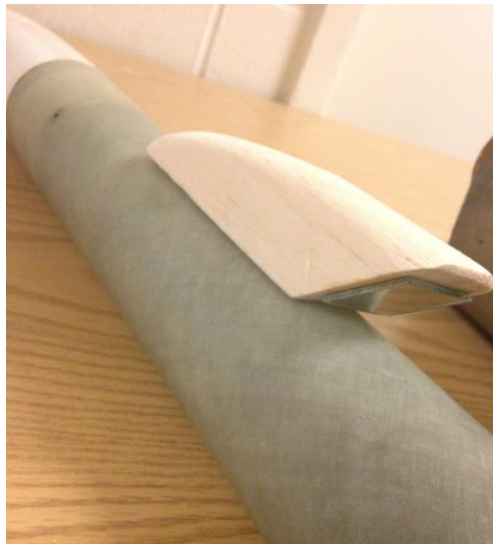
One change that is being made regards the method of retrieving downward facing video coverage. The team came to a conclusion that the best way of getting great footage was to attach a mirror shroud on the outside of the body tube. Essentially, the mirror shroud will work like a periscope. The camera will look straight out of the body tube horizontally at a mirror and the image will redirect downwards. The mirror will be attached to a block of balsa wood that has been sanded down to be as aerodynamic as possible to minimize drag. Unfortunately, this shroud was not placed on the rocket by the time the practice launch arrived, though the shroud had been constructed. One challenge that will face team before the competition is successfully situating the camera itself inside the rocket. The massive forces of the motor thrust, as well as the shock caused by the sudden ejection of the streamer and parachutes in the dart section would be substantial enough to dislodge the camera from its mount inside the tube. Thus, the team has considered using zip ties, tape, and/or epoxy to secure the camera horizontally pointing towards the mirror.

**Figure 8.** Mirror shroud (periscope) for the camera to take downward footage

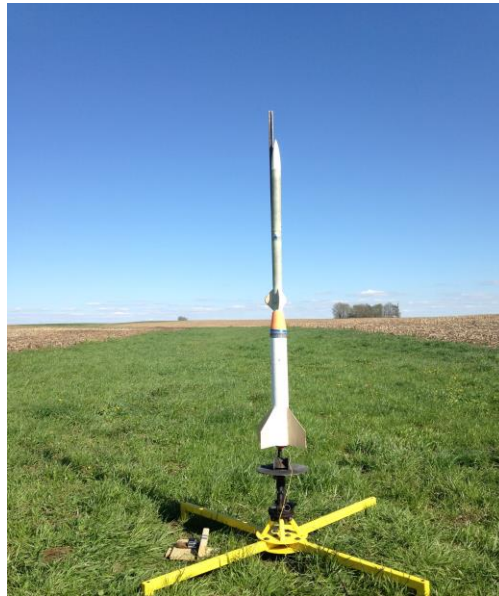
**Figure 9.** The boosted dart rocket on the launch pad prior to launch

After the rocket was assembled at the launch site, it was put onto the launch pad. High winds of about 10-15 mph were making the boosted dart sway on the pad and those winds indubitably hampered the flight of the rocket. The team lowered the rail, carefully passed the rail buttons through the rail, lifted the rocket to the upright position, inserted the igniter into the motor, and connected the lead clips. On the launch pad, the booster sat nicely on the launch pad but the dart seemed a little tilted on top of the transition piece. This could have been because the ground was unlevel. For the competition launch, the team will make sure to secure the dart as vertical as possible by adding a centering ring inside the transition piece and wrapping the tailcone with a thin layer of masking tape to make the fit tighter. Even though the dart was a little tilted towards one way on the launch pad, it was vertical and stable enough to be safe and it was cleared for launch. Altering with the stability margin of the rocket will be a topic of discussion by the team in the near future.

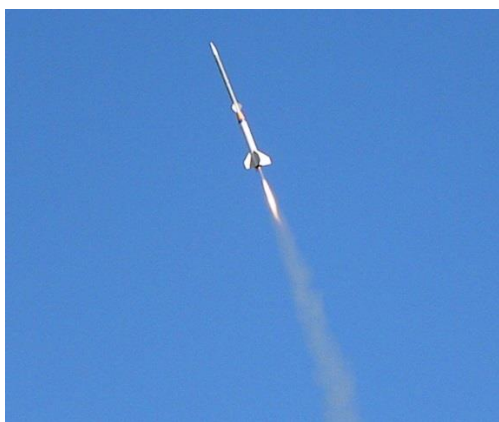
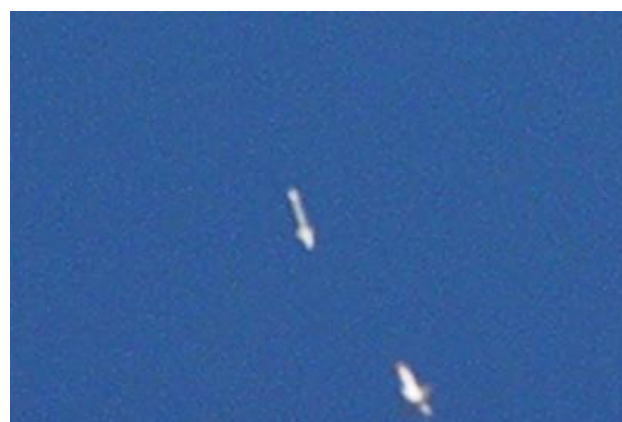
**Figure 10.** The rocket in flight prior to separation

**Figure 11.** Seconds after the dart had separated from the booster

From the data retrieved by the Stratologger barometric altimeters in the booster and the dart, the apogee altitudes were 1065 ft. and 1608 ft. respectively. This puts the separation distance between the apogees of the booster and dart at 543 feet.

For the preliminary design report, it was estimated from the simulation that the separation distance would be roughly 800 feet. Even though the prediction was off by approximately 264 feet, this prediction was based on assumption that the drag-inducing device would be implemented. For the test launch, the team decided not to incorporate the aerobrake system because there were other parts of the rocket that needed more attention with a higher priority. Also, the team wanted to observe how the separation would be without the drag device to reconsider whether adding the deployable flaps would be beneficial or not. After the launch, the team was surprised at how good the separation distance was even without the drag inducing equipment. Because of how successful the rocket was at separating, the team will discuss the use of a drag device in the near future (refer to section 5.1).

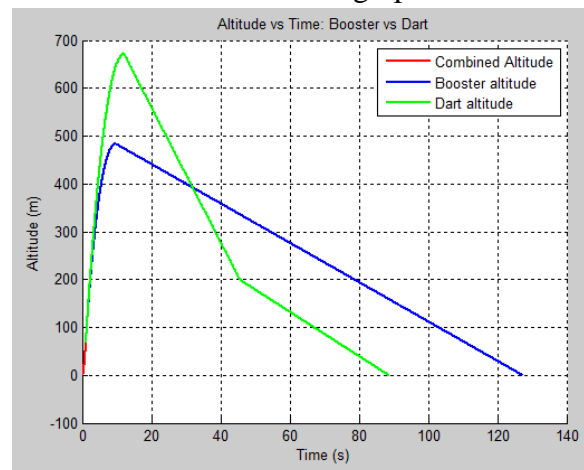
**Figure 16.** Predicted altitude vs. time graph for both the booster and dart

The predicted altitudes for the dart and booster section were 2205 ft. and 1588 ft. This corresponds to a separation of 617 ft.

The most likely cause for the discrepancy between the predicted performance and the actual data is the arbitrary choice of drag coefficients for the rocket sections. Without wind tunnel testing, it is impossible to know exactly what the drag coefficient for the rocket and individual sections would be. The chosen values were merely based off of the shape of the rocket and the drag coefficient of general shapes found online. The windy conditions on the launch date may have also hindered the rocket's performance.

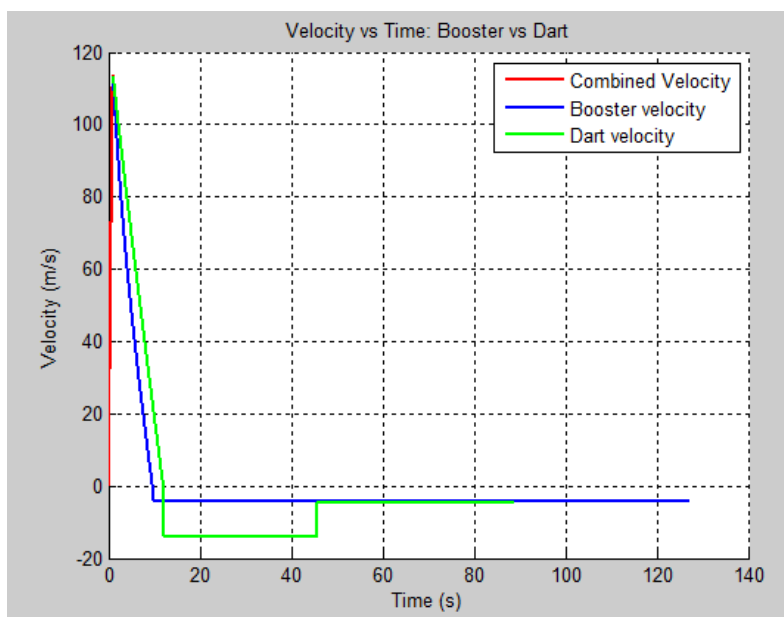
**Figure 19.** Predicted velocity vs. graph for both the booster and dart

The measured peak velocity for the dart section was 418 ft/s, and the maximum peak velocity for the booster section was 796 ft/s. The predicted peak velocity for both sections was 373 ft/s.

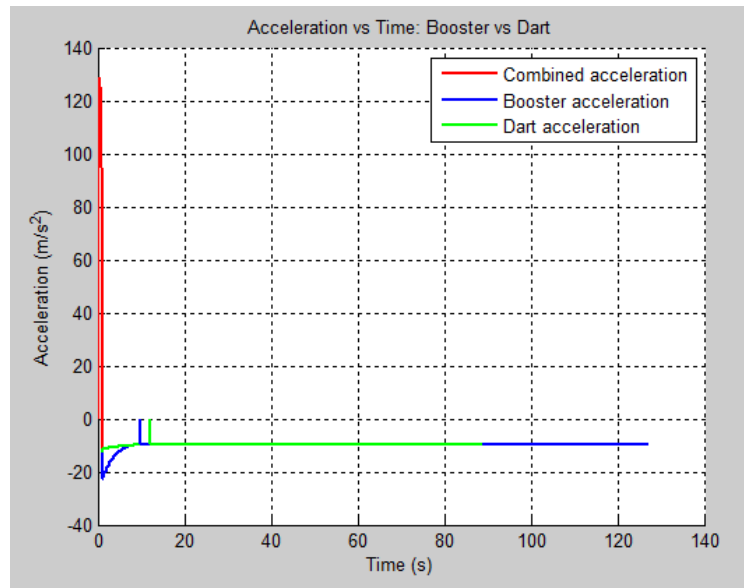
**Figure 22.** Predicted acceleration vs. graph for both the booster and dart

Both of the graphs of measured acceleration showed the proper acceleration trends for a rocket launch, but the magnitudes departed quite heavily from the predicted value of  $423 \text{ ft/s}$  for both sections.
