The Aisled Hall at Mellor
An appraisal of the evidence

Mellor Geophysics

0.1 SUMMARY

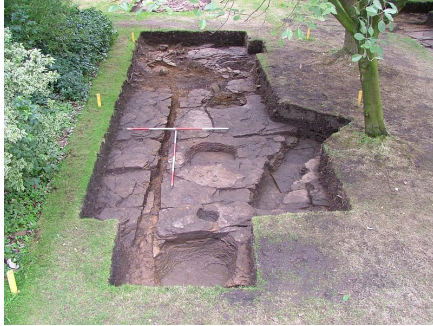
(a) Row of postholes with scale

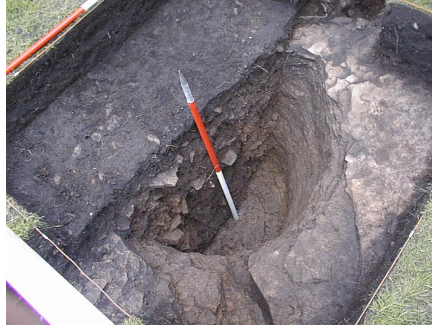
(b) Posthole with postpipe

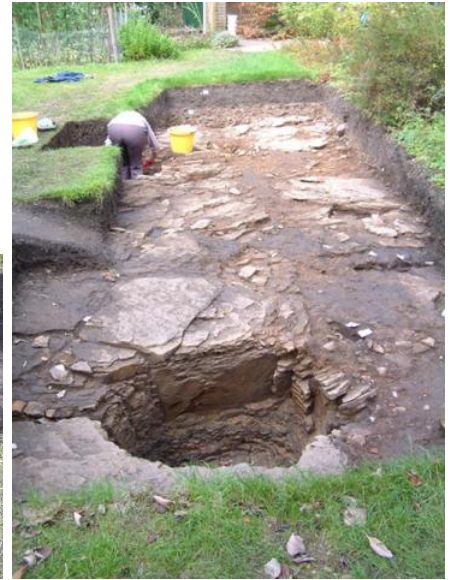
(c) Postholes being excavated

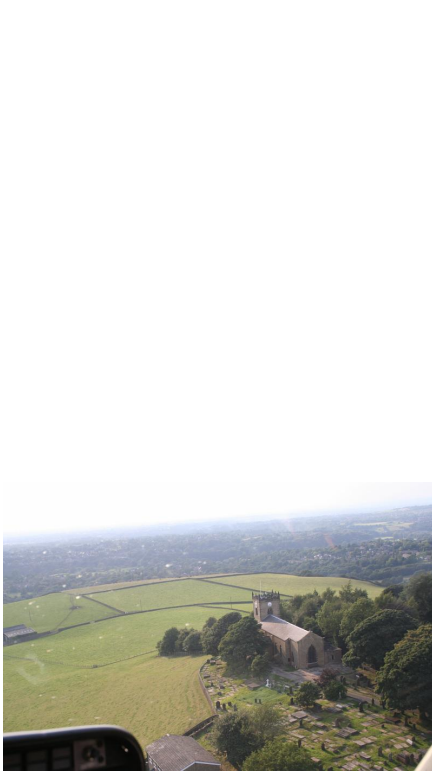
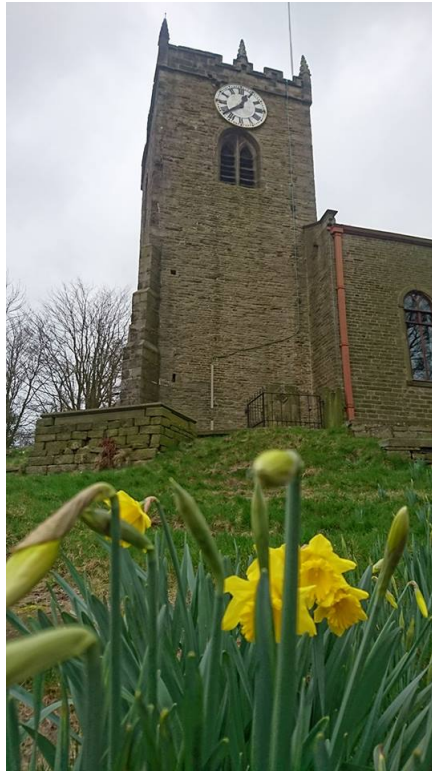
Figure 3: St. Thomas' church in Mellor

(a) The Tower

(b) The Tower

A stone church almost certainly existed on the present hilltop site at Mellor (Figure ??) in the 12th Century, and quite possibly parts had been there for several centuries; for example, the base of the tower at the west end (Figure ??) is thought to date from around or before 1100. Some of the furnishings inside the present church (for example, the font and pulpit, Figures 5a and 3c) may date from Saxon times, suggesting the existence of an earlier (probably wooden) church on or around the same site. It is, therefore, conceivable that the postulated Aisled Hall was, during the relevant period, the residence of the local priest. It is also possible that the structure originates

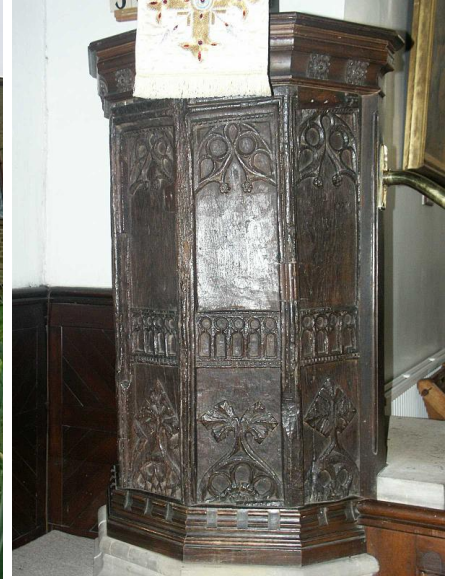
(c) The pulpit is carved from a single oak log

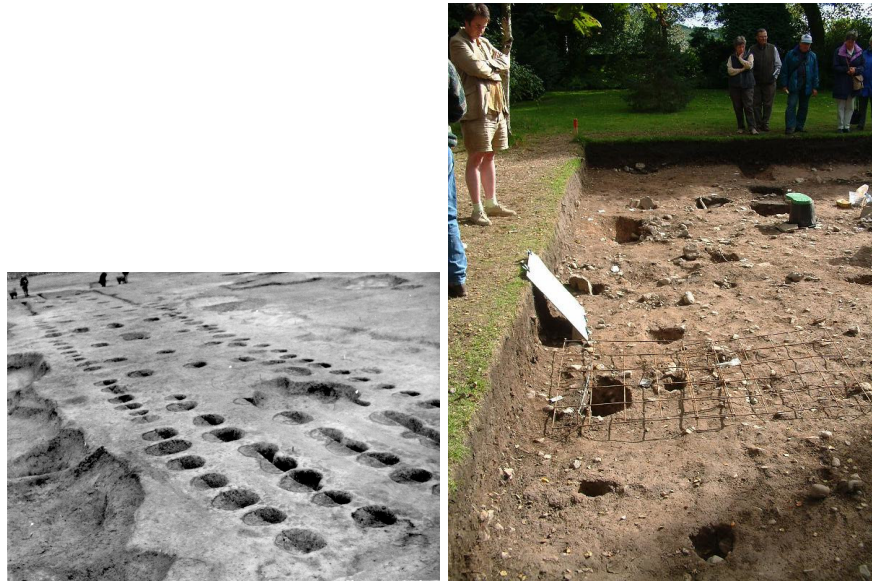
Figure 4: Pre-Norman Postholes

(a) Neolithic Longhouse at Bylany

(b) Round-house Postholes

buildings supported along a central ridge, with small, closely-spaced post-holes running down the centre of the structure. The existing post-holes in Mellor do not fit this design and the space between the existing post-holes lack any evidence of the smaller indentations required for this hypothesis. Known Mesolithic houses in Britain used a circular arrangement of posts.

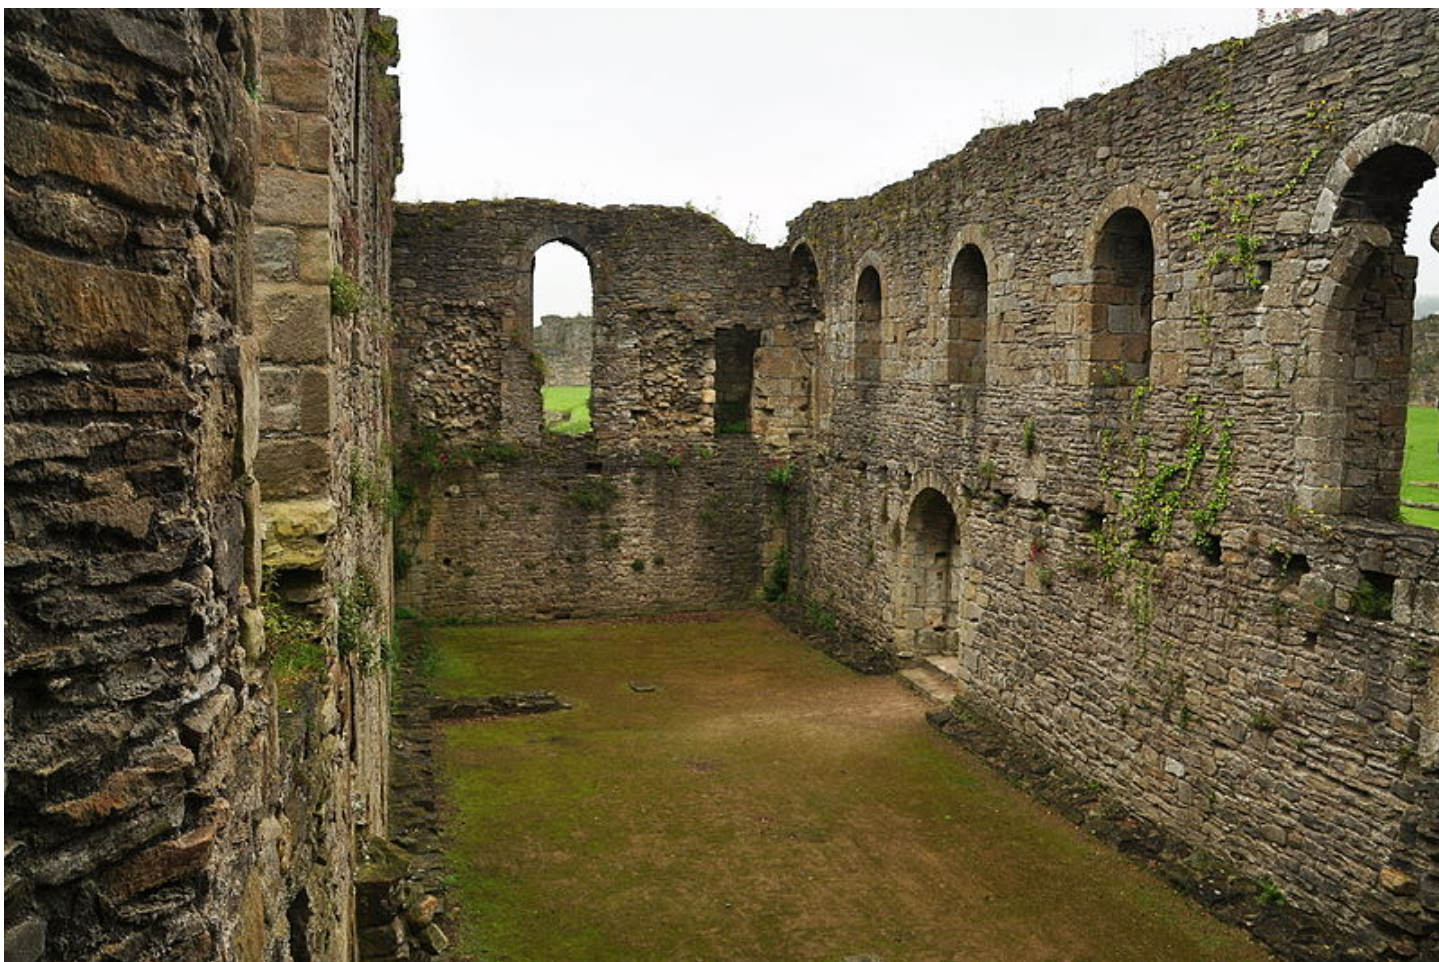
Figure 6: Scolland's Hall, Richmond Castle

Scolland's Hall, Richmond Castle, is recognized as an example of a First Floor Hall. (Hill, Nick and Gardiner, Mark – 2017 – The English Medieval First-Floor Hall, The Evidence from the Eleventh to Thirteenth Century, Archaeological Journal)

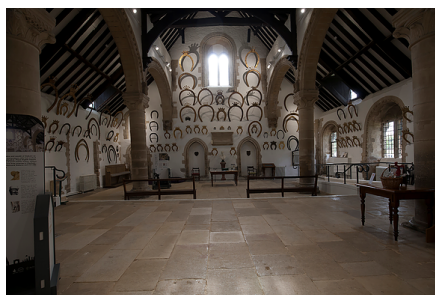
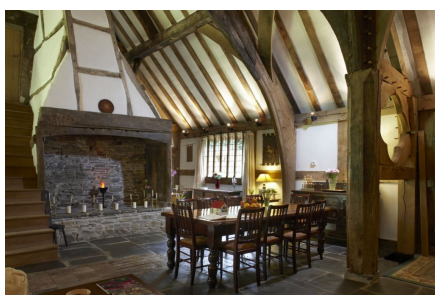
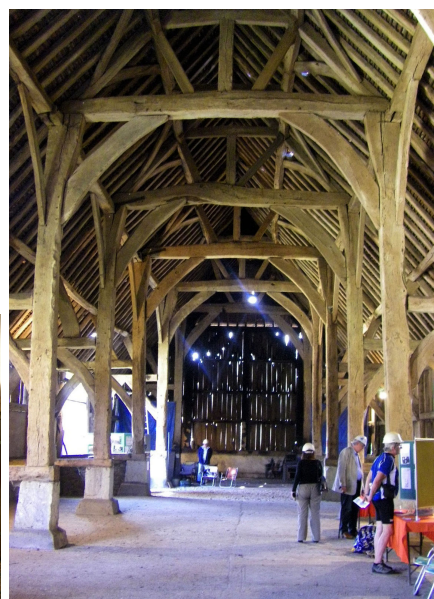
Figure 7: Extant Aisled Halls

(a) Oakham Castle

(b) Ty Mawr

(c) Harmondsworth Great Barn

As with First-Floor Halls, Aisled Halls were also relatively common in England between the 11th and 13th centuries (reference). These Halls were generally fairly wide buildings and used lines of posts to hold up the roof. In cases in which the Halls had multiple floors, this technique was also used to hold up the ceiling. Aisled Halls were typically built at the ground floor level, and varied in size, shape, and mode of construction. Some were built of stone, or stone and brick, and many of these are still in existence (see Figure 7a for an example). But many were built entirely of wood, and some of these are also in existence (see Figures 7b & 7c). The largest known Aisled Hall had support posts two feet square set in holes six feet deep. This would in principle allow for these posts to be fifty or sixty feet high. The shape varied from being almost square to being three or four times as long as wide, although the design did not place any real limit on the length of the structure.

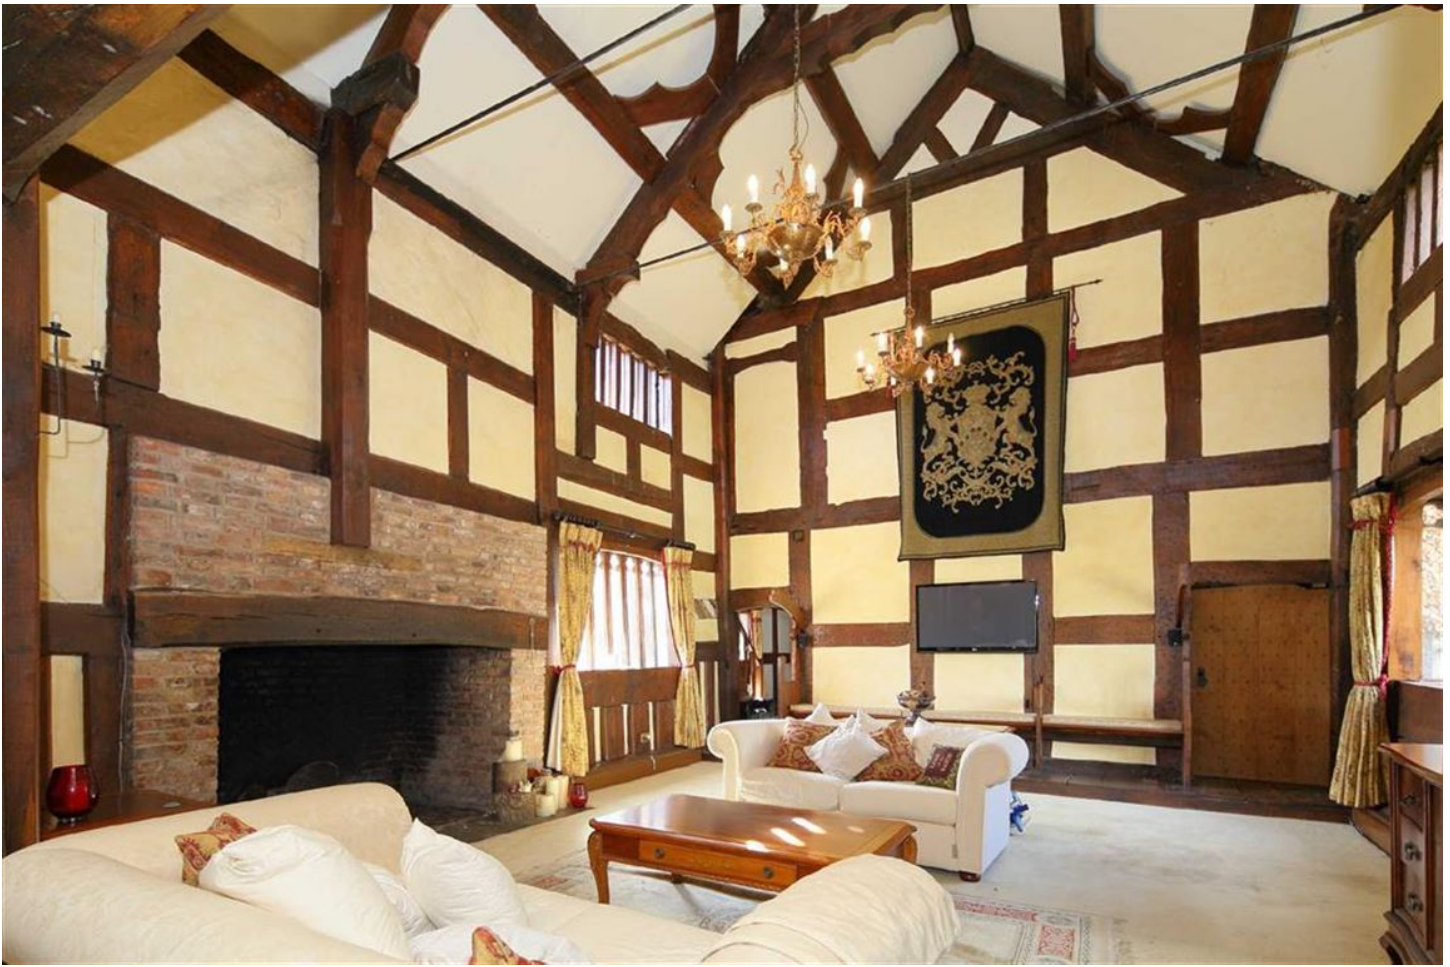
Figure 9: Spruce Truss Hall at Althrey Hall in Wrexham

These are a derivative of the Aisled Hall, which appeared as advancements in roof technology improved. A Spere Truss Hall (Figure 9) used a braced collar beam for the central span, eliminating the need for the posts within the Hall itself. Only the posts for the outer walls were required. These structures are 14th century, which is later

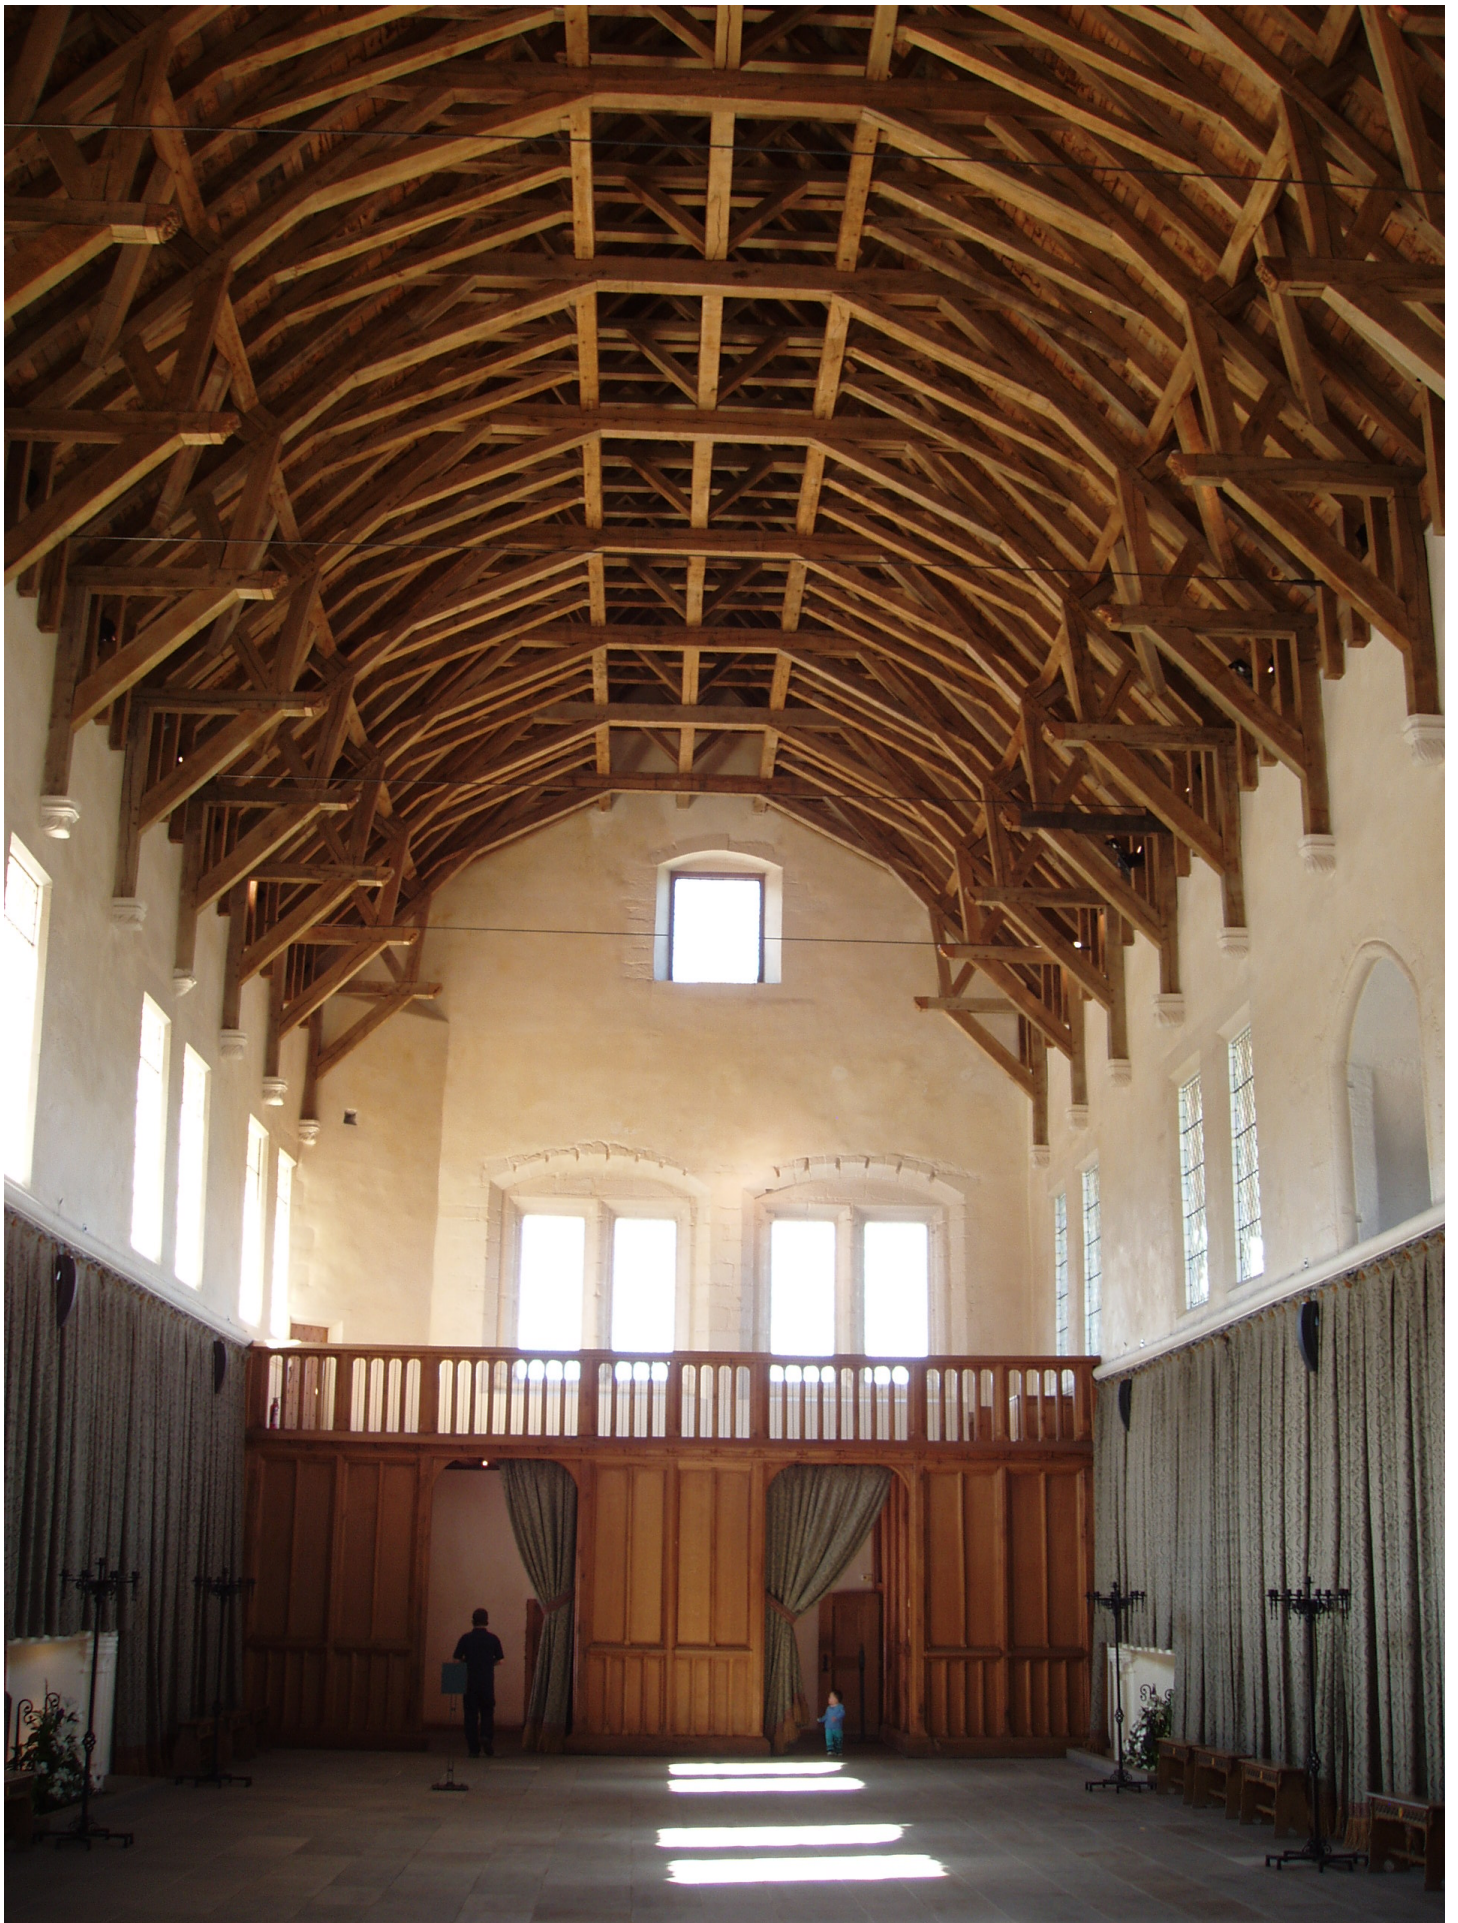
Figure 10: Great Hall of Stirling Castle

During the 13th century, another new design was being developed which omitted interior support posts. These Great Halls (Figure 10) used elaborate networks of beams and arches connecting to the outer wall to provide the support for the roof. Because the excavations in Mellor have revealed a central row of supports, the Great Hall can be immediately excluded from consideration.
