Aviation Investigation Final Report

Location:	Oral, South Dakota	Accident Number:	CEN22FA109
Date & Time:	January 30, 2022, 17:10 Local	Registration:	N3177F
Aircraft:	Christavia MK1	Aircraft Damage:	Substantial
Defining Event:	Loss of control in flight	Injuries:	1 Fatal
Flight Conducted Under:	Part 91: General aviation - Personal

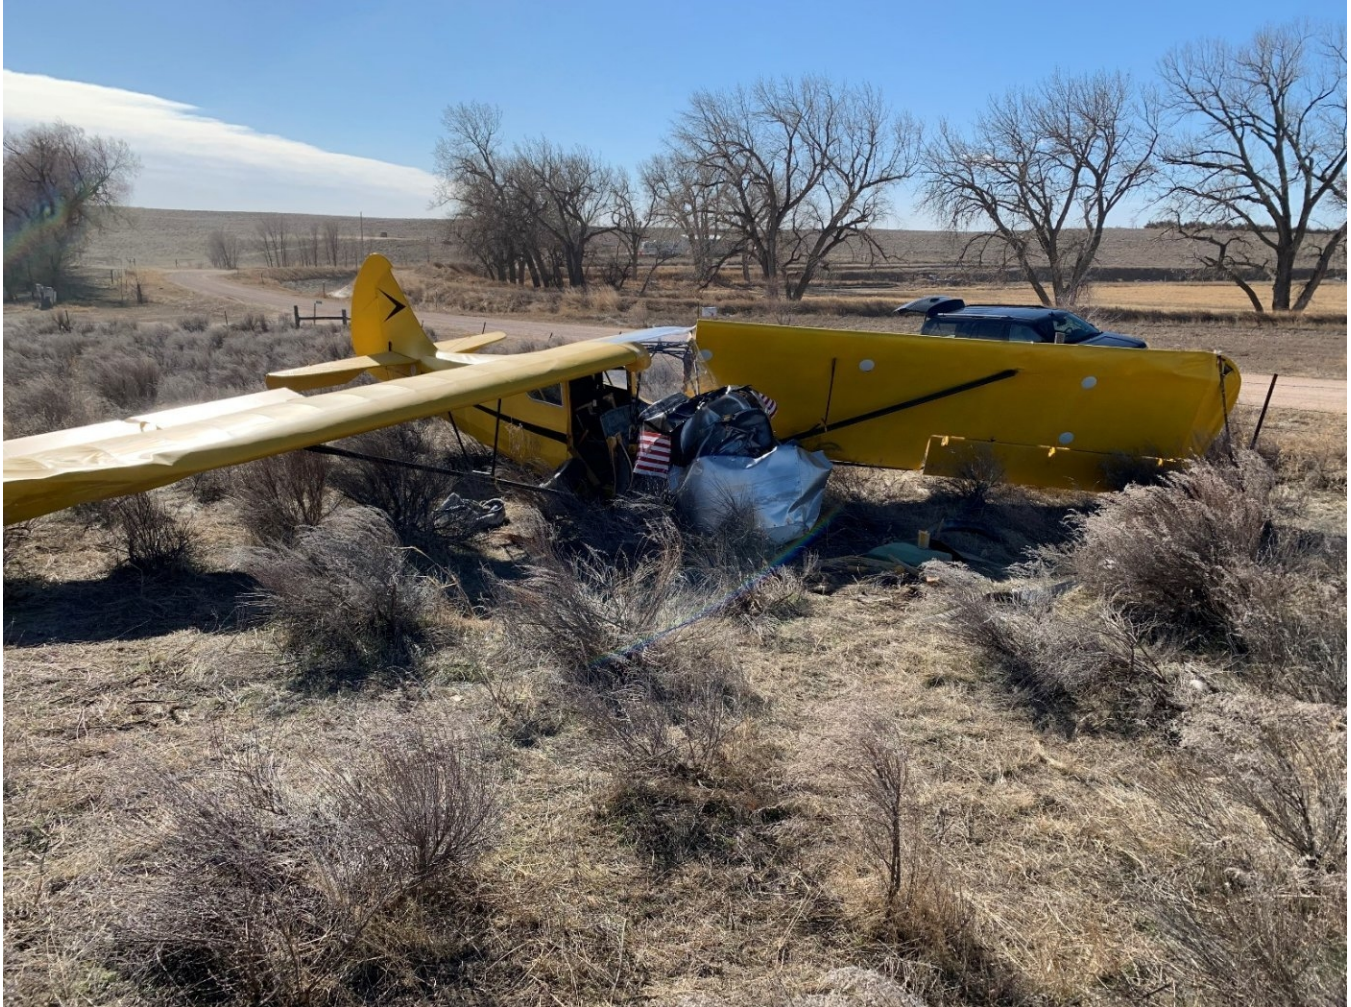
Postaccident examination of the airplane revealed that the left-wing aft spar was separated at the wing root, and the wing was displaced forward. The lower forward fuselage was crushed upward and aft. The outboard right wing displayed leading edge aft crush damage. A ground scar consistent with the wing leading edge was located below the wing. The engine was displaced downward and to the right (see figure). The fixed-pitch propeller was located about 5 ft forward of the main wreckage and was separated at the engine crankshaft flange. The propeller blades displayed forward twisting deformation.

Figure. Accident Airplane
