SEISMIC PERFORMANCE OF HIGH-STRENGTH REINFORCED CONCRETE COLUMNS AFTER FIRE EXPOSURE

SUMMARY

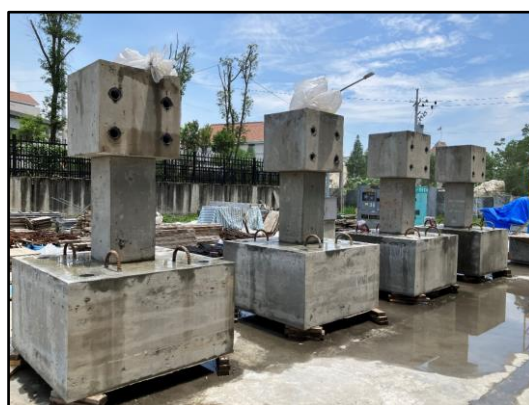
Figure 1 Photo of the specimens

A total of 4 single-column specimens were made in this study, which is shown in Figure 1. The specimens were divided into 2 groups in terms of design compressive strength of concrete, which is general-strength 35 MPa and high-strength 70 MPa, respectively. In each group, 1 specimen was subjected to 2-hour fire exposure test, and the other was the control group which was not subjected to fire test. In addition, except for the design compressive strength of concrete, the other configurations of the 4 specimens were the same, and columns were designed for single curvature with 15% axial compression ratio, which is shown in Table 1.

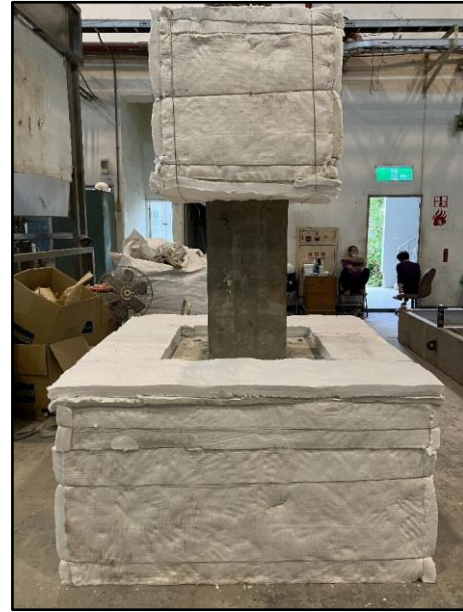
Figure 3 Configuration of ceramic fiber fireproof cotton

In order to prevent the damage of the upper and lower bases of the single-column specimens during the fire test, 2 layers of ceramic fiber fireproof cotton with a total thickness of 7.5 cm will be pasted on the surface of the upper and lower bases before the experiment. In addition, to reduce the insulation effect caused by fireproof cotton on the plastic hinge area of the specimens, fireproof cotton will not be pasted on the area near the column by half column width (20 cm), as shown in Figure 3.

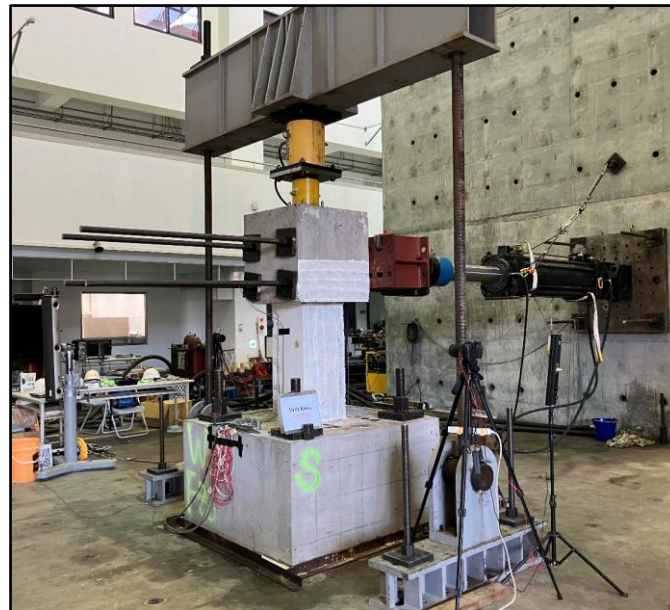
Figure 4 Setup of cyclic loading tests

In this study, cyclic loading tests were carried out in conjunction with reaction wall and strong floor, and the seismic behavior of the specimens were evaluated by the hysteresis loops and failure patterns from the tests. The experimental setup is shown in Figure 4, which includes a 1000-kN horizontal actuator in the lateral side and a set of 2000-kN axial force jack on the top. The test will first load vertically to the target axial force and then control the top of the column to reach the specified drift ratio by displacement control method. The target drift ratio are 0.25, 0.375, 0.5, 0.75, 1, 1.5, 2, 3, 4, 5, 6, 7 and 8%, respectively, and each drift ratio is carried out for two cycles, as shown in Figure 5. In addition to the displacement sensor of the horizontal actuator, an additional optical measurement system was set up to obtain more accurate displacement datas in this study. The optical measurement system uses the NDI Optotrak Certus instrument of Northern Digital Incorporation (hereinafter referred to as NDI), which principle is to send a signal by the NDI host to the sensors pasted on the surface of the specimens, and receive its reflected signal to record the coordinates.

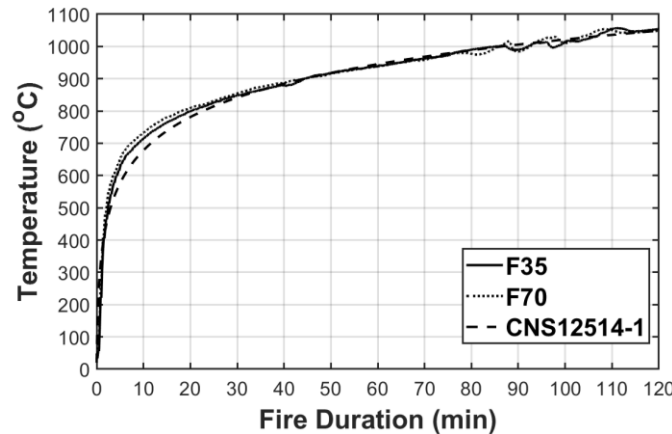
Figure 6 Heating curve of Furnace

Both F70 and F35 specimens were successfully completed the 2-hour fire exposure test, which has 4.5 and 4.0% of moisture content in concrete surface before the experiment and 69 and 76 days of concrete age, respectively. The comparison between the furnace temperature history and the standard heating curve is shown in Figure 6, which can be seen that the experimental heating conditions are consistent with the standard heating curve of the experimental program.

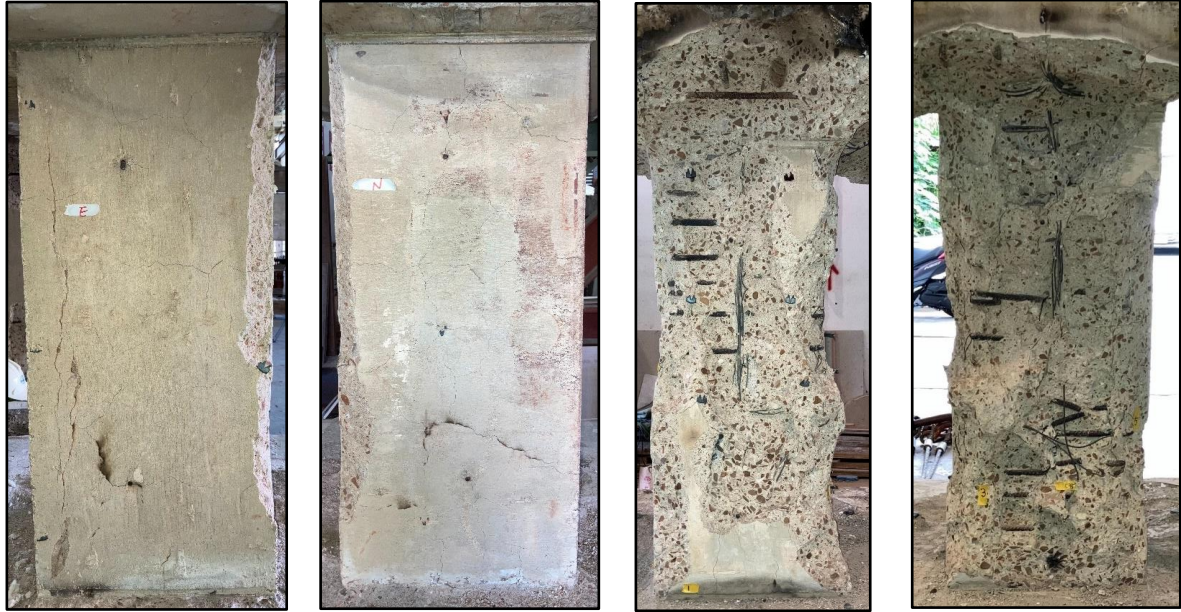
Figure 7 The surfaces of the fired specimens after 2-hour fire exposure test

The severely damaged surfaces of F35 and F70 specimens after fire test are shown in Figure 7. From the interface between the lower base and the shaft, it can be seen that the color of the concrete surface after exposure to fire will change from gray to yellowish brown, and it can also be seen that there are many cracks on the concrete surface, which do not penetrate the shaft and they are arranged in sheets for the surface of F70 specimens, and the moisture content in the concrete surface of both specimens after the experiment are almost 0, therefore, it is judged that these cracks are caused by shrinkage of the concrete due to the loss of moisture. In addition, F70 specimen can clearly observe the moment of explosive spalling on concrete surface during the experiment, and it can be seen from Figure 7(c)(d) that the concrete spalling is serious and stirrups can be seen directly in many places, which means that the spalling depth of concrete has exceeded the thickness of the cover (4 cm). If the duration of the fire keep increasing, the temperature of the rebars which are exposed to fire directly will rise rapidly to cause a large reduction in strength. Compared with the F35 specimen, only a corner of the concrete spalled off, which shows that high-strength concrete is less refractory than general-strength concrete due to the explosive spalling behavior during fire.

(a) East side of F35 (b) North side of N35 (c) East side of F70 (d) North side of F70

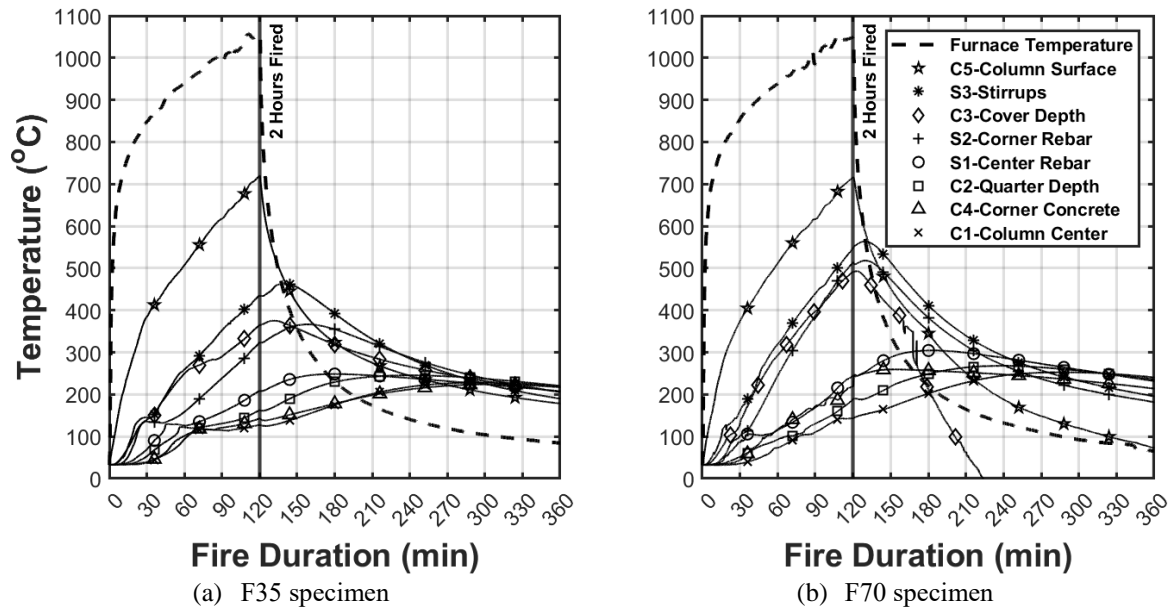
Figure 8 Representative heating curve of fired specimens

Due to the concrete spalling in the fire test, some thermocouples were damaged by directly exposed to fire, therefore, the complete and smooth temperature datas were selected as the representative heating curve, and the datas had been recorded until 4 hours after the fire test, which is the moment that every measuring point had reached the highest temperature and cooled down slowly, as shown in Figure 8.

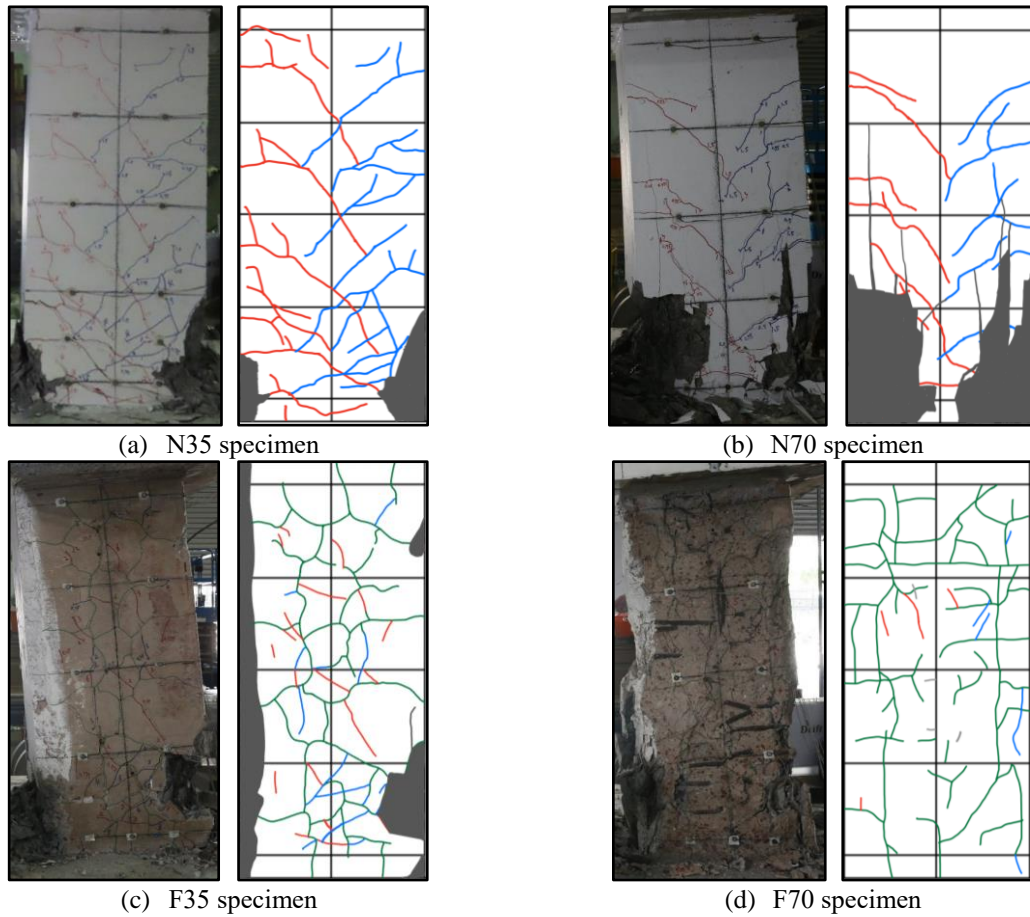
Figure 12 Failure patterns

For N70 specimen, the maximum lateral strengths in positive and negative directions are 444 and 462 kN, respectively, and both occur in the loops of drift ratio of 1.5%. The effective stiffnesses in positive and negative directions are 38.7 and 32.8 kN/mm, respectively. The negative failure drift ratio is 6.3%, and the lateral strength at the drift ratio of 7% still remains 86% of the maximum lateral strength in positive direction. The failure pattern are shown in Figure 12(b), the cracks developed horizontal flexural cracks before the drift ratio of 0.75%, and

developed oblique flexural-shear cracks after the drift ratio of 0.75%, and the concrete was crushed at the drift ratio of 1.5 and 2% in positive and negative directions, respectively.

- (2) For the failure patterns, unfired specimens develop flexural cracks to flexural shear cracks, and concrete crushed in the end, while the fired specimens develop the cracks along the cracks caused by the fire test and with no obvious concrete crushing moment. In addition, the use of high-strength concrete will result in concrete crushing at smaller drift ratio than the use of general-strength concrete.
