A NEW HIGH RESOLUTION OPTICAL SYSTEM FOR INSPECTION OF GUN- AND MULTI-CELL RESONATORS IN ISO-4 CLEANROOMS

Marco Schalwat, Ruediger Bandelmann, Alexej Daniel, Nicolay Krupka, Axel Matheisen, Sven Sievers, DESY, Hamburg, Germany

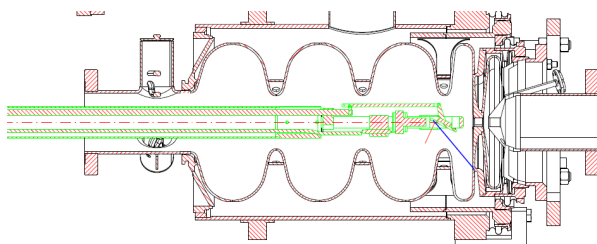
Figure 1: Drawing of 3.5 cell SRF gun cavity with optical inspection system.

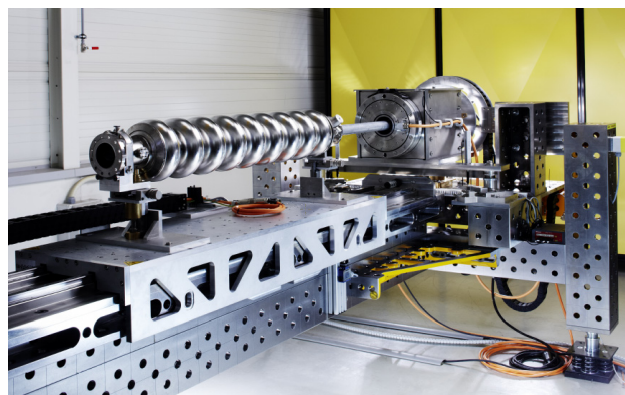
Figure 2: Picture of the OBACHT optical inspection system.

The second purpose was the installation of the new system in a cleanroom. The DESY OBACHT system (Fig. 2) is currently installed in a non-cleanroom area. At the moment it is necessary to transport cavities over long distances within DESY premises for the inspection of the inner surface. After each transport and OBACHT inspection an ultrasonic and UPW rinsing has to be done before the cavity can be used for further actions.

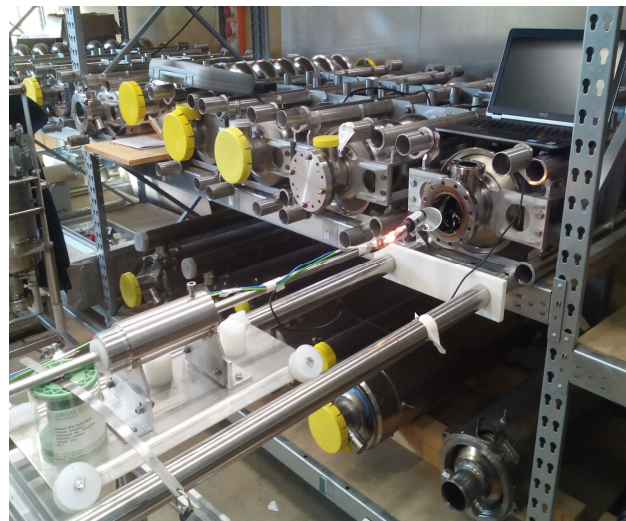
We established a test installation for the inspection of the inner surface of cavities outside the cleanroom to gain experiences on how to set up the new system. The existing devices for the installation of the field profile measurement system (FMS) was modified (Fig. 3).

With the FMS device it was possible to align the camera for the inspection in the centre of the beam tube.

Figure 3: First steps to establish the new system.

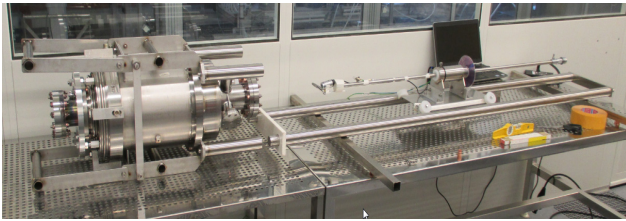
Figure 8: 3.5 cell SRF gun cavity installed in the cleanroom.

The first cavity which was inspected was a 3.5 cell SRF gun cavity, commissioned for the Helmholtz Centre Dresden Rossendorf (Fig. 8)[3]. This cavity was inspected with a conventional Web Cam.

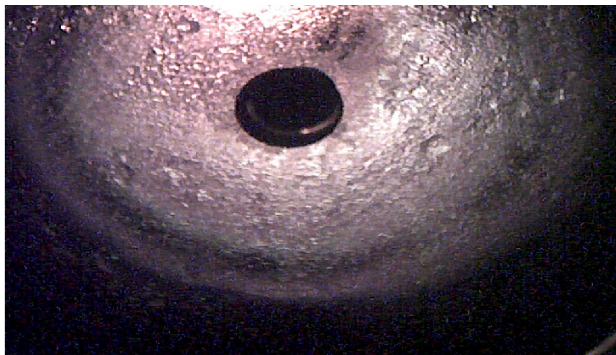
Figure 9: View to the back plate of the Rossendorf SRF gun cavity with webcam.

Our first test set up with the conventional web cam was unsatisfactory. The resolution of the pictures had low quality (Figs. 9, 10).

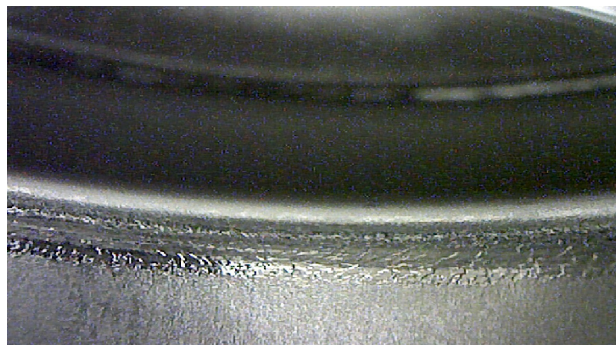
Figure 10: View to an inspected iris weld of the Rossendorf SRF gun with webcam.

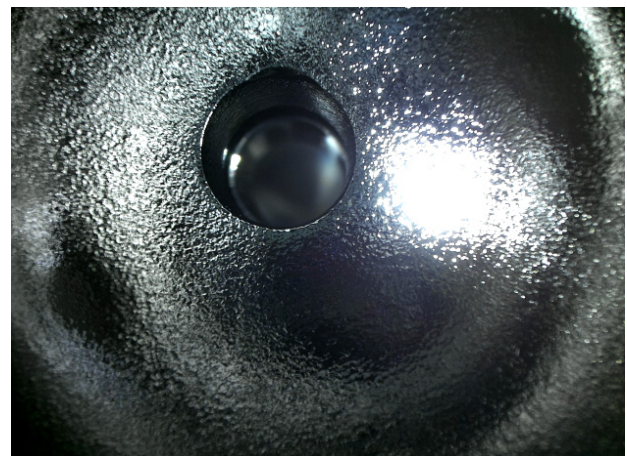
Figure 11: Inspection of the back plate with new camera.

After a new camera system had been installed a second inspection on the SRF gun cavity could take place. The quality of the pictures were significantly better (Figs. 11, 12), however no reason for bad measurement results could be detected.

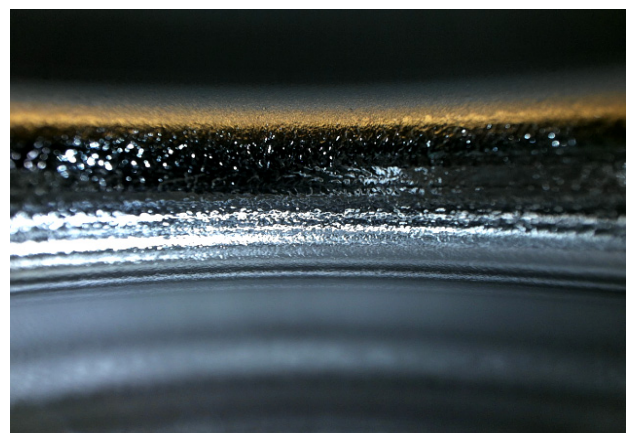
Figure 12: Inspected weld with new camera.

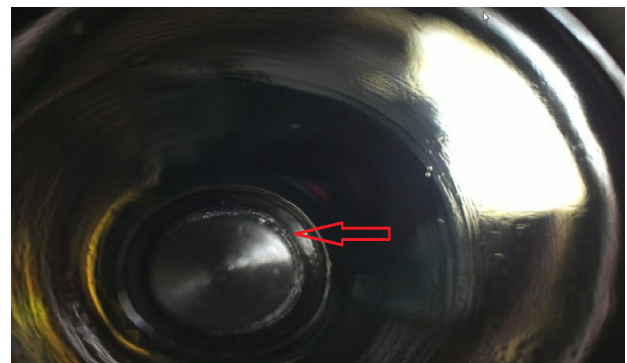
The inspection of the 1.6 cell DESY SRF gun cavity has shown irregularities. In the middle of the back plate at the cathode hole, damages were found (Fig. 13). Closer investigations showed indium which is used for sealing of the lead plug.

Figure 13: View to the back plate of the DESY SRF gun cavity.

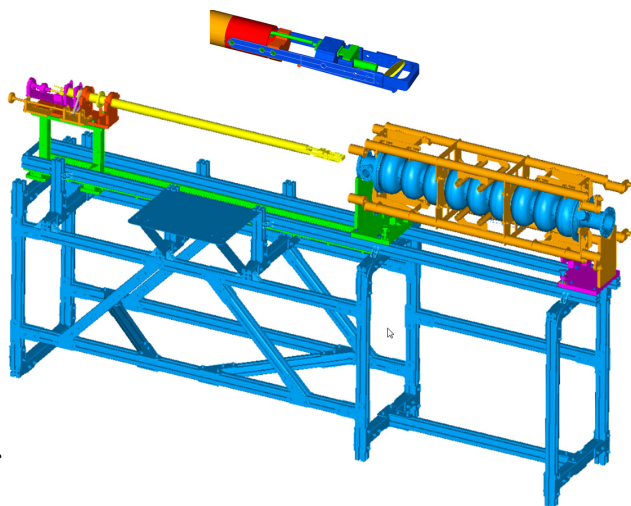
In the future it will be possible to adjust the mirror during inspection (see Fig. 14). Due to the stiffer rod there will be less vibrations. The lightening will be axial.

Figure 14: View to the improved device.

The first experiences during the cavity inspections have shown that parts of the device have to be revised. Due to the thin rod, the weight of the holder and the camera, the rotation of the camera causes vibrations during movement. The minimum number for the new design is an adapter for the camera, a tilted mirror, a rod which is picking up the camera, and a lengthwise adjustment. A new device is under construction.

A support which can capture cavities up to nine cells, with or without helium vessel, will be included to guaranty a better horizontal orientation.
