City of Poquoson, Virginia Shoreline Inventory Report Methods and Guidelines

**Comprehensive Coastal Inventory Program
Center for Coastal Resources Management
Virginia Institute of Marine Science, College of William and Mary
Gloucester Point, Virginia
November, 2013**

Special report in Applied Marine Science and Ocean Engineering No. 438 of the Virginia Institute of Marine Science

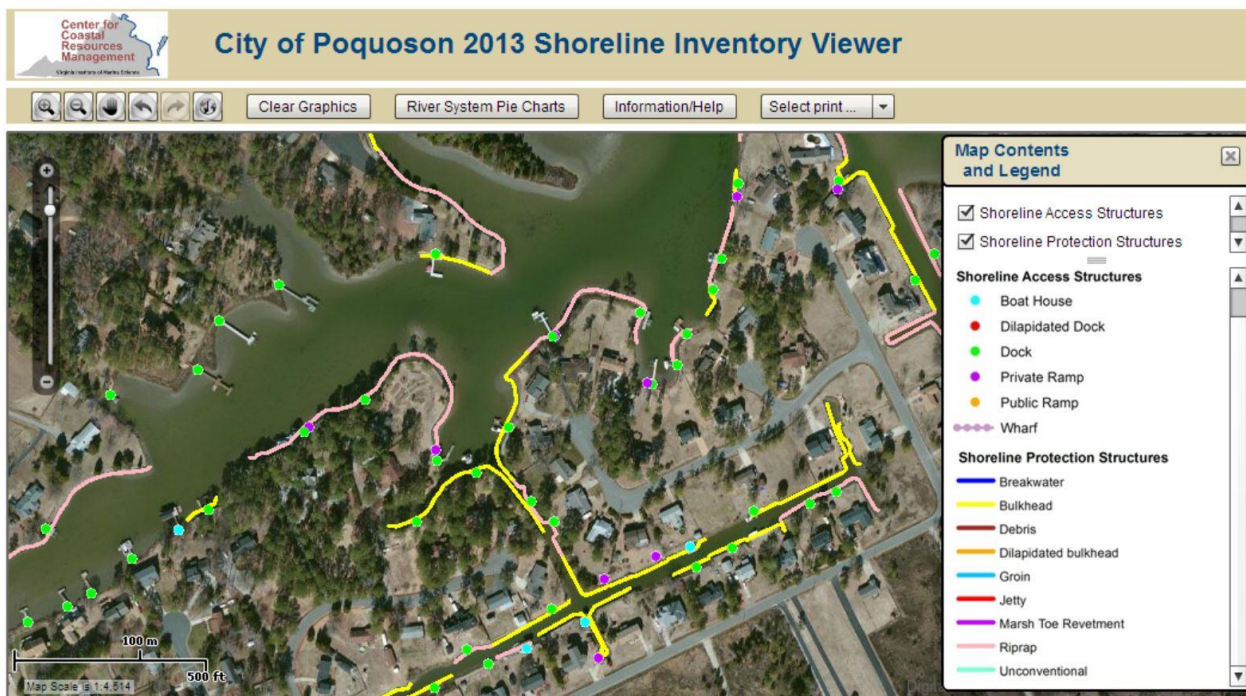
Figure 4. Map Viewer illustrates Shoreline Access and Protection Structures.

In Figure 4, Shoreline Access Structures, and Shoreline Protection structures are selected. Shoreline Access structures are point features that includes piers and boat ramps. The actual footprint of these structures is not measured; only their location. Shoreline Protection Structures are line features and are mapped and illustrated in the viewer to show where they occur along the shoreline. Figure 5 illustrates riparian land use.

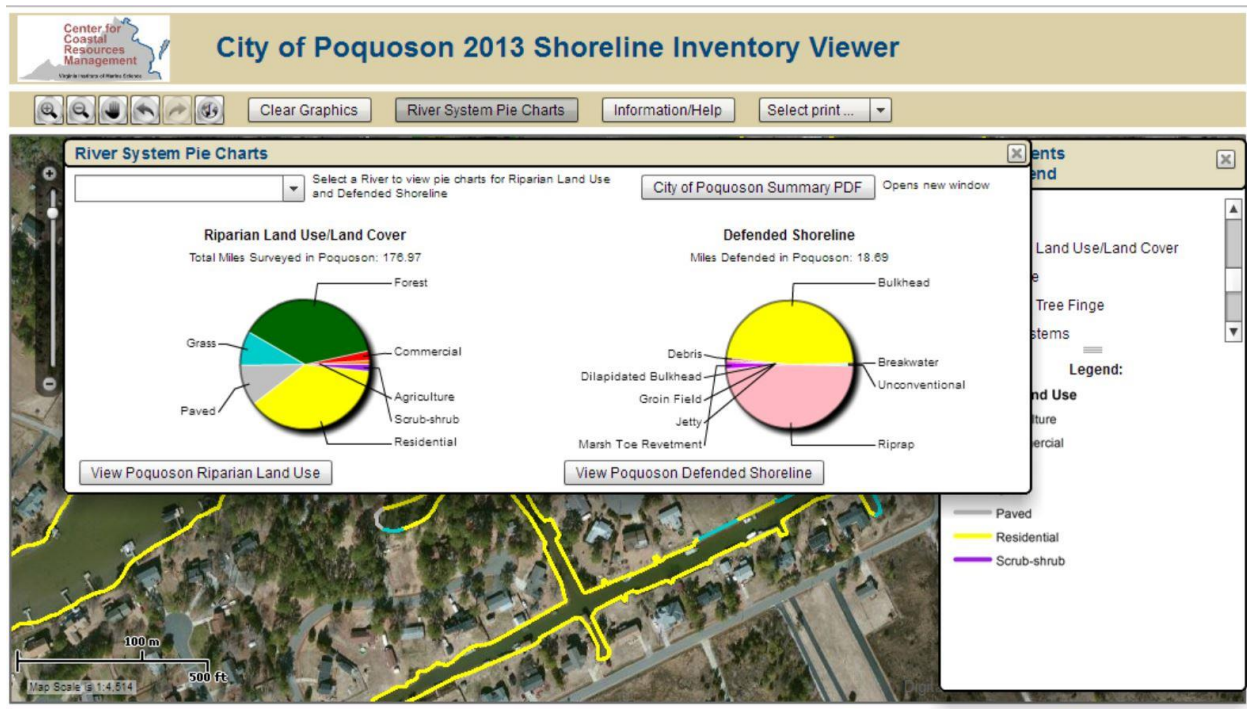
Figure 7. Pie charts display land use and shoreline hardening statistics for each tributary.

The top toolbar also includes tabs to access some important status information for the locality. By clicking on the “River System Pie Charts” button, users can obtain a statistical summary distribution of the riparian land use and amount of hardened shoreline for a specific water body which is selected from the drop down menu in the upper left (Figure 7). More detailed results in table format can be found by clicking the City of Poquoson Summary PDF button also in the window. The summary statistics are reported by river systems (Figure 2).
