This tutorial was created based on the replacement procedure for a similar car part on: BMW 3 Saloon (E90) 318i 2.0

REPLACEMENT: ANTI ROLL BAR LINKS – BMW 1 COUPE (E82). AUTODOC EXPERTS RECOMMEND:

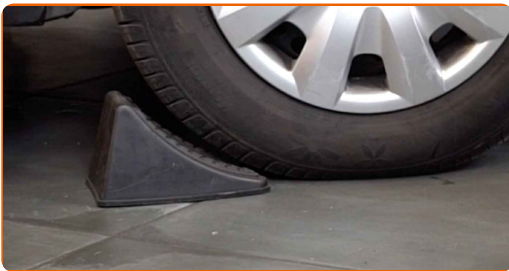
1

Secure the wheels with chocks.

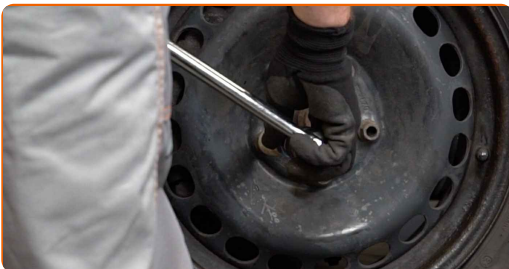
2

Loosen the wheel mounting bolts. Use wheel impact socket #17.

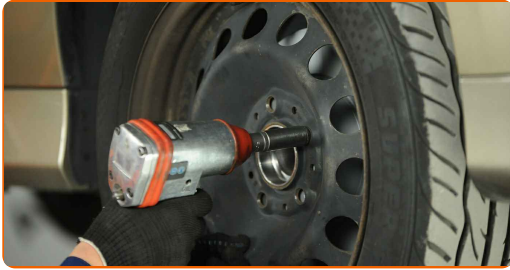
4

Unscrew the wheel bolts.

- Warning! To avoid injury, hold the wheel while unscrewing the fastening bolts.
BMW 1 Coupe (E82)

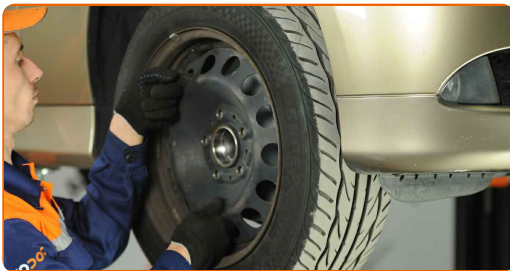
5

Remove the wheel.

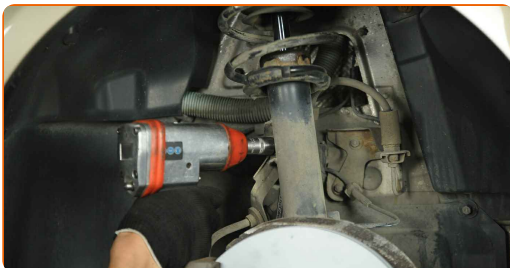
7

Unscrew the fastener connecting the stabilizer link to the shock strut. Use a combination spanner #17. Use a drive socket #16. Use a ratchet wrench.
